SERVICE DIRECTIVE BULLETIN NO. 0088

1. SUBJECT: Cracks in Lower Swashplate Universal Housing, Part Number 28-16119-1
2. MODEL: F28A, 280, F28C, 280C, F28F, 280F, and 280FX
3. EFFECTIVITY: F28A, 280, F28C, 280C, and 280F; All Serial Numbers  
F28F; Serial Number 808 and prior  
280FX; Serial Number 2079 and prior

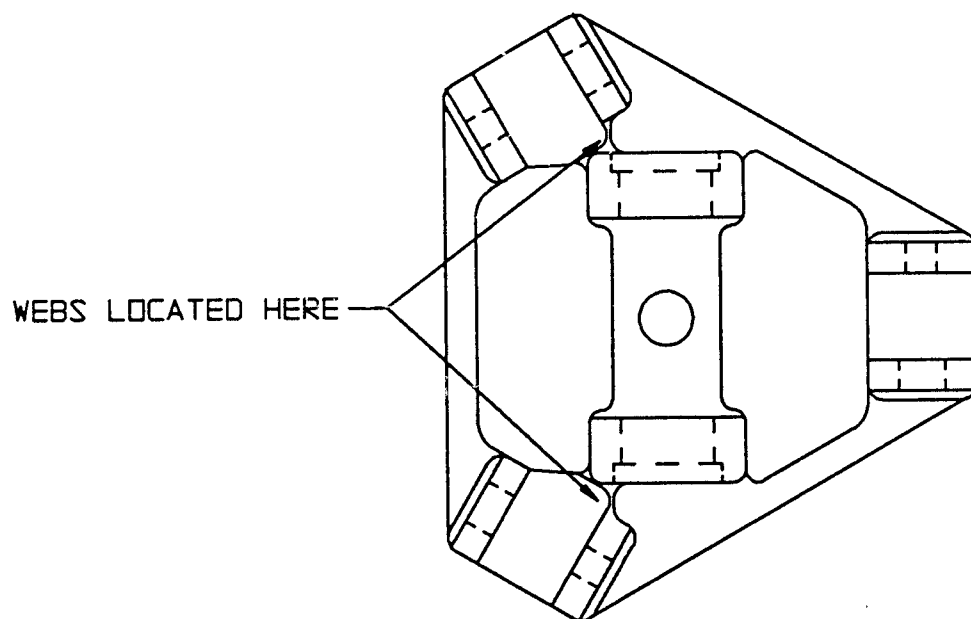
FIGURE 1

Enstrom has received reports of cracks developing in the lower swashplate universal housing. The cracks occur at the top of the thin web located between the mounting lugs for the universal shaft and the rod end bearings commonly referred to as "dog leg bearings" (See Figure 1).

Investigation revealed that the cracks are stress relieving in nature due to the thin web. The cracks do not propagate to critical areas of the lower swashplate universal housing. There has never been an in-service failure of the lower swashplate universal housing due to cracks.

The machining process for the lower swashplate universal housing has been modified to eliminate the thin web in all new lower swashplate universal housings, P/N 28-16119-3.

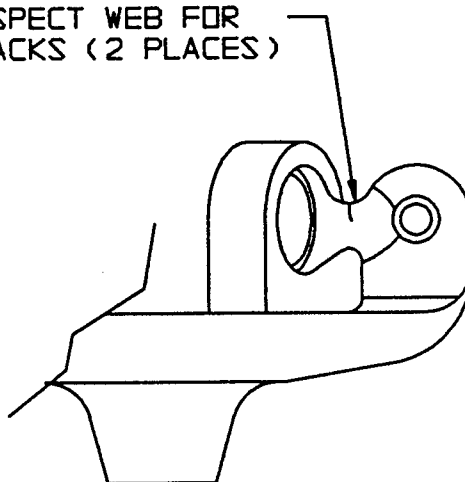
FIGURE 2

INSPECT WEB FOR  
CRACKS (2 PLACES)

b. Using a suitable light source and a 10X magnifying glass, visually inspect the web area between the universal shaft and rod end bearing mounting lugs for cracks (See Figure 2).
