SERVICE DIRECTIVE BULLETIN NO. 0093

1. SUBJECT: Tail Rotor Control Cable Inspection
2. MODEL: F-28A, F-28C(-2), F-28F, 280, 280C, 280F, and 280FX
3. EFFECTIVITY: All serial numbers equipped with tail rotor control cable pulleys installed in the tailcone (Refer to paragraph 4)
4. BACKGROUND:

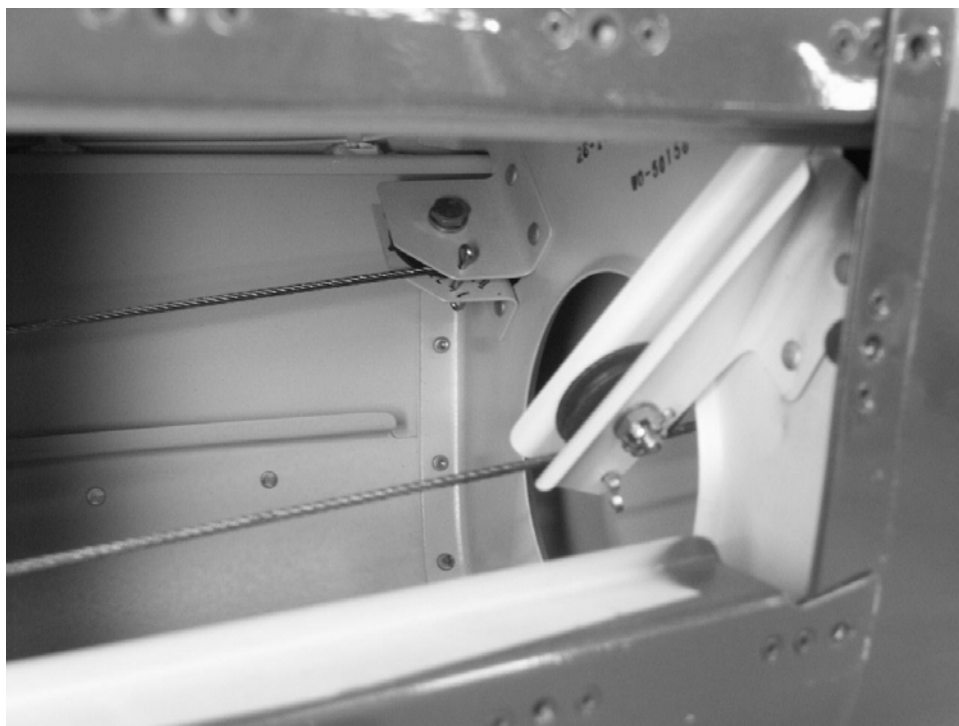
Figure 1. Tail Rotor Control Cable Pulley Installation

Enstrom has received reports from inspection personnel in the field of frayed and worn tail rotor control cables. The reports indicate that the wear is occurring at the pulleys (See Figure 1) in the tailcone located aft of the horizontal stabilizers. These pulleys are installed in tailcone assemblies installed on all 280FX model aircraft and F-28F model aircraft, S/N 744 and subsequent.

Figure 1 shows the latest tail rotor control cable pulley installation. On earlier installations, the left side pulley installation is a mirror image of the right side pulley installation.

4. Partially pull the tail rotor control cables out of the tailcone through the access opening and inspect the areas of the tail rotor control cables that pass over the pulleys and inspect the pulleys in accordance with FAA Advisory Circular 43.13-1B, paragraph 7-149, Cable System Inspection (Appendix A to this Service Directive Bulletin). If the pulleys are rubbing on the mounting brackets, AN960-10L Washers may be used as shims to eliminate the interference.

5. Replace/Reinstall the tail rotor control cables and/or pulleys as required. Set the control cable tension and tail rotor rigging in accordance with the maintenance manual.

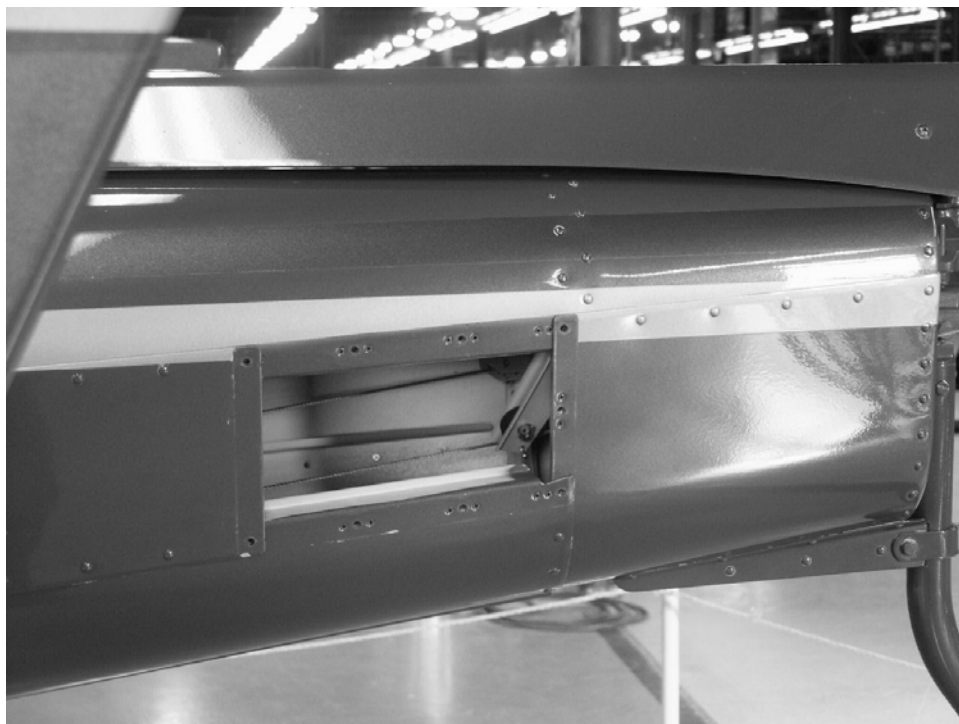
Figure 2. Access Panel Location

1. Remove the access panel located aft of the horizontal stabilizer on the left side of the tailcone (See Figure 2) and determine if the tailcone is equipped with the pulleys.
