SERVICE DIRECTIVE BULLETIN NO. 0100

1. SUBJECT: Inspect Swashplate Rod End (Dog Leg) Assembly, P/N 28-16143, for excessive play/wear.
2. MODELS: F-28A, F-28C, F-28C-2, F-28C-2R, 280, and 280C
3. EFFECTIVITY: All Serial Numbers
4. BACKGROUND:

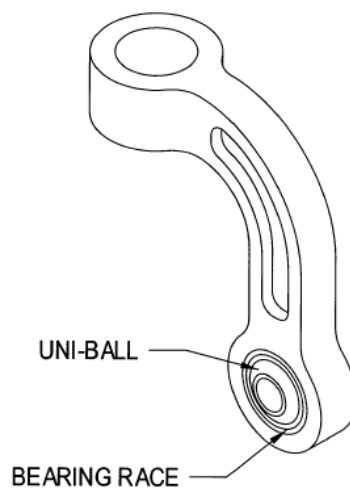
Figure 1. Uni-Ball Bearing Location

As initially reported in 2006, Enstrom received a report from the field of two swashplate rod end (dog leg) assemblies, P/N 28-16143-1, with excessive play/wear in the uni-ball bearings. Initial photographs showed that on one of the dog leg assemblies the outer race of the uni-ball bearing was worn through at the bottom and the rod end assembly was approximately 60% worn through the bottom. The bolts securing the dog legs to the lower swashplate assembly and the lower swashplate assembly were also damaged from the excess play/wear. The dog legs were installed in a 280FX with approximately 500 hours time since new.

- 1. Using a suitable light source and inspection mirror, as required, visually inspect each of the dog leg assemblies for condition and/or excessive radial play/wear between the bearing uni-ball and the uni-ball bearing race (Refer to Figure 1). To accomplish the inspection, a second person should slightly rotate, in the pitch axis, the main rotor blade corresponding to the dog leg assembly being inspected.

- 2. If the visual inspection of the dog leg assemblies indicates obvious uni-ball play exceeding approximately 0.025"/0.635 mm, remove the lower swashplate assembly from the aircraft and remove the dog leg assemblies from the aircraft. Inspect and replace the dog leg assemblies with airworthy components as required.

- 4. If the lower swashplate assembly has been removed, inspect the bolts and spacers (IPC, Figure 8-2, Item 30 and Item 40, respectively) for excessive wear/damage (Refer to Figure 1). Replace the bolts and/or spacers as required.
