**SERVICE DIRECTIVE BULLETIN**

SERVICE DIRECTIVE BULLETIN NO. 0105

1. SUBJECT: Collective Bellcrank Inspection
2. MODEL: F-28A, F-28C, F-28F, 280, 280C, 280F, and 280FX
3. EFFECTIVITY:

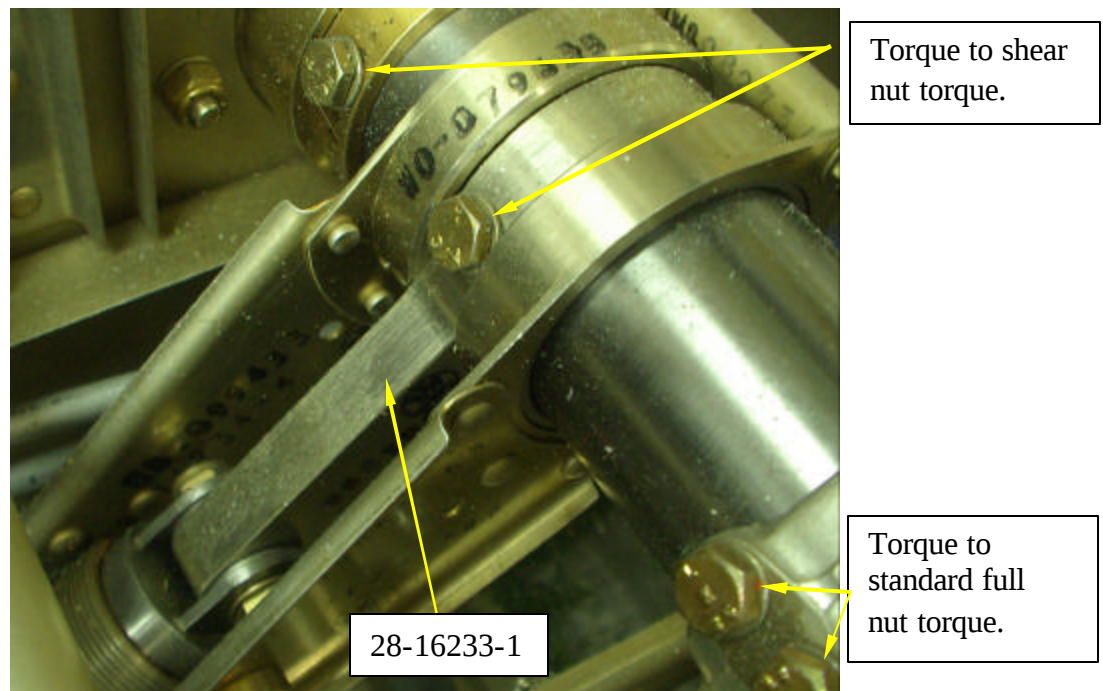
Figure 1. Collective Spring Capsule Bellcrank P/N 28-16233-1/-3

Enstrom has received four reports of failures of the P/N 28-16233-1 bellcrank that attaches the collective spring capsule to the torque tube. In 2005, Enstrom changed the design of the bellcrank to strengthen it. All of the failures were of the old design bellcrank. This Service Directive Bulletin (SDB) requires a mandatory inspection of the bellcrank and makes owner/operators aware of the redesigned bellcrank and recommends they replace the old design with the new design.

- E. Model F-28F, 280F, or 280FX: Disconnect the collective bellcrank from the spring capsule by following steps 1 through 9 in Section 12-5 of the F-28F/280F Series Maintenance Manual. See Figure 1
- F. Model F-28A, F-28C, 280, or 280C: Disconnect the collective bellcrank from the spring capsule by following steps a through h in Section 11 of the F-28A/F-28C or 280/280C Series Maintenance Manual (pages MM-11-4 and MM-11-5). See Figure 1.
- G. Remove the bolt through the collective bellcrank and torque tube. The collective bellcrank may now be rotated freely on the torque tube to inspect the opposite radius on the bellcrank.
- H. Report any failed or cracked bellcranks to Enstrom Customer Service.

- K. Do not overtorque the bolts in the torque tube. Torque to shear nut torque. Use full torque on all bolts connecting the collective stick fitting to the torque tube. See Figure 1.
- L. Verify collective trim rigging IAW Section 12, Paragraph E of the F-28F/280F Series Maintenance Manual.

- J. Do not overtorque the bolts in the torque tube. Torque to shear nut torque. Use full torque on all bolts connecting the collective stick fitting to the torque tube. See Figure 1.
- K. Verify collective trim rigging IAW Section 11 "Rigging", page MM-11-6, of the F-28A/F-28C/280/280C Maintenance Manual.
- L. Patch the hole in the cabin side wall per AC 43.13-1B, Chapter 3.
