**ENSTROM HELICOPTER CORPORATION**

## SERVICE DIRECTIVE BULLETIN

SERVICE DIRECTIVE BULLETIN NO. 0106

1. SUBJECT: Main Rotor Pitch Change Bellcranks Missing Chamfers
2. MODEL: F-28A, F-28C, F-28F, 280, 280C, 280F, and 280FX
3. EFFECTIVITY: All serial numbers
4. BACKGROUND:

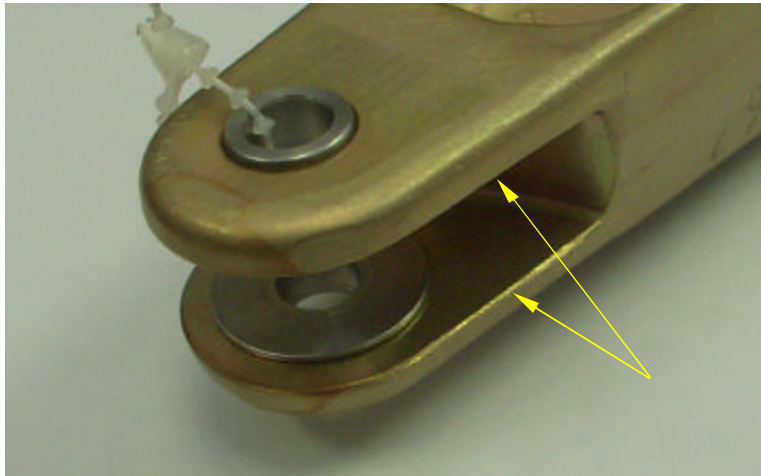
Enstrom has become aware of three (3) Pitch Change Bellcranks (Bellcranks), P/N 28-14207-101, that are missing chamfers on the bottom of the inboard ears. The missing chamfers do not create a Safety of Flight issue; however, the chamfers are required in accordance with (IAW) the FAA Approved Engineering Data.

- A. Using a suitable light source and inspection mirror or by disconnecting the pitch change bellcranks from the main rotor control rods and attachment bracket, inspect the bottom of the inboard ears for a .02" - .04" X 45° / 0.5 mm – 1.0 mm X 45° chamfer (refer to Figure 1). If chamfers are not on the Bellcrank(s), rework the Bellcrank(s) to add the chamfers IAW paragraph 5.2. If the chamfers are on the Bellcranks, reinstall the Bellcranks and return the aircraft to service.

**Figure 1. Chamfer on the inboard ear – two places**

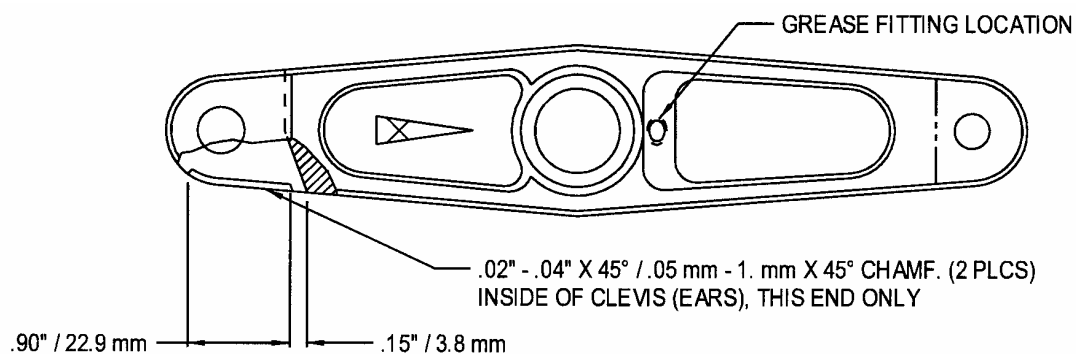
NOTE: BLEND ENDS OF CHAMFER INTO ADJACENT MATERIAL

**Figure 2. Dimensional data for chamfer application**

- A. Remove the Pitch Change Bellcranks from the helicopter following the procedures in the applicable maintenance manual.
- B. Using a small file or other suitable device, add a .02" - .04" X 45° / 0.5 mm – 1.0 mm X 45° chamfer to both sides of the bottom inboard ear (refer to Figure 2). Apply a protective coating of epoxy primer (Desoto #593 X 300 or equivalent) to the reworked area.
- C. Reinstall the Pitch Change Bellcranks following the procedures in the applicable maintenance manual and return the aircraft to service.
