**ENSTROM HELICOPTER CORPORATION**

## SERVICE DIRECTIVE BULLETIN

SERVICE DIRECTIVE BULLETIN NO. 0108

1. SUBJECT: Cracked Pylons
2. MODEL: F-28F, 280F, and 280FX
3. EFFECTIVITY: All Serial Numbers
4. BACKGROUND:

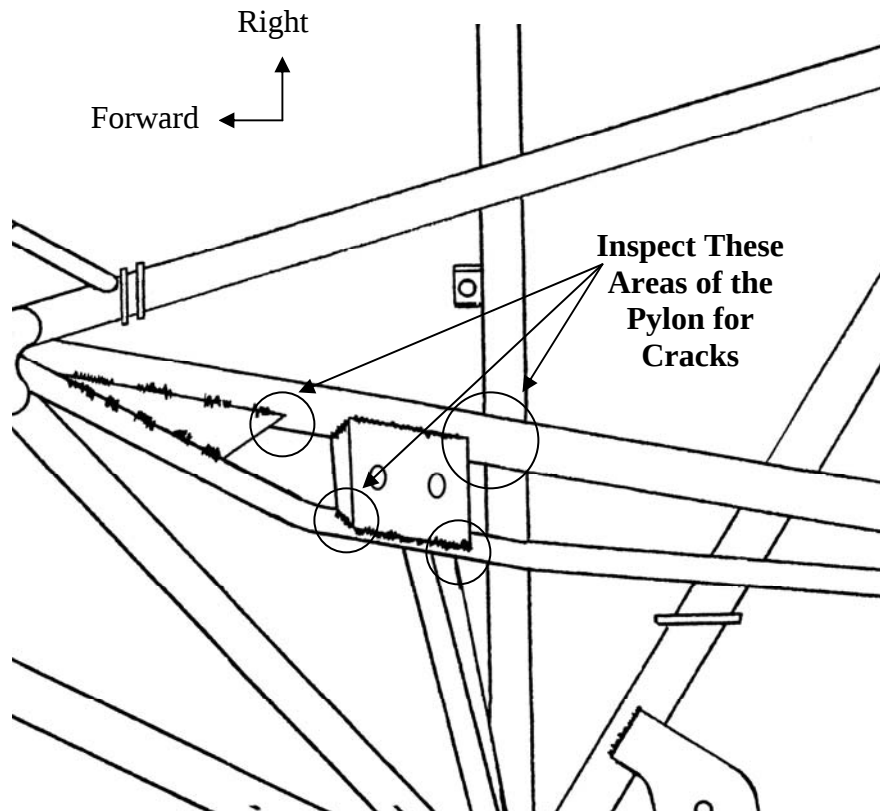
Figure 1. Pylon (Viewed from Top)

Enstrom recently received reports of 4 cracked pylons. The failures occurred in the area adjacent to the mounting bracket for the belt tension assembly bracket (Refer to Figures 1 and 2). Refer to Enstrom Service Information Letter SIL 0152 for additional information.

- A. Remove the cowling to gain access to the pylon in the area of the belt tension assembly.
- B. Using a 10-power glass, inspect the pylon area adjacent to the belt tensioning assembly mounting bracket and the gusset for cracks and other damage. (Refer to Figures 1 and 2).

- 1.) If no damage is found, continue to Step C.
  - 2.) If damage is found, contact Enstrom Customer Service for repair instructions and to report the aircraft serial number and time in service, and the serial number, part number, and manufacturer of the drive belt.

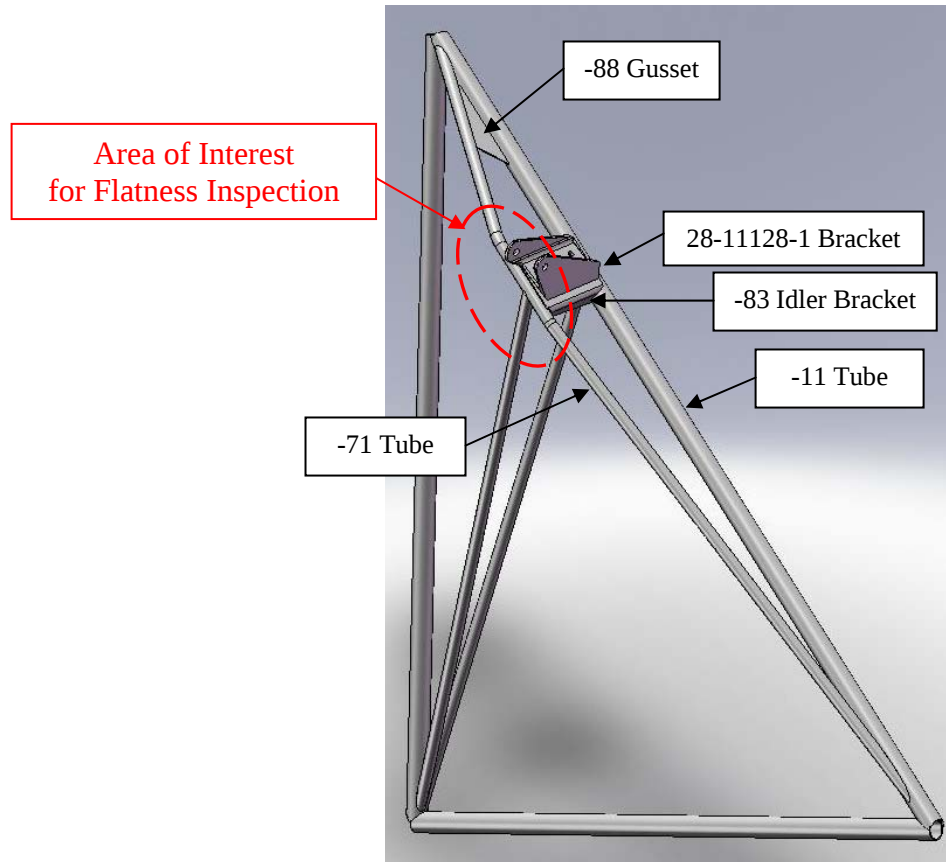
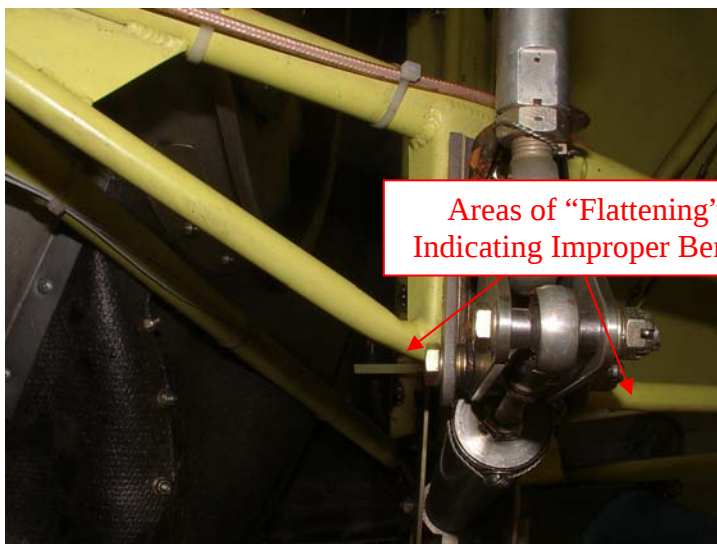
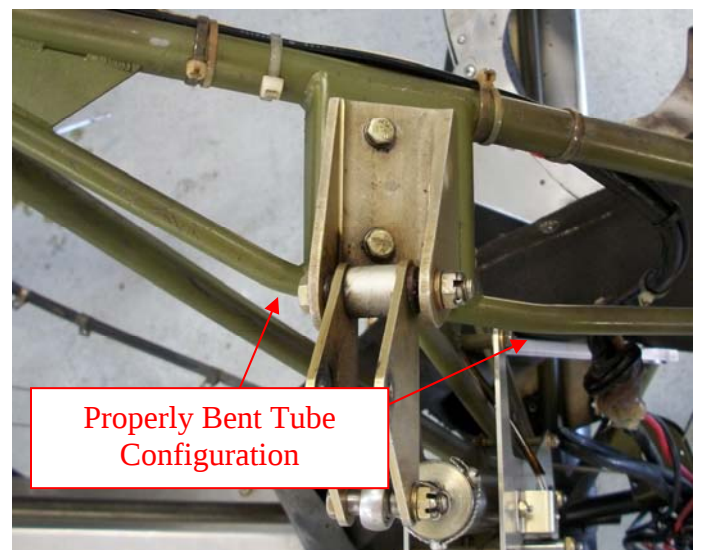
Figure 3. Flatness Inspection Criteria

Enstrom has determined the cracked pylon tubes were assembled with improperly bent pylon tubes in two places. Figure 3 depicts improperly bent and properly bent tubes for reference. Flattening of the smaller tube is evident in both bends on the tube in the improperly bent configuration.

- C. Inspect the pylon tube in the area adjacent to the belt tensioning assembly mounting bracket for flattening in the bend (Refer to Figures 3 and 4).

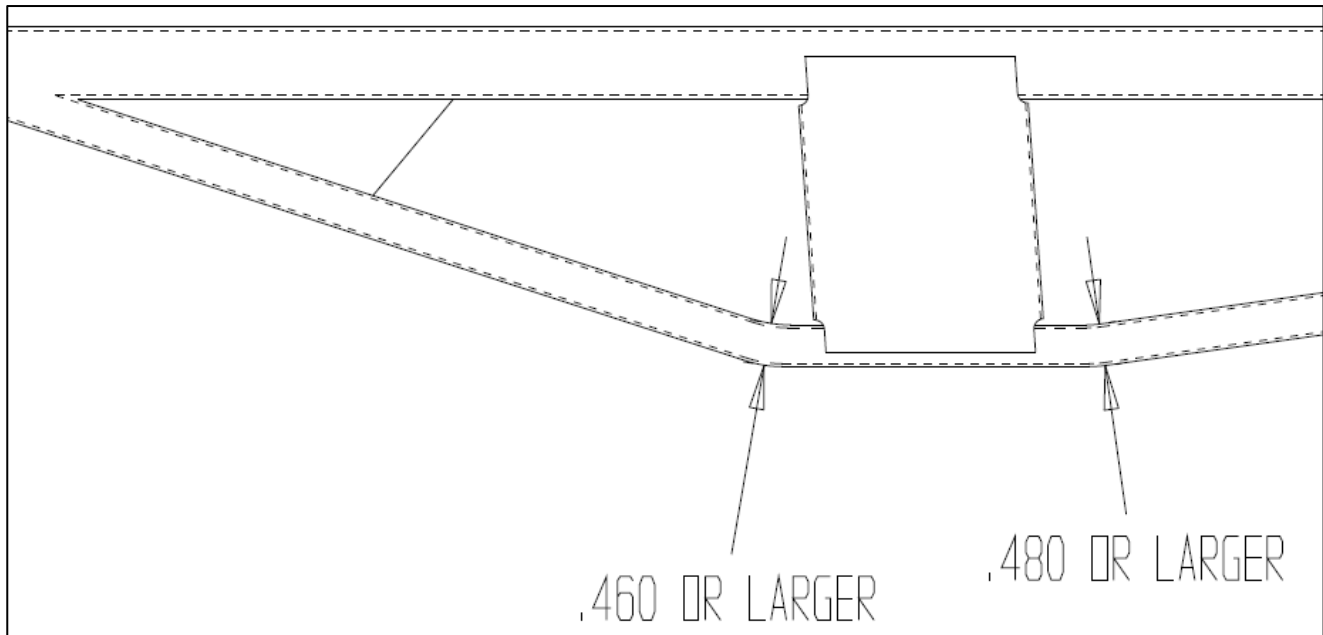
Figure 4. Minimum Dimensions for Tube in the Bend Areas

- 1.) If the width of the tube in the areas shown is greater than the dimensions shown in Figure 4, return the aircraft to service.
  - 2.) If deformation or flattening of the bends in the tube is found, and the resulting tube thickness is less than that shown in Figure 4, contact Enstrom Customer Service to report the aircraft serial number and time in service and conduct 25 hour repetitive inspections as detailed in Paragraph 11.
