SERVICE DIRECTIVE BULLETIN NO. 0113

1. SUBJECT: Cyclic Trim Actuator Switch Assembly Inspection
2. MODEL: F-28A, 280, F-28C, 280C, F-28F, 280F, and 280FX
3. EFFECTIVITY: S/N 828 and prior; S/N 2133 and prior
4. BACKGROUND:

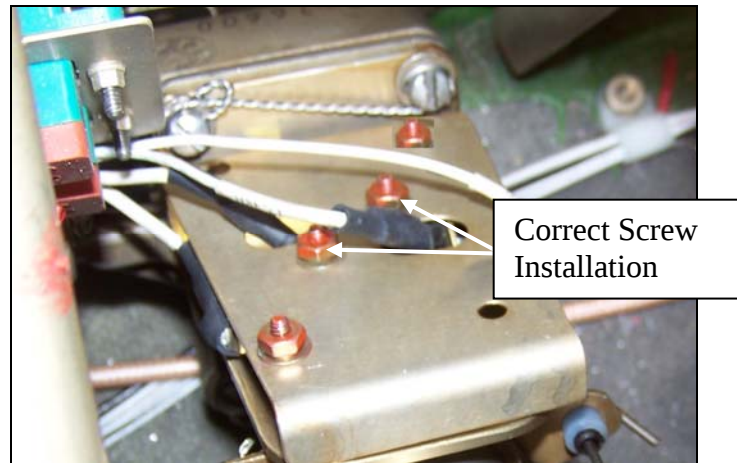
- 6.1 Locate the trim actuator assemblies by removing the seat deck.
- 6.2 Inspect the lateral and longitudinal trim switch assemblies for the proper screw orientation. The screw shanks and nuts should be visible on the wiring side of the switch assembly (*Figure 1 and Figure 2*). The heads of inner screws should be facing the spring capsule.

Figure 1. Properly Installed Screws – The heads of the inner screws face the spring capsule.

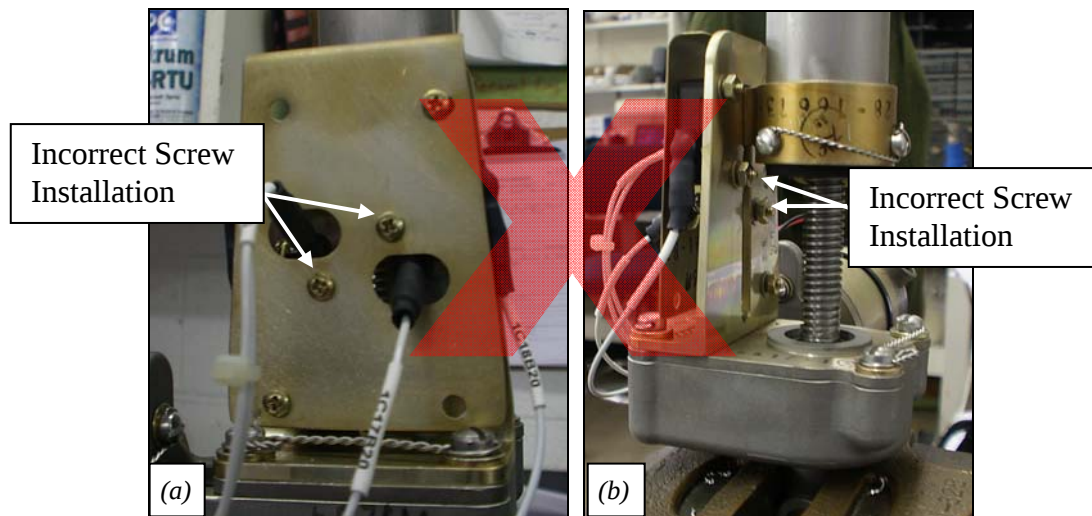
Enstrom has received a report of an incorrectly assembled trim actuator switch assembly used in the cyclic trim system. The screws that assemble the switches to the bracket were inadvertently installed in the opposite direction. This is a concern for the screws adjacent to the bracket slot, as the protruding shanks could interfere with the spring capsule travel and possibly compromise the performance of the cyclic trim system.

Figure 2. Improperly Installed Screws (a) (b) – The shanks of the inner screws face the spring capsule (b). (The trim actuator is removed from the aircraft.)

- 6.8 Remove the inner screws (3), washers (4) (5), and nuts (6) from the switch assembly. Re-install the inner screws (3), washers (4) (5), and nuts (6) such that the screw heads face the spring capsule. Use care to avoid moving the position of the switches when installing the screws.
