SERVICE DIRECTIVE BULLETIN NO. 0122

Revision 2

DATE: April 26, 2018

1. SUBJECT: Exhaust Clamp Installations
2. MODEL: F-28C, F-28C-2, F-28C-2R F-28F, F-28F-R, 280C, 280F, and 280FX
3. EFFECTIVITY: All S/N
4. BACKGROUND:

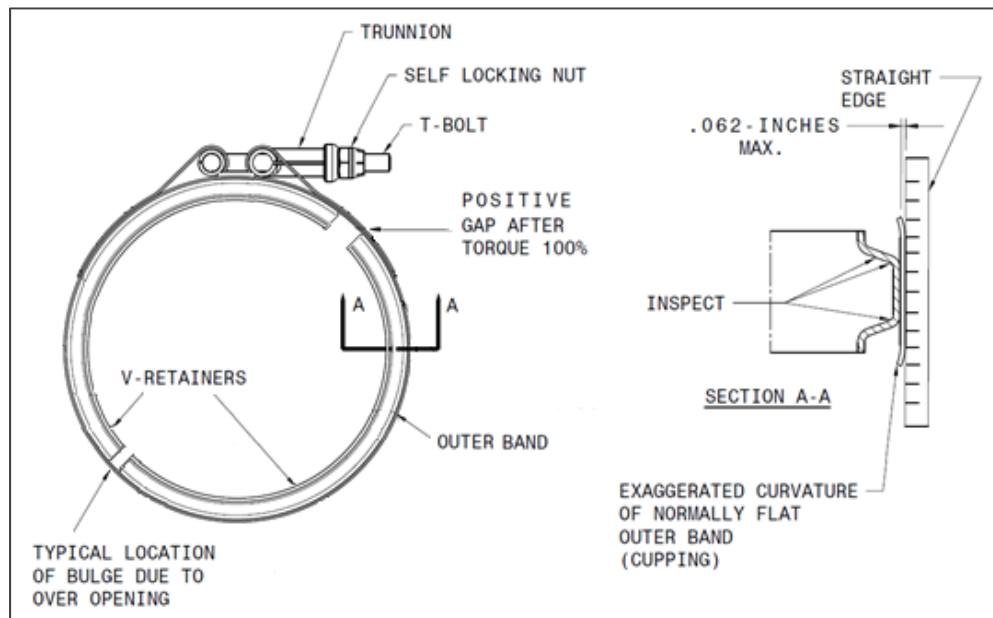
6.3.2 Inspect the clamp outer band for “cupping” (Figure 2).

6.3.2.2 The gap between the straight edge and the band must be less than 0.062” (1.58 mm).

6.3.3.1 Inspect for bulges in the outer band circumference (Figure 2).

**Figure 2. P/N LW-13464 Schematic – Inspection Checks**

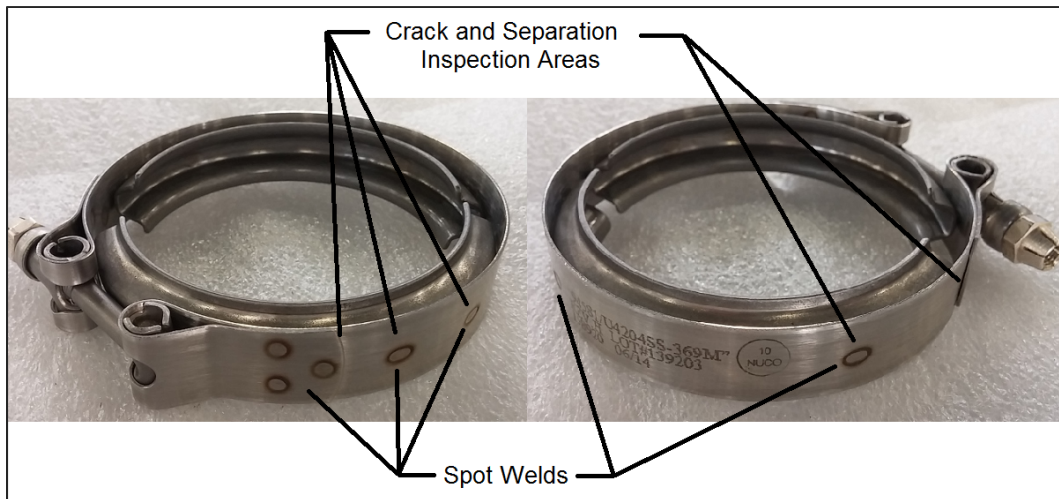
- 6.3.4 Inspect for cracks in the bend radii of the inner V-retainer segments throughout the length of the segments, particularly if soot was noted previously. (This inspection applies to the hinged clamp, P/N 28-12162-1, and the continuous band clamp, P/N LW-13464, if removed).
- 6.3.5 Inspect the clamp for other damage including, but not limited to, cracks, gouges, notches, tears, bulges, bumps, deterioration, and fractures
- 6.4 Replace the clamp if any of the conditions listed in paragraph 6.3 are evident. Refer to paragraph 7 for parts.
- 6.5 Perform a visual inspection of both P/N 28-12162-1 **and** P/N LW-13464 clamp bands for cracks through the band spot welds.
- 6.5.1 Remove surface oxidation from the band at the spot welds (Figure 3).

6.5.1.2 Replace the clamp (reference paragraph 7) if oxidation is not easily removed with a polymer cleaning pad or if pitting is evident.

6.5.2 Using a flashlight or other bright light source, inspect the band for cracks at the spot welds.

**Figure 3. Spot weld locations and crack and separation inspection areas (P/N LW-13464 shown)**

- 6.6 Replace the clamp if any of the conditions listed in paragraph 6.5 are evident. Refer to paragraph 7 for parts.
- 6.7 Install the clamp as follows:
  - 6.7.1 P/N 28-12162-1
    - 6.7.1.1 Proceed with paragraph 6.7.3.
  - 6.7.2 P/N LW-13464
    - 6.7.2.1 If removed, proceed with paragraph 6.7.3.
    - 6.7.2.2 If not removed, proceed with paragraphs 6.7.7 through 6.7.11.

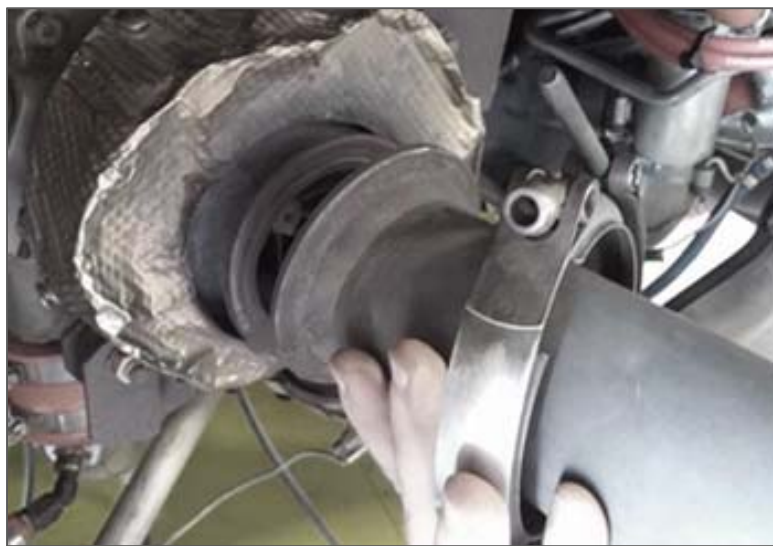
**Figure 5a. Clamp P/N LW-13464 prepared for joining the tailpipe to the turbocharger outlet**

- 6.7.3 Slip the clamp over the tailpipe or exhaust manifold flange, as applicable (Figure 5a).

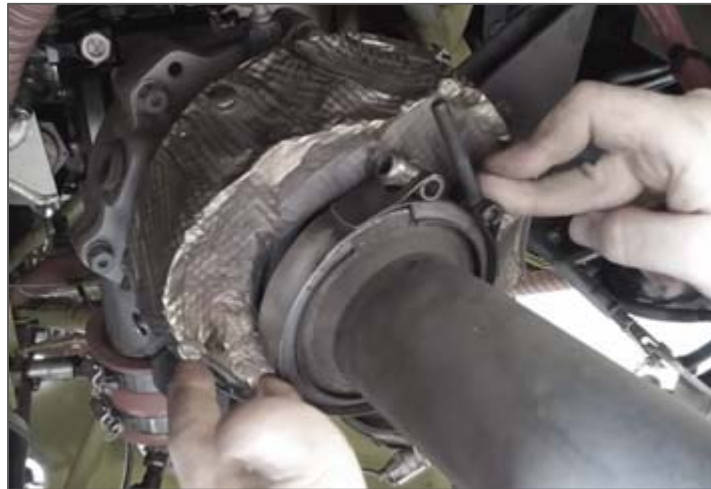
**Figure 5c. Flanges and metal gasket joined; clamp positioned over joint**

- 6.7.6 Assemble the clamp over both flanges and the gasket (Figure 5c).

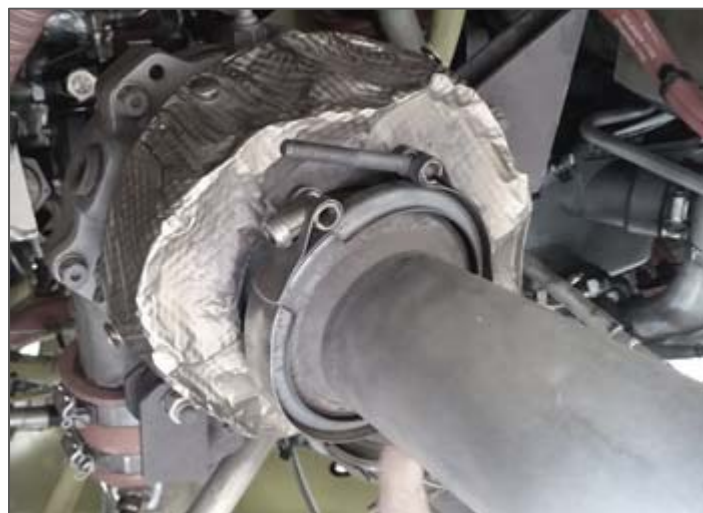
**Figure 5d. Clamp positioned for ease of spot weld inspections**

- 6.7.6.1 Position the clamp to facilitate visual inspections of the spot welds (Figure 5d).
