# SERVICE DIRECTIVE BULLETIN

SERVICE DIRECTIVE BULLETIN NO. 0126

Revision 1

1. SUBJECT: Cabin Bellcrank Mounts and Bellcrank Attachment Inspection
2. MODEL: F-28A, 280, F-28C, F-28C-2, F-28C-2R, 280C, F-28F, F-28F-R, 280F, and 280FX
3. EFFECTIVITY: All S/N (Note special exclusion in paragraph 5.3.)

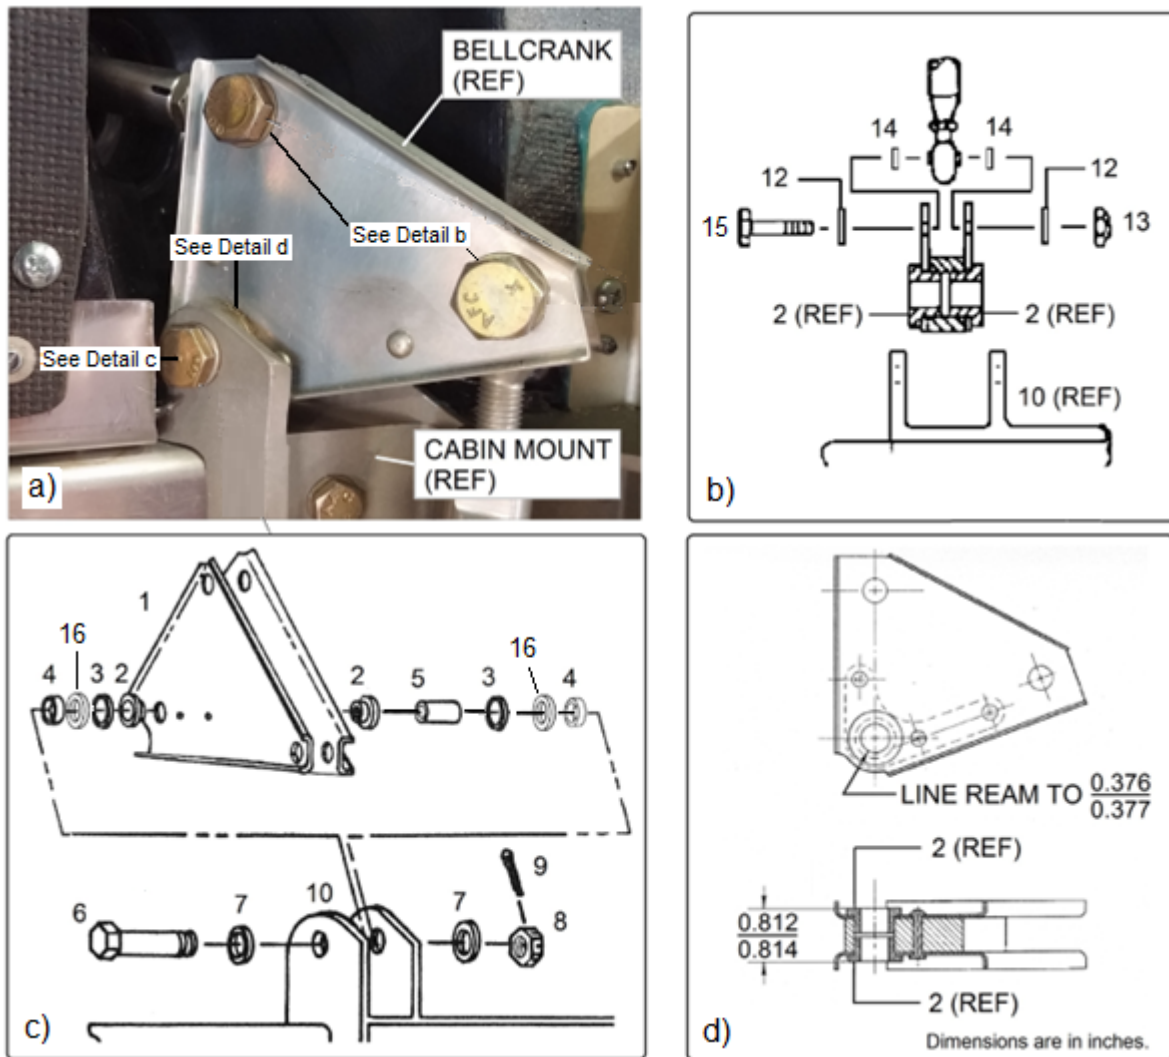
Figure 3. Cabin Mount, Control Tube, and Bellcrank Installation Detail

**Looseness (side-to-side movement) in the bellcrank installation is attributed to worn bearings, loose hardware, or improper stack-up, whereas binding is attributed to interference caused by constriction in the joint. This occurs when the torque load is carried through the bearings and the cabin mount rather than through the internal spacer.**

6.3.2.2 If the looseness is detected (deflection, audible clicking, slack between the bearings and washer, etc. is observed), the bearings and spacers (Figure 3-c, Items 2, 4, and 5) must be replaced.

6.3.2.2.1 Remove the control tube and bellcrank hardware (Figure 3-b, -c). Remove the bellcrank and press out the bearings (Figure 3-c, Item 2) from the bellcrank.

6.3.2.2.3 Ream the bearings in accordance with Figure 3-d.

6.3.2.2.4 Install the bellcrank with new spacers (Figure 3-c, Items 4 and 5) and shims (Figure 3-c, Item 16), as required, and complete the installation (torque 50-70 in-lb/5.6-7.9 Nm).

6.3.3.2 If the binding is detected, remove the nut, spacers, shims (if present), washers, and bolt. Verify the length of the spacer (Figure 3-c, Item 5) (0.817/0.819"). File the hat-end of the bearing to reduce the thickness or protrusion. Deburr and remove any debris from the assembly.

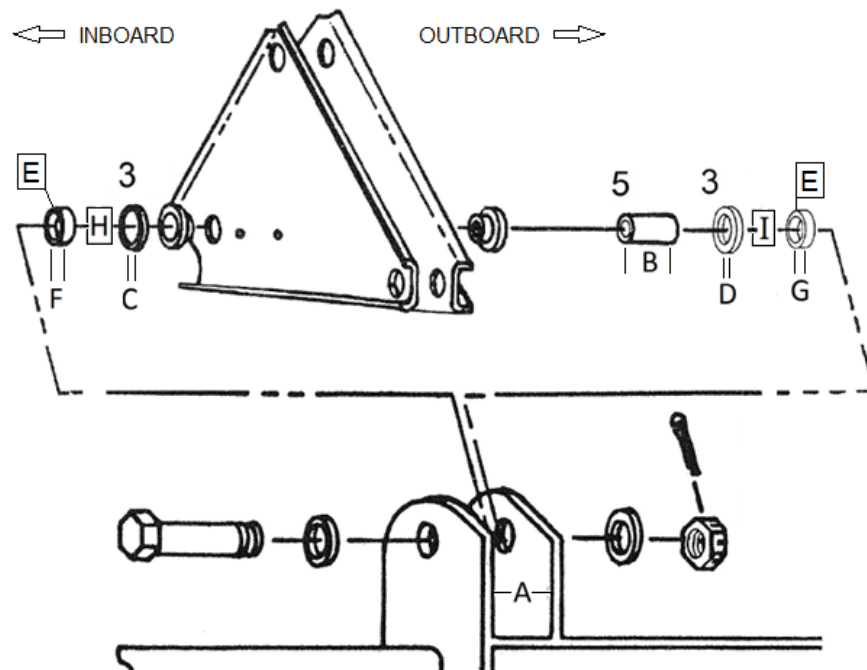
Figure 5. Hardware Stack-up Calculation

**This procedure compares the measurement between the cabin mount ears and the calculated length of the hardware stack-up. Any deficiency in hardware stack-up is corrected by installing spacer P/N 28-16209-x (if required) and shim P/N 28-16217-x as required.**

- 6.4 Hardware stack-up for the LH cabin mount. See Figure 5.
  - 6.4.1 Measure the distance between the 0.250 inch diameter holes of P/N 28-11307-1 mount. This is Measurement A.

- 6.4.6 Determine spacer (Item 4) selection from this formula:  $\Delta / 2 = E$ 
    - 6.4.6.1 Select spacer P/N 28-16209-1 if E value is  $\geq 0.101$  inch.

- 6.4.9.1 Solve for H using this formula:  $E - F = H$
    - 6.4.9.2 Select P/N 28-16217-x as required to equal H.
  - 6.4.10 Determine the shim thickness required for the outboard side. This will be Measurement I.

- 6.4.10.1 Solve for I using this formula:  $E - G = I$
    - 6.4.10.2 Select P/N 28-16217-x as required to equal I.
  - 6.4.11 Verify that  $(B + C + D + F + G + H + I) = A (+0/-0.001)$

- 6.4.12 Install P/N 28-16217-x (Item 16) shims, as required, between Item 3 and Item 4, inboard and outboard, respectively.
- 6.5 Torque (50-70 in-lb/5.6-7.9 Nm) and safety the nut.
- 6.6 Repeat steps 6.4 and 6.5 for the RH cabin mount.
- 6.7 Reinstall the control tube covers, if installed.
  - 6.7.1 Reinstall the four cover fasteners.
  - 6.7.2 Reposition the boot and secure with cable ties.
  - 6.7.3 Seal the cover edge with RTV sealant (Dow Corning 732, or equivalent).
- 6.8 Reinstall the fuel tanks.
- 6.9 Reinstall the seat structure cover.
