# SERVICE DIRECTIVE BULLETIN

SERVICE DIRECTIVE BULLETIN NO. 0130

1. SUBJECT: Battery Hold Down Installation
2. MODEL: F-28A, 280, F-28C, F-28C-2, F-28C-2R, 280C, F-28F, F-28F-R, 280F, and 280FX
3. EFFECTIVITY: S/Ns equipped with the 28VDC electrical system
4. BACKGROUND:

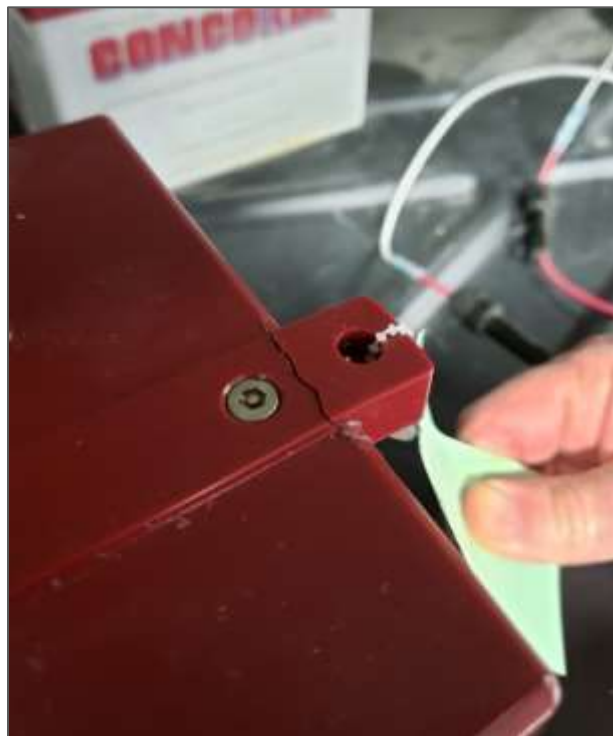
Enstrom has discovered a cracking issue with the mounting tabs on the Concorde RG24-11M battery during installation (Figure 1). If the mounting hardware is over-torqued, this can result in the cracking of the tabs. To prevent the possibility of cracking and improve the strength of the tabs, the hold down that is supplied with the aircraft battery must be installed.

*Figure 1. Cracked battery mounting tab*

At the next 100 hr/annual inspection, check the battery mounting tabs for signs of cracking (Figure 1). If cracks are present, the battery cover must be replaced and the hold down installed at that time. If no cracks are present, install the hold down onto the battery in accordance with paragraph 6.

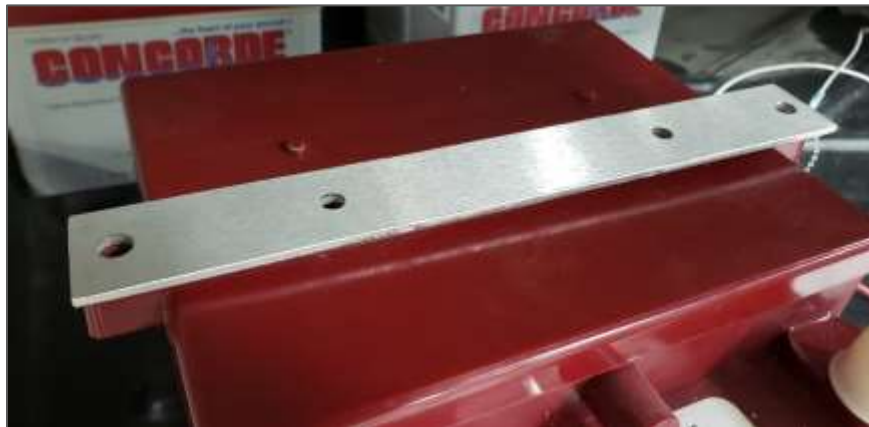
*Figure 2. Hold down lined up with mounting tab holes*

- 6.1 Remove the right side step access panel to access the battery.
- 6.2 Remove the safety wire and battery mounting hardware.
- 6.3 Line up the outer holes of the metal hold down with the holes in the battery mounting tabs (Figure 2).

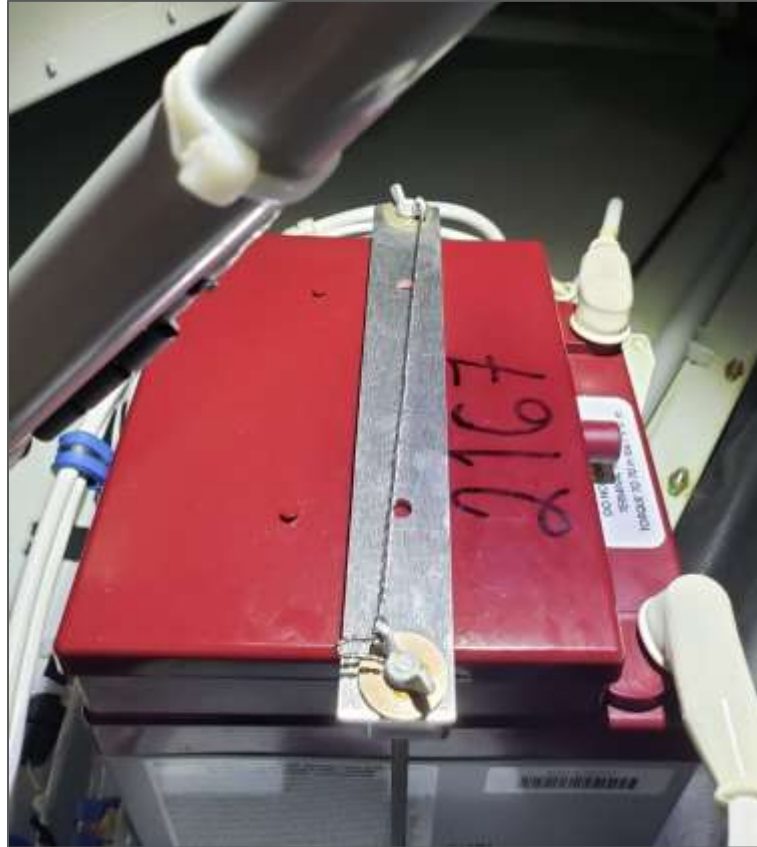
*Figure 3. Battery hold down installed*

- 6.4 Reinstall the mounting hardware (Figure 3). Tighten the hardware until the rod assembly and washer contact the hold down and then make one full turn after contact.
- 6.5 Replace the safety wire (Figure 3).
- 6.6 Reinstall the step access panel.
