# SERVICE INFORMATION LETTER

SERVICE LETTER NO. 0026

Subject: Safety Lock Washer on Damper Rod End

Model: F-28A

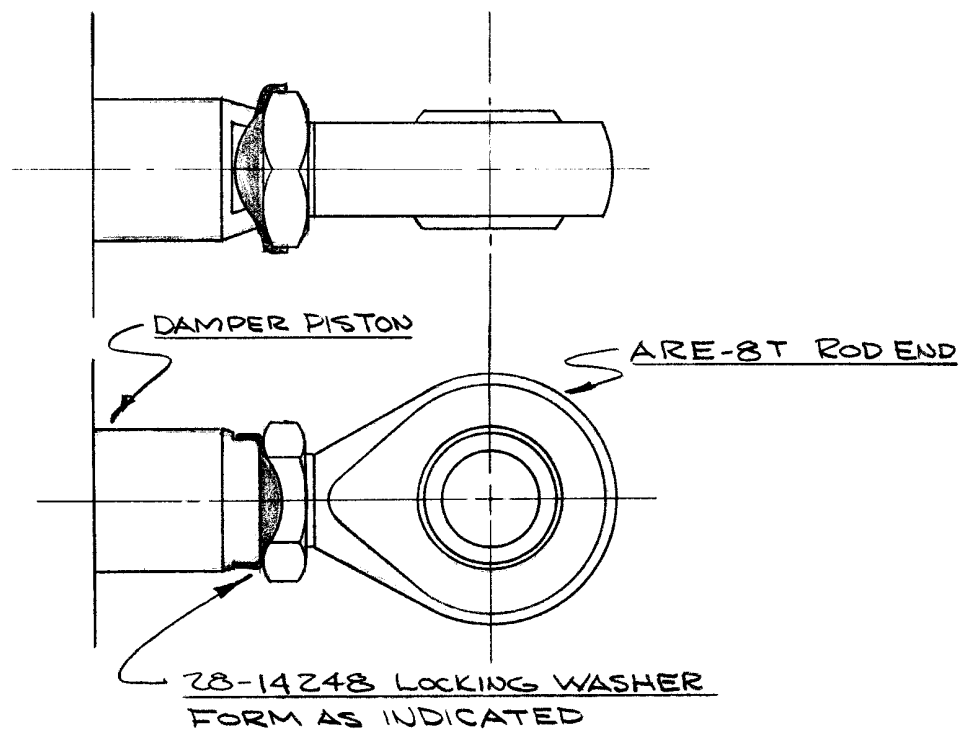
There have been two cases of the damper rod end working loose because of the jamb nut and locking washer not being properly secured.

The following method is recommended for locking the ARE—8T rod end to the damper piston. The AN316-8R should be torqued to 290 - 410 inch pounds. The thin steel washer 28-14248 behind the nut should be deformed into the flats on the piston shaft by the use of a pin punch and hammer. Note this should be accomplished on both flats. The other portions of the washer are to be deformed over the flats of the AN316-8R jamb nut. See illustration below.

A visual check should be made on the next preflight inspection. If the locking washer is not deformed as described or illustrated, it should be reworked according to the aforementioned instructions.
