**THE ENSTROM HELICOPTER CORPORATION**  
**TWIN COUNTY AIRPORT, P.O. BOX 490, MENOMINEE, MICHIGAN 49858**

# SERVICE INFORMATION LETTER

SERVICE LETTER NO. 0027  
Revision A

Subject: Inspection of Over-Center Mount Pad 28-11100-83

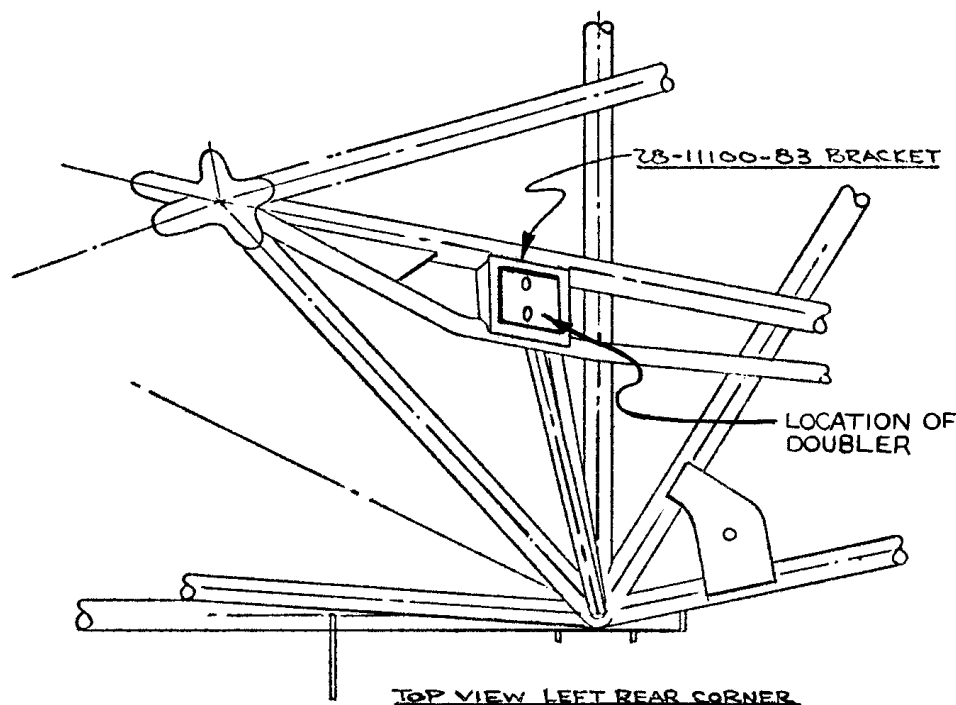
There have been a number of reports of cracks adjacent to the mount holes in the over-center mount pad 28-11100-83. The use of recommended washers in Service Letter 0027 has not eliminated this problem. Upon inspection of this mount pad 28-11100-83 at the owner's earliest convenience or within the next 50 hours, the following procedure is recommended.

If, upon inspection, small cracks are found, these should be welded either by heliarc or gas. The surface should then be ground or filed smooth, and a doubler of 4130 x .040 or thicker sheet steel be attached. Size should be approximately .25 smaller on all sides of flat surface of mount pad 28-11100-83. Doubler is to be match-drilled to mount pad and welded along all edges by heliarc or gas by a certified operator. See illustration below.
