**THE ENSTROM HELICOPTER CORPORATION**  
**TWIN COUNTY AIRPORT, P.O. BOX 490, MENOMINEE, MICHIGAN 49858**

# SERVICE INFORMATION LETTER

SERVICE INFORMATION LETTER NO. 0090

Subject: Fuel Nozzle Air Vent Modification

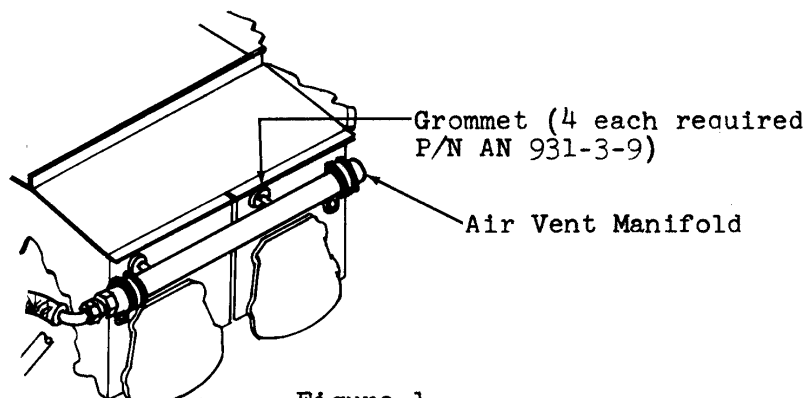
Figure 1

There exists the possibility of failure to the air vent manifold assembly in the area of the small tube attachment, (due to lack of cushion in the grommet where the tube passes through the engine baffle). This manifold is located on either side of the engine and just above the rocker box covers. Reference Figure 1.

In order to reduce the possibility of failure to the nozzle air vent manifold the following corrective procedure is recommended.

1. Loosen clamps that secure rubber hose from fuel nozzle and slide hose from the nozzle vent manifold tube.
2. Remove the nozzle vent manifold assembly left and right by removing screws from clamps at either end of manifold.
3. Remove the old rubber grommet from the engine baffle and enlarge the hole to .56".
4. Install new rubber grommet P/N AN931-3-9 in the enlarged hole.
5. Reinstall the air manifold assemblies and reconnect the nozzle air vent hose from fuel nozzle.
