# SERVICE INFORMATION LETTER

SERVICE INFORMATION LETTER NQ. 0093

Subject: Starter Ring Gear Clearance

Models: All

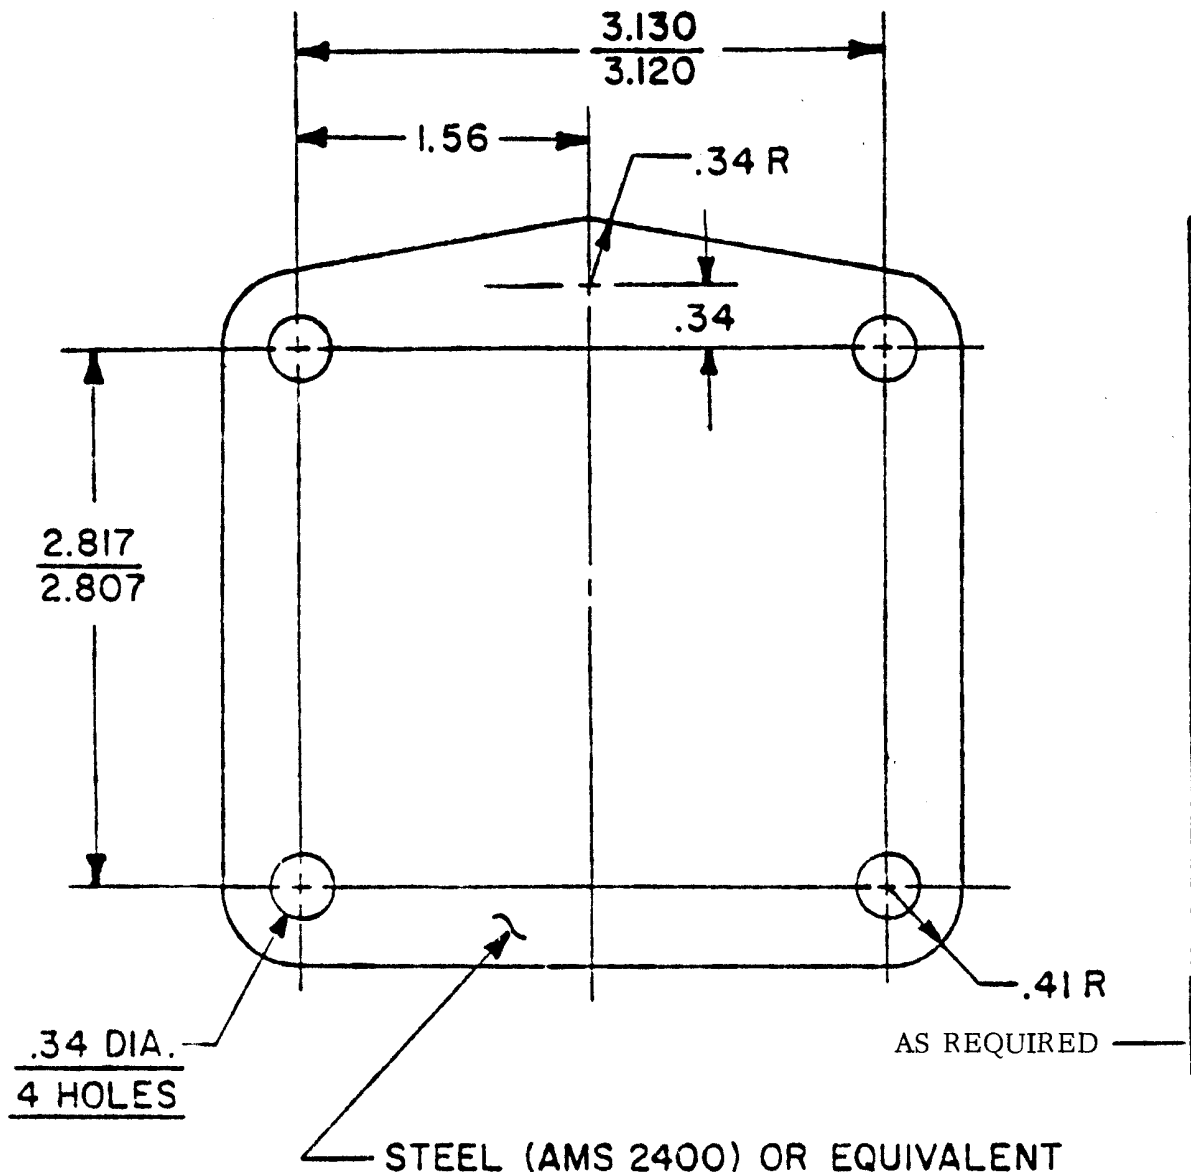
It has been determined that some starter failures which Enstrom owners have experienced have been caused by improper tooth clearance between the gear of the bendix and the ring gear. The specified clearance is from .010 to .030 inch. This clearance may be altered by installing a shim between the starter and the mounting pad of the engine. The following sequence may be used for checking for sufficient clearance:

Shims may be obtained from any Lycoming distributor (P/N LW16152), available in one thickness only (.013tt). This spacer may be fabricated in the field and may be made to the required thickness. The use of one or more shims may be used if necessary. Reference drawing below. Stainless steel shim stock is acceptable material for shims.
