SERVICE INFORMATION LETTER HO. 0098

Subject: Turbocharger Gasket Replacement

Models: F-28C, 280C All Serial Numbers

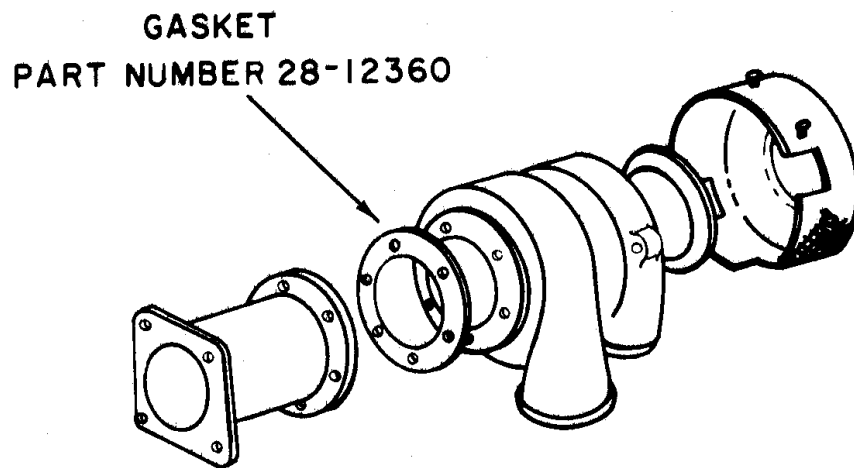
FIGURE 1

There is a possibility that the six screws securing the adapter assembly to the turbocharger flange will lose their torque, which may permit the gasket to fail causing induction air loss and eventual permanent damage to the turbo housing. This loss of torque to the screws has been attributed to the compressibility of the cork type gasket that occurs with thermal cycling.

It is recommended that a new asbestos gasket P/N 28-12360 be installed as soon as practical. Refer to the Parts Manual page 16-2, item 15 for gasket location. (also see fig. 1 attached)

1. Mark position of adapter assembly in relation to turbo unit for ease of reassembly.
2. Remove six attaching screws AN5O3-IO-8. Discard old cork gasket.
3. Reassemble using new asbestos gasket P/N 28-12360. Torque screws to 20 inch lbs. Safety in pairs with .032 wire.
4. Install unit in helicopter in reverse order of removal.
