# **SERVICE INFORMATION LETTER**

SERVICE INFORMATION LETTER NO. 0129  
Page 1 of 16

SUBJECT: Minor Maintenance & Repair of Main & Tail Rotor Blades

MODEL: F-28A, 280, F-28C, 280C, F-28F & 280F Helicopters

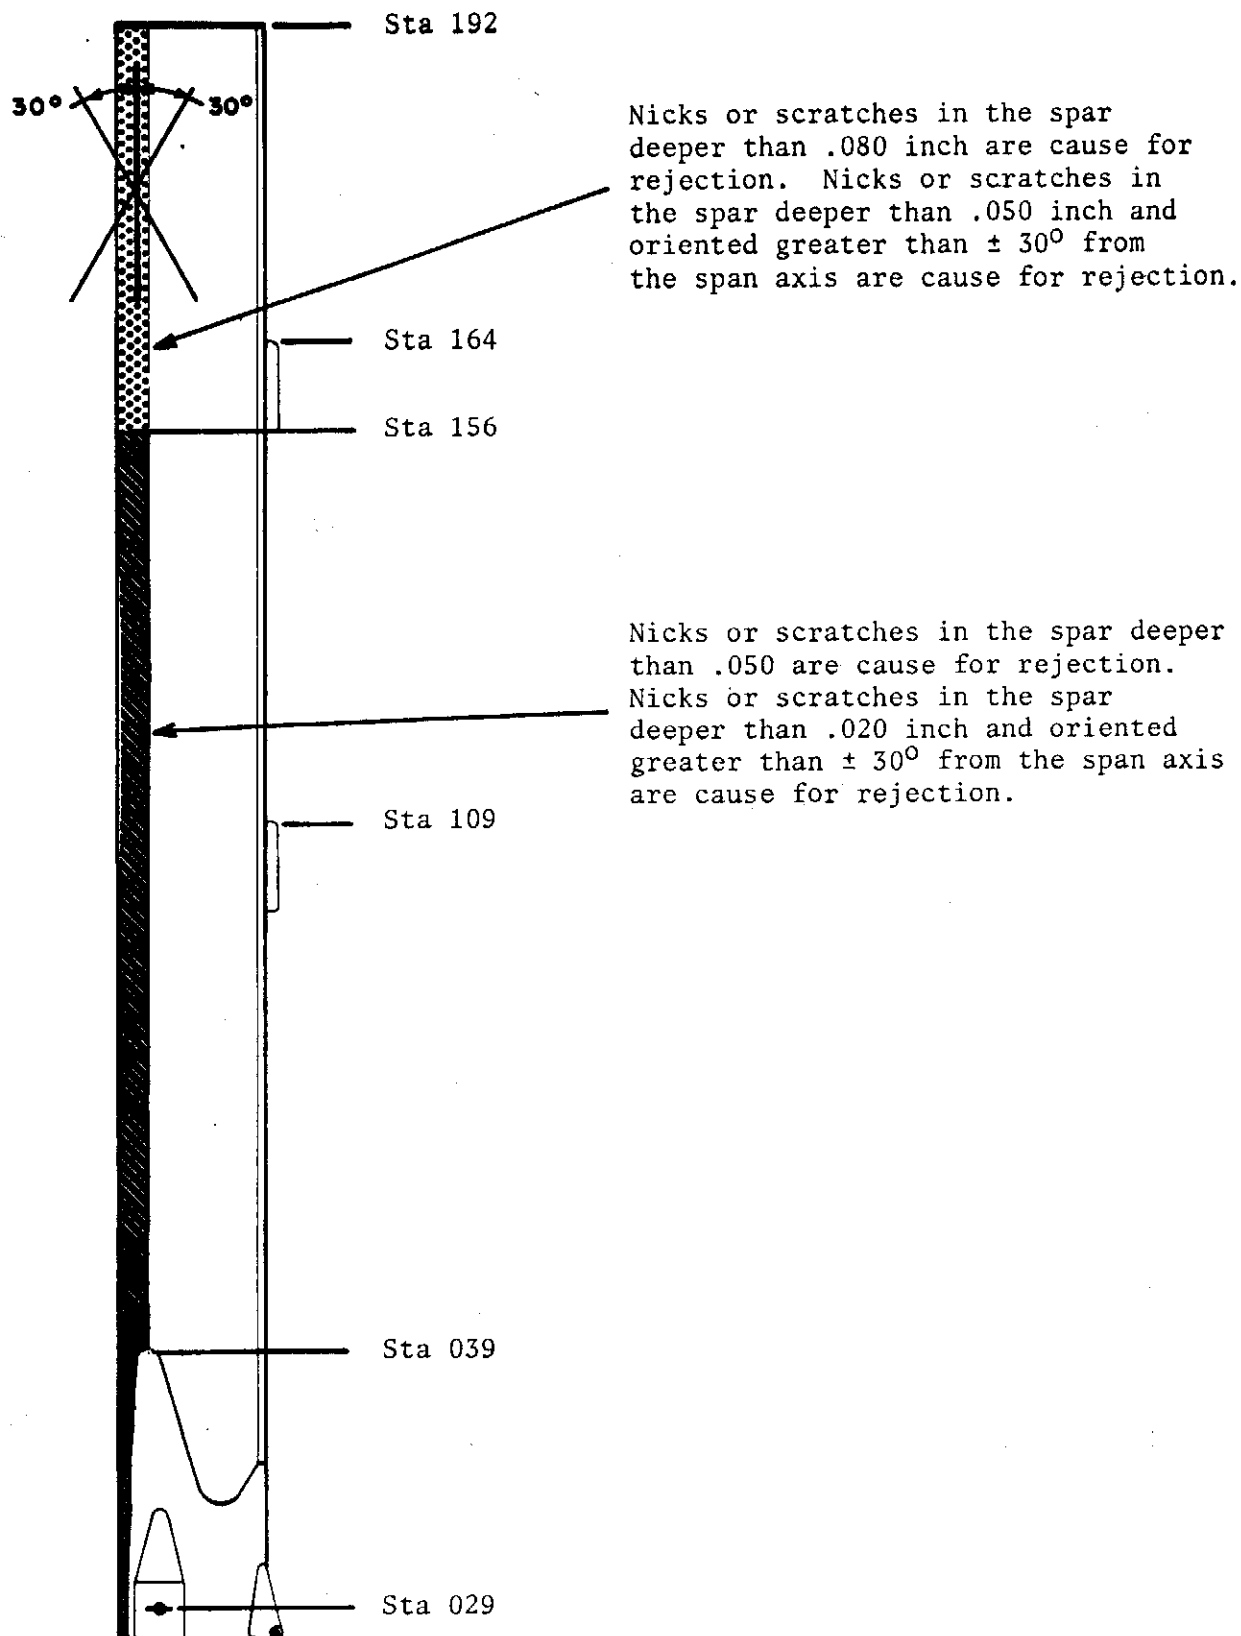
FIGURE 2  
Spar Rejection Criteria -  
Nicks and Scratches

- a. Nicks and scratches greater than the limits on Figure 2 are cause for rejection.
- b. Leading edge dents with smooth surfaces greater than the limits shown on Figures 3 and 4 are cause for rejection.
- c. Leading edge dents with sharp width to depth ratios (i.e., less than 3:1), or with torn, nicked, scratched or creased surfaces greater than the limits in Figure 5 are cause for rejection.

NOTE: 1. Nicks and scratches less than these limits must be repaired using approved procedure (see Figure 6).

- a. Nicks and scratches within repairable limits should be polished out and blended smooth as shown in Figure 6.
- b. Sharp dents within the permissible limits shown in Figure 5 must be blended as noted in Figure 7.

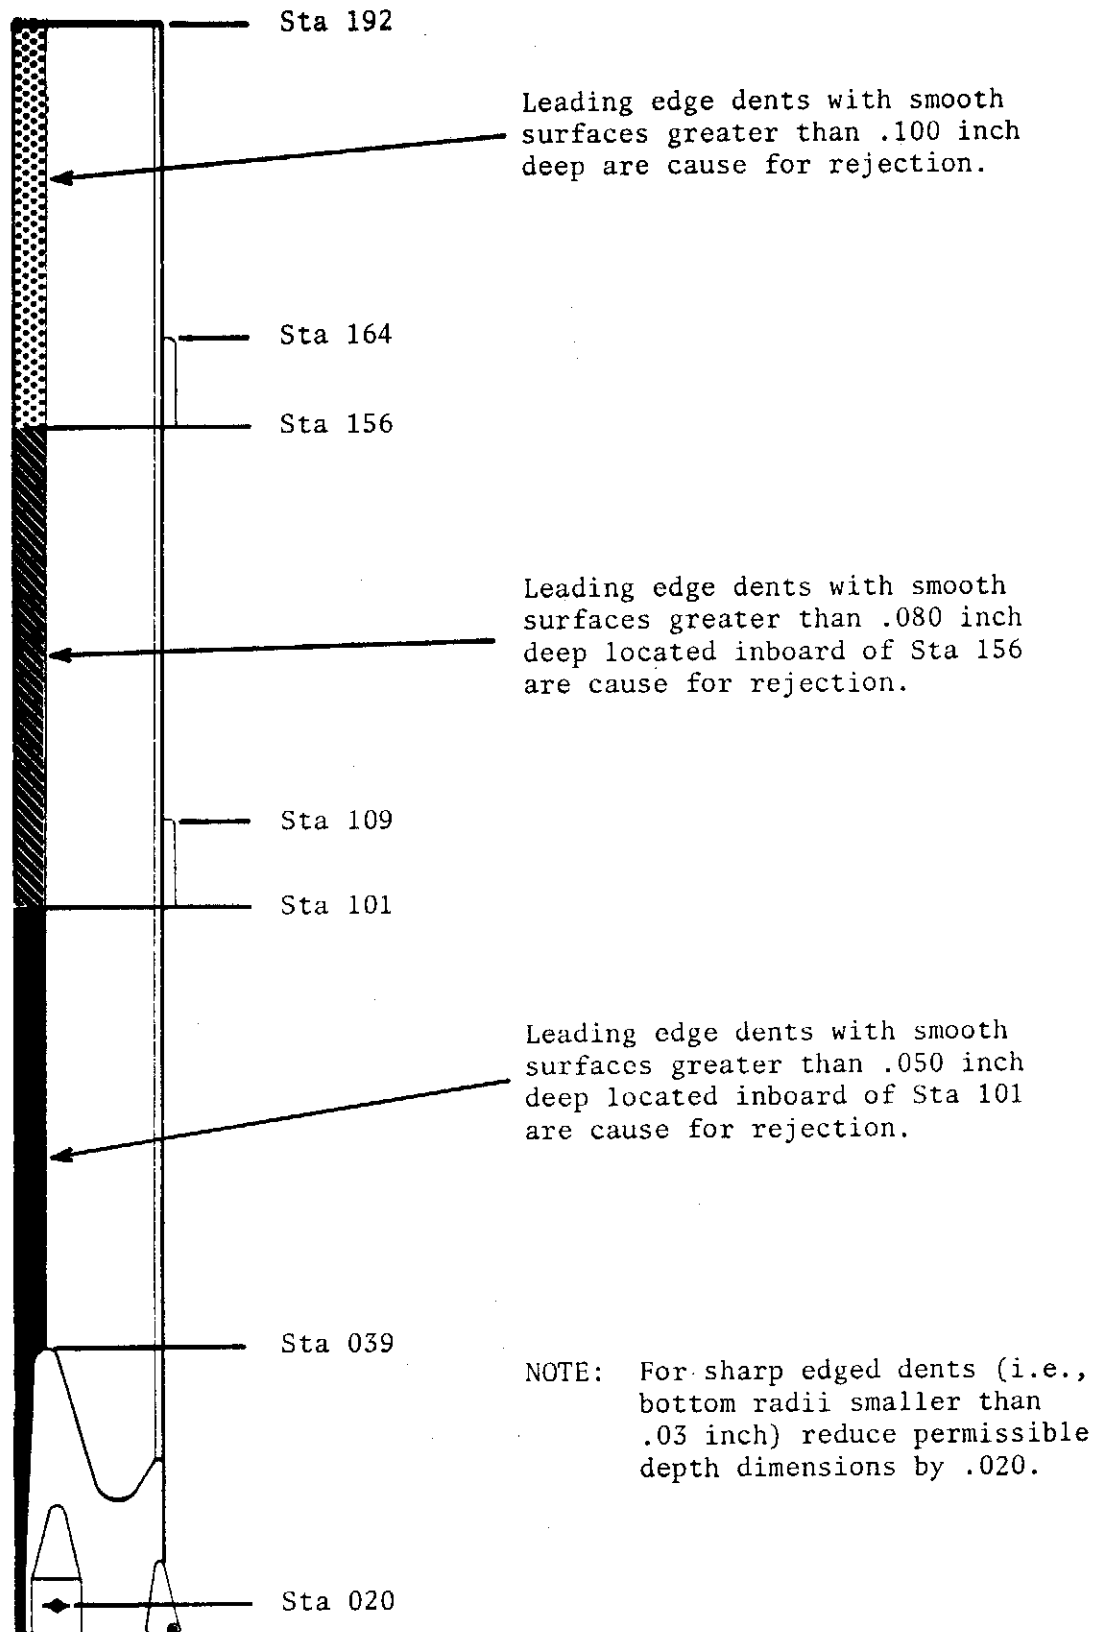
FIGURE 3  
Spar Rejection Criteria -  
Smooth Dents at Leading Edge

NOTE: 1. Leading edge is considered to be .5 inch above and below the nose, measured around the contour (see Figure 4).

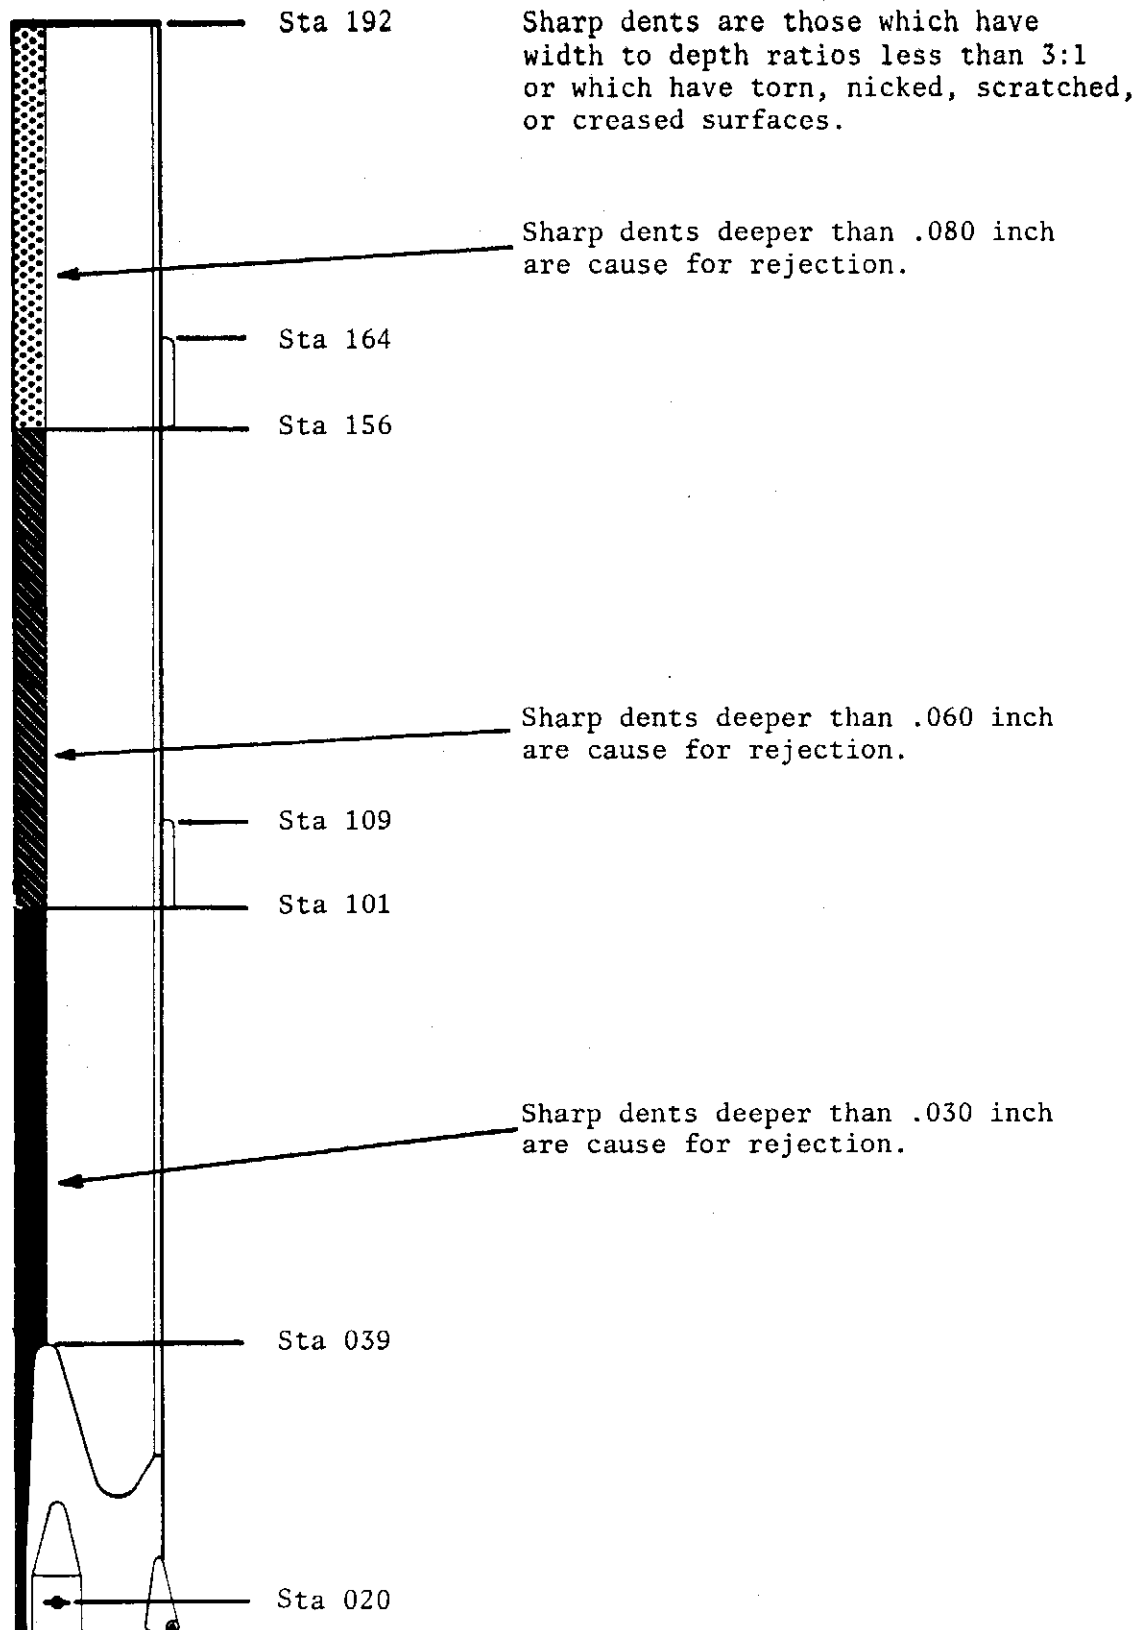
FIGURE 5.  
Spar Rejection Criteria - Sharp Dents at Leading Edge

NOTE: 1. Sharp dents less than these limits must be repaired using approved procedure (see Figure 7).

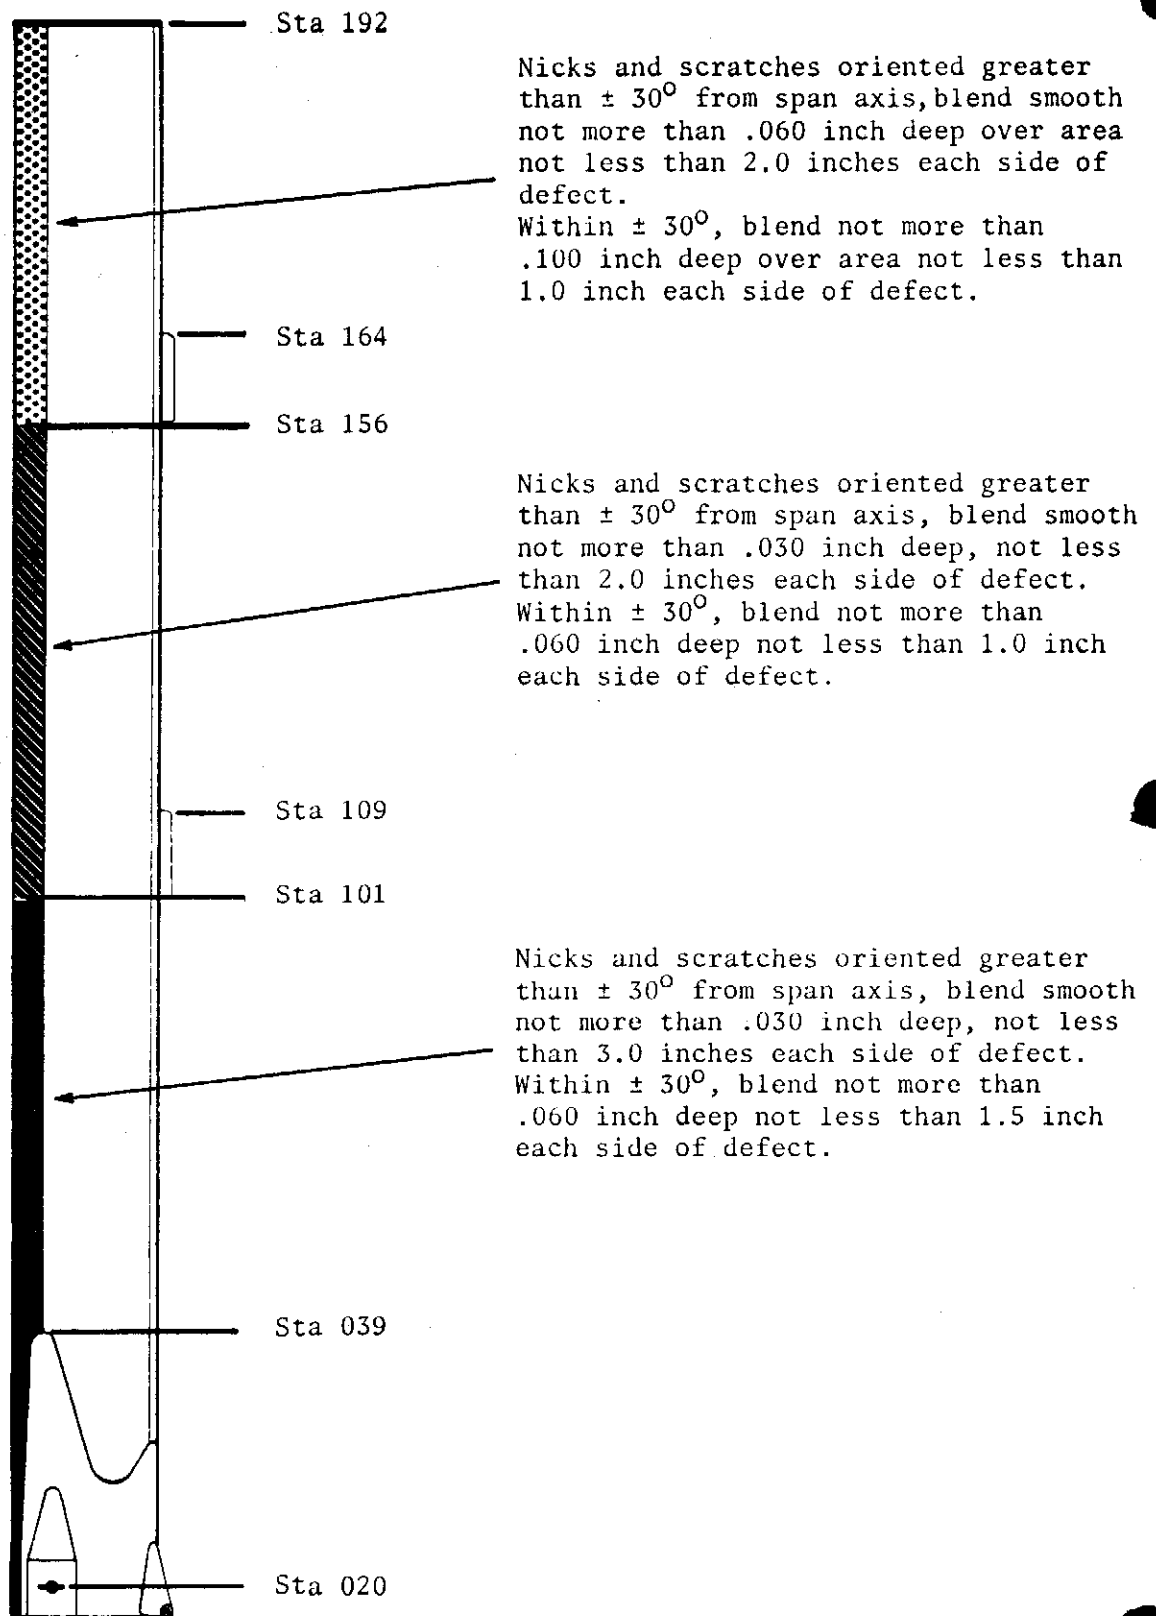
FIGURE 6

Spar Repair Criteria - Nicks & Scratches

- NOTES:
1. Repairs exceeding these depths are cause for rejection.
  2. Excessive material removal will affect track and balance.
  3. Measure depth of material removed from Enstrom contour template

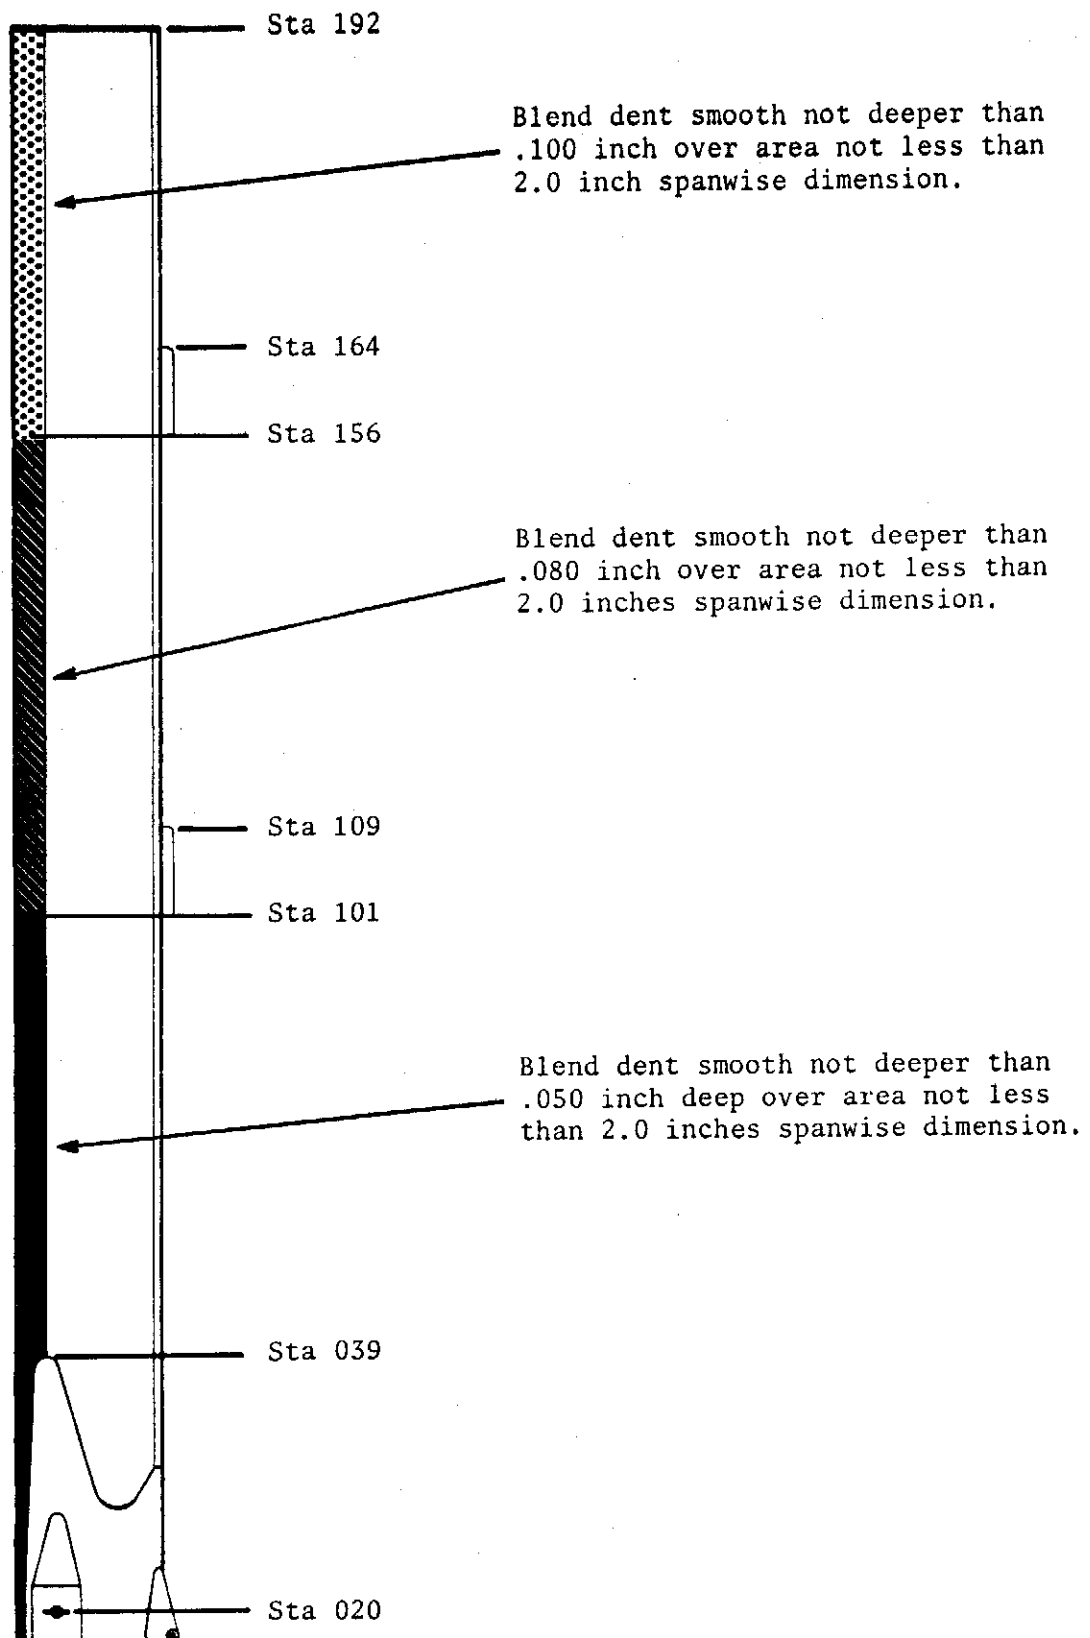
FIGURE 7.

Spare Repair Criteria - Sharp Dents at Leading Edge

- NOTES: 1. Material removal beyond these depths is cause for rejection.
2. Excessive disruption of leading edge contour will affect track.

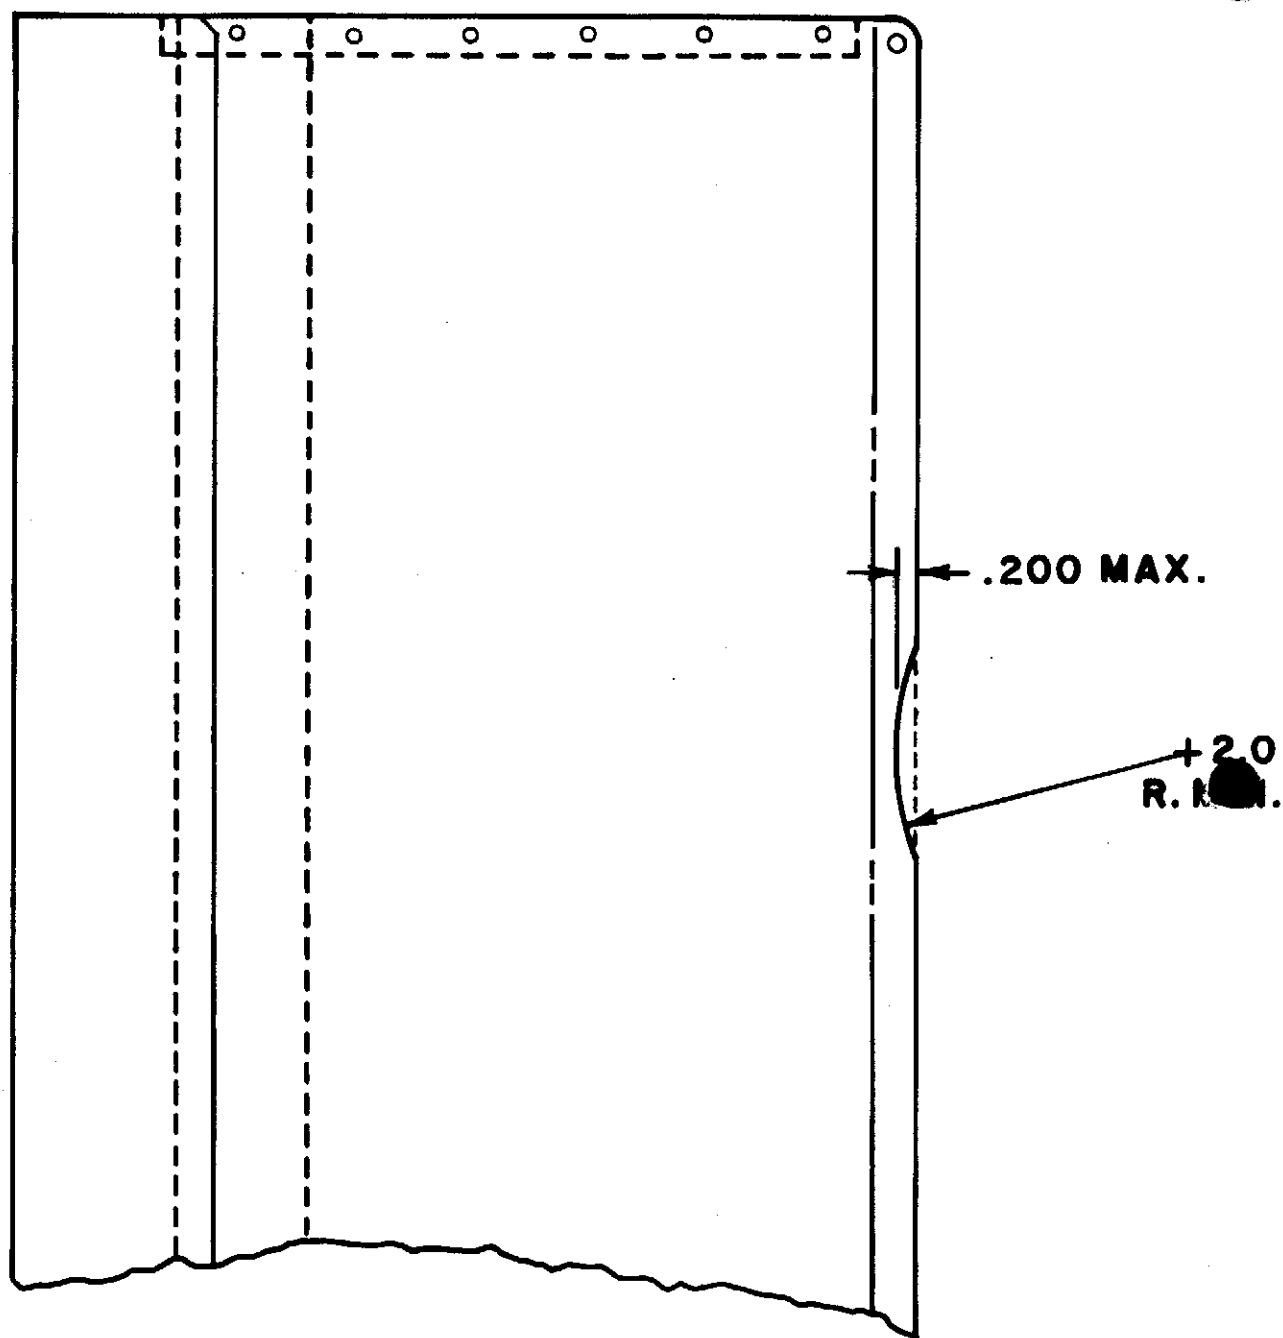
**FIGURE 8**  
**TRAILING EDGE DAMAGE REMOVAL**  
**( MAIN ROTOR BLADE )**

- a. Punctures in the blade skin.
- b. Sharp dents with width to depth ratios of less than 3:1 and deeper than .020 inch, in which the metal has either been creased or the surface scratched or nicked, are cause for rejection.
- c. Dents which have resulted in permanent skin deformation greater than .060 inch in depth are cause for rejection.
- d. Trailing edge chordwise dents or nicks deeper than .20 inch are cause for rejection.
- e. Trailing edge flapwise kinks extending more than .20 inch chordwise are cause for rejection.

- a. Blend out nicks and kinks to a chordwise depth not exceeding .20 inch, on a circular arc with not less than a 2.00 inch radius (see Figure 8).

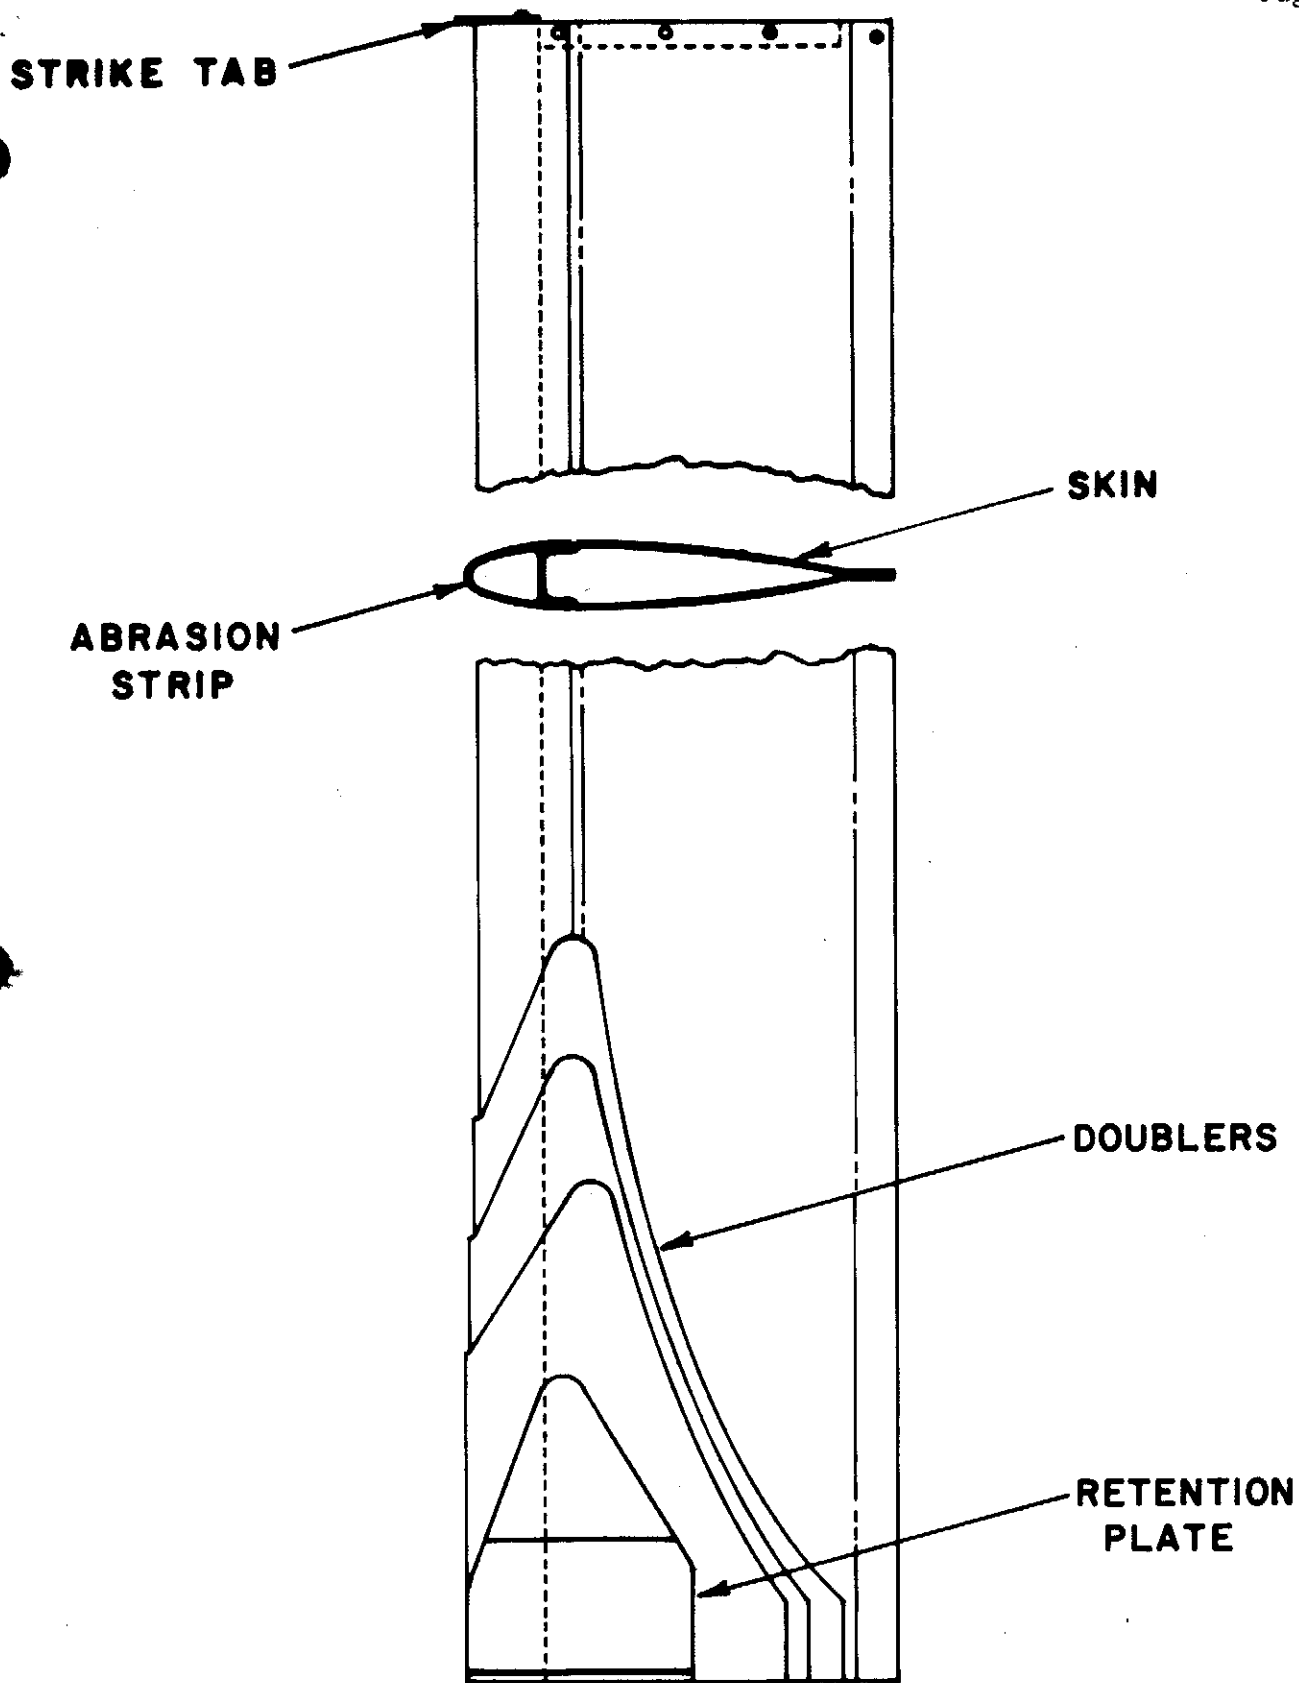
**FIGURE 9**  
**BLADE ASSEMBLY**  
**(TAIL ROTOR)**

Inspect the tail rotor blade, skins, abrasion strip, retention plates and root doublers for nicks, scratches, dents and cracks (see Figure 9). Check the tip rib for loose rivets and strike tab for damage.
