# SERVICE INFORMATION LETTER

SERVICE INFORMATION LETTER NO. 0189

1. SUBJECT: Magneto Retard Terminal P-Lead Insulator
2. MODEL: F-28C, F-28C-2, F-28C-2R, F-28F, F-28F-R, 280C, 280F, and 280FX
3. EFFECTIVITY: F-28F S/N 832 and prior; 280FX S/N 2158 and prior; any F-28C, F-28C-2, F-28C-2R, F-28F, F-28F-R, 280C, 280F, and 280FX that may have had the P-lead insulator changed in the field
4. BACKGROUND:

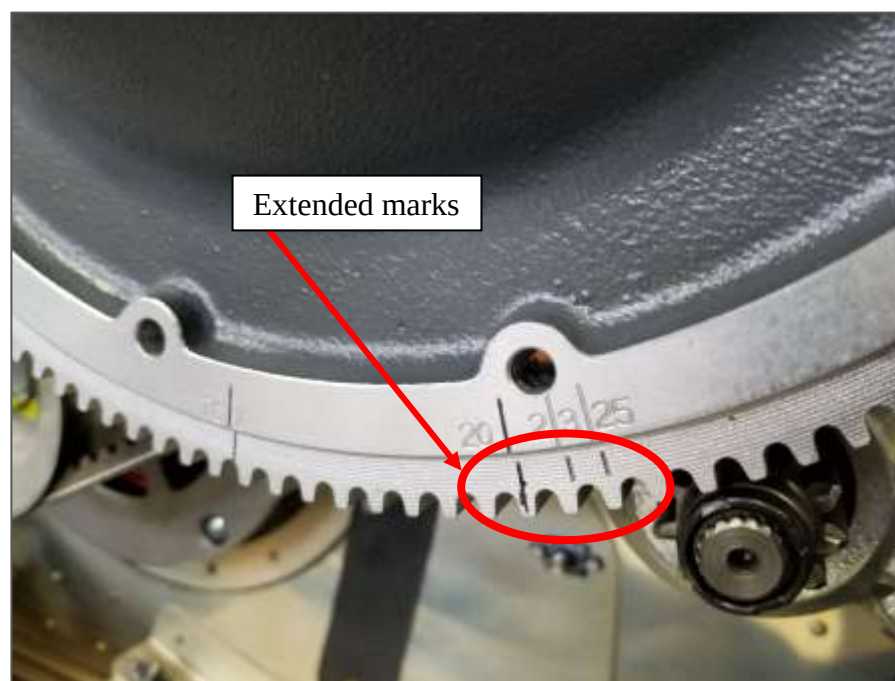
**NOTE:**     **The ignition timing marks are stamped into the starter ring gear support assembly and not actually on the ring gear. To aid in setting the magneto timing, it may be advisable to extend the marks onto the ring gear using a fine Sharpie® or similar marker (Figure 1).**

Figure 1. Timing index marks extended onto the ring gear

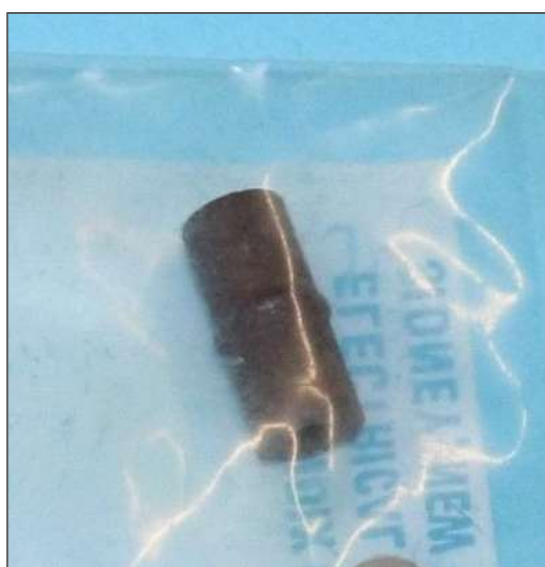
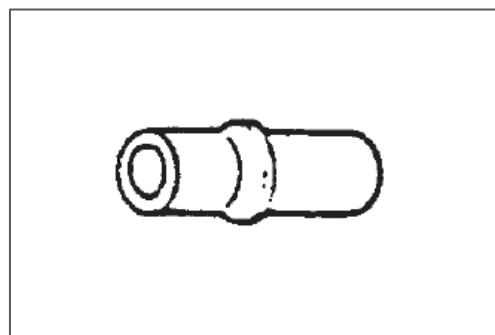
The magneto retard terminal insulator may be either phenolic or soft rubber. The soft rubber insulator is generally used in pressurized magnetos. It forms a tight seal but the compressed insulator may hold the wire insulation and prevent the lead from seating on the terminal and making proper electrical contact. The phenolic insulator will not trap the wire insulation so the lead will make better contact with the terminal. The aircraft with the serial numbers listed above were assembled with a soft rubber insulator (Figure 2). Enstrom recommends checking for this rubber insulator and, if installed, replacing with a phenolic bushing to allow the lead to seat properly.

Figure 2. P/N 10-382812 Rubber Insulator

At the next 100 hr/annual inspection, determine if the P-lead insulator is rubber. If so, replace P/N 10-382812 rubber insulator with P/N 10-157212 (Kit P/N 10-157208) bushing in accordance with paragraph 6.

6.6 Slide the rubber P-lead insulator (P/N 10-382812) (Figure 2) off of the wire and slide the phenolic insulated bushing (P/N 10-157212) (Figure 3) onto the wire.

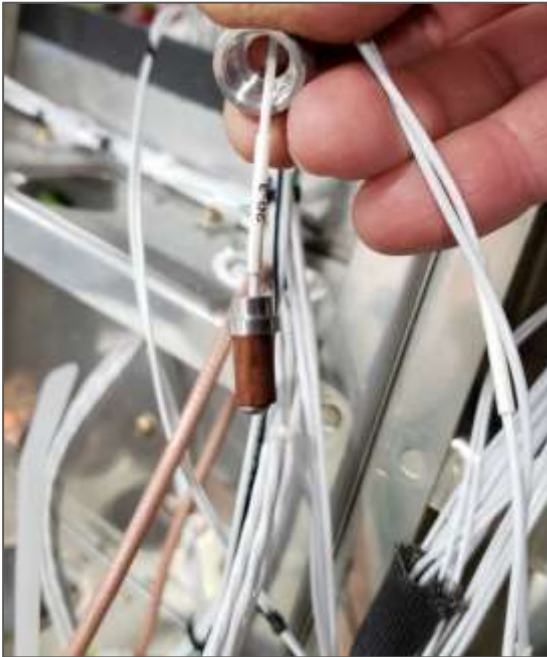
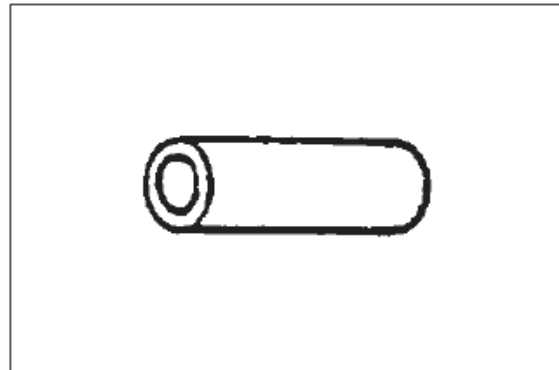
Figure 3. 10-157212 Phenolic Bushing

**The magneto retard terminal bushing (P/N 10-157212) is similar to right and left P-lead connection bushings (P/N 10-382697), but is shorter in length. Ensure the correct bushing is being installed on the retard terminal P-lead wire. Installing the incorrect bushing will cause improper magneto operation.**
