# SERVICE INFORMATION LETTER

SERVICE INFORMATION LETTER NO. T-027

DATE:            November 10, 2017

1.     SUBJECT:    Tail Rotor P/C Link Installation Inspection
2.     MODEL:       480 and 480B
3.     EFFECTIVITY:   All
4.     BACKGROUND:

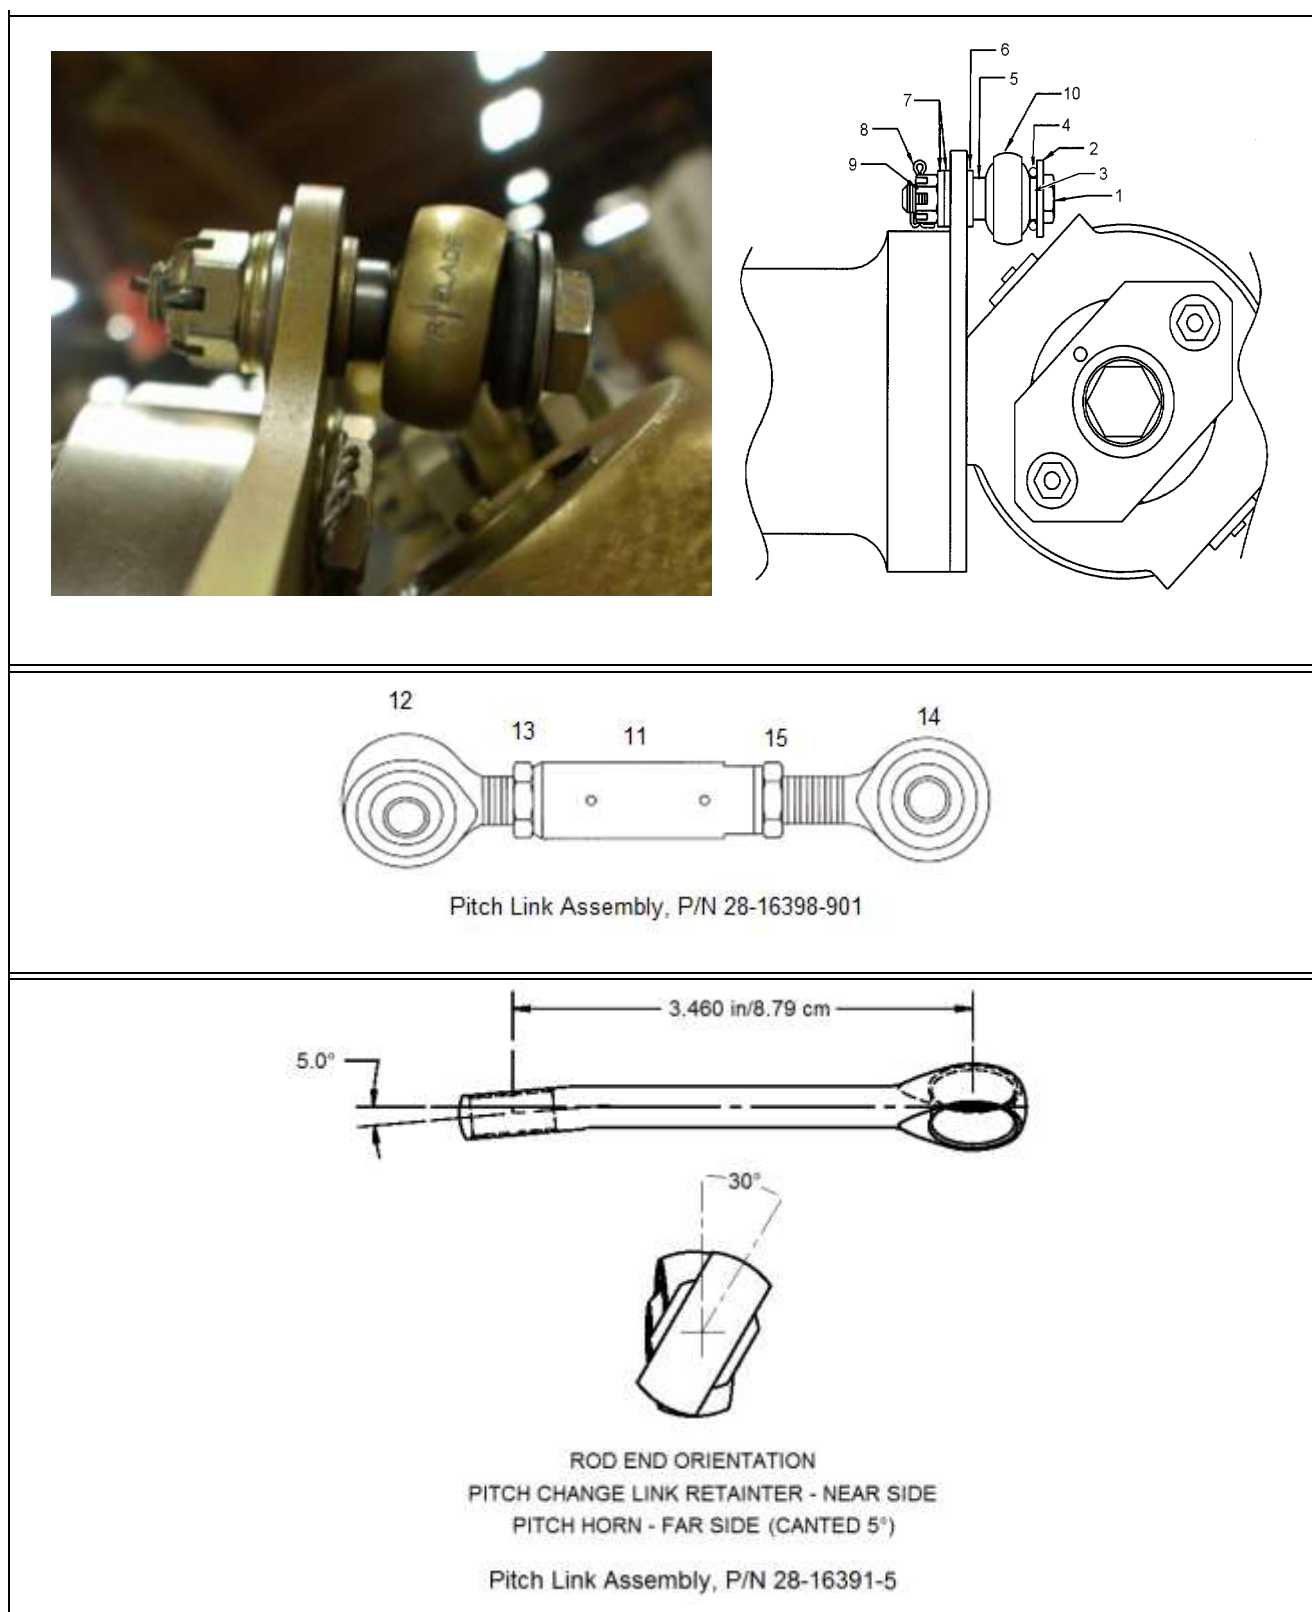
**Figure 1. Tail Rotor Rotating Controls**

5.1.1 Inspect both tail rotor pitch link change installations for proper and secure installation hardware in accordance with Figure 1.

- 5.1.8 Connect the pitch change link (10) to the pitch arm with the hardware in the following sequence: bolt (1) (bolt head installed in the direction of rotation), Harper washer (2), thin spacer (3), O-ring (4), pitch change link rod end (10), thick spacer (5), washer (6), pitch arm, washer(s) (7), and nut (9). Torque the nuts (55-75 in-lbs/6.2-8.5 Nm) and install new cotter pin (8).

5.2.1 Remove and install the tail rotor pitch change link assemblies in accordance with the applicable maintenance instructions for each model aircraft and in accordance with step 5.1.8 above. **NOTE:** The P/N 28-16391-5 (and P/N 28-16391-3) tail rotor pitch link assembly has the label “T/R↑BLADE” etched on the rod end that is canted 5°. This end must attach to the tail rotor and the arrow must point toward the tail rotor blade (see photo in Figure 1).
