# SERVICE INFORMATION LETTER

SERVICE INFORMATION LETTER NO. T-041

1. SUBJECT: Blade Tape Repair
2. MODEL: TH-28, 480 and 480B
3. EFFECTIVITY: All
4. BACKGROUND:

This SIL (Service Information Letter) defines the procedures for making small repairs to the 3M 8681HS tape when installed on Enstrom 28-14100 series main rotor blades.

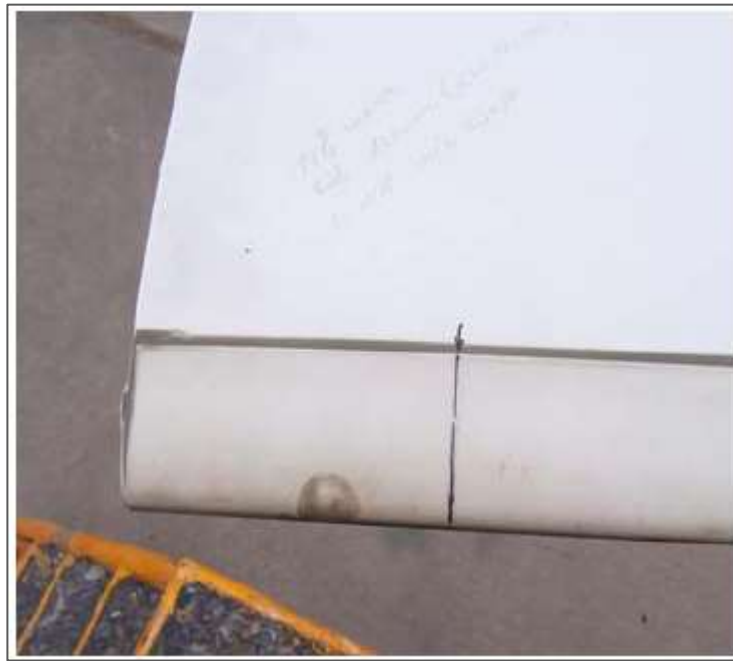
*Figure 1. Area marked for blade tape repair*

- 6.1 Mark a line on the blade on either side of the damaged section at right angles to the edge of the tape line (Figure 1).
- 6.2 Use a razor blade to cut the tape along this line.

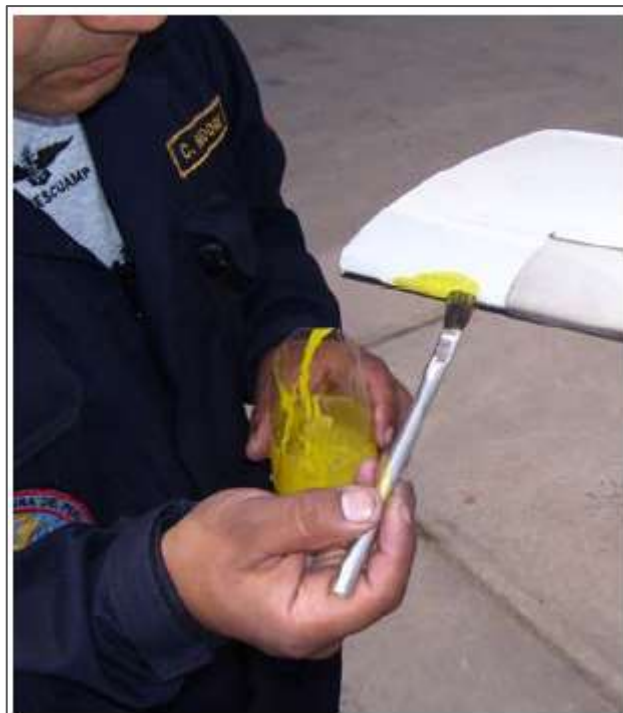
*Figure 2. Primer applied to exposed area*
