## SERVICE INFORMATION LETTER

SERVICE INFORMATION LETTER (SIL) NO. T-073

1.    SUBJECT:     Pylon Reinforcement Doubler Installation
2.    MODELS:     480, 480B
3.    EFFECTIVITY:   S/N 5254 and prior
4.    BACKGROUND:

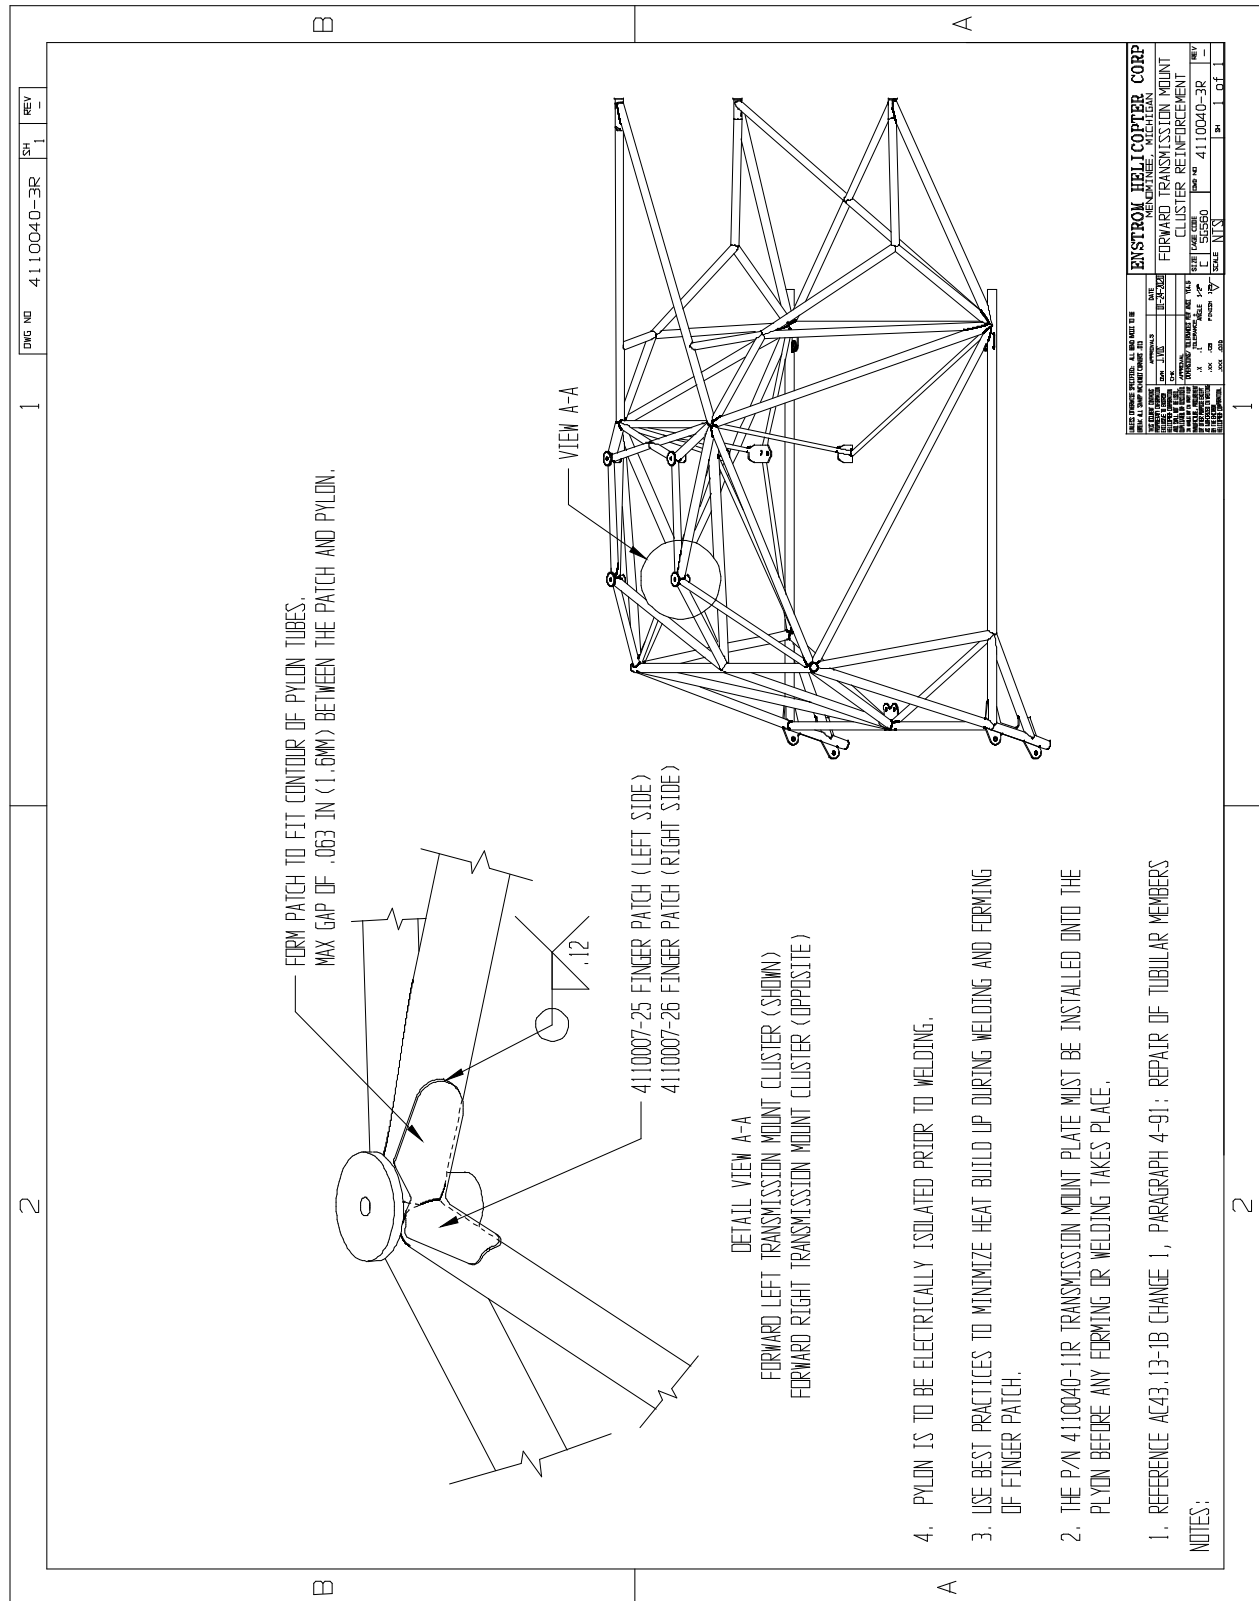
Figure 1. Drawing 4110040-3R – Forward Transmission Mount Cluster Reinforcement

Enstrom received reports of cracks in the pylon joint under the forward left and/or right transmission mounts of three aircraft used in training operations. Enstrom issued Service Directive Bulletin (SDB) T-065 requiring inspection of the pylon for cracks.

- 6.5 Clean the pylon tubes and welds in the area of the transmission mount using a suitable solvent (refer to paragraph 7.2).
- 6.6 Using chemical paint remover, remove epoxy primer from the finger patch area (reference Figure 1 and paragraph 7.2).

- 6.8 Weld P/N 4110007-25 and P/N 4110007-26 finger patches to the pylon joints (reference Figure 1).
  - 6.8.1 Form the patch to fit the contour of the pylon tubes. It is permissible to heat the finger patch to assist in forming. The maximum gap between the patch and pylon is 0.063 in/1.6 mm.
- 6.9 Once the welds have cooled, remove P/N 4110040-11R pylon repair fixture.
- 6.10 Apply epoxy primer (reference paragraph 7.2) to the finger patch and welds.
- 6.11 Install the fuel cell support structures and fuel cells (MM paragraph 8-76).
- 6.12 Install the engine (MM paragraph 13-7).
- 6.13 Install the main rotor transmission (MM paragraph 11-37).
- 6.14 Install airframe grounded instruments and avionics (MM paragraph 7-14 and TH-28/480 Series Maintenance Manual Supplement 5 or applicable manufacturer installation manual of relevant installed equipment, as applicable).
