# Trouble Shooting Tail Rotor Pitch Change Problems

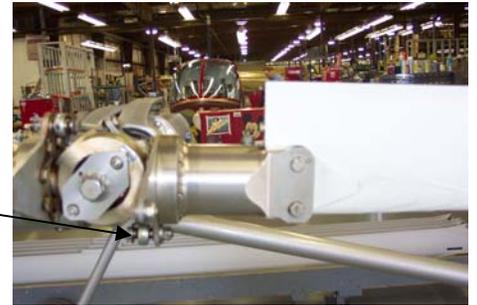
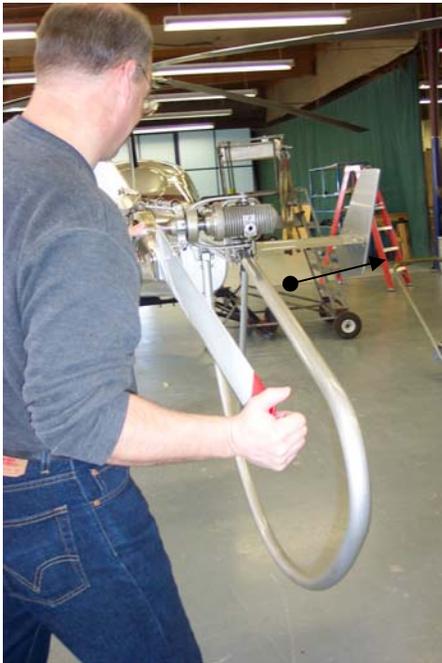
4. To make this determination disconnect the pitch link at the blade retention plate.

Then, pushing on tip of the blade with one hand, use your other hand to rotate the blade, feeling for roughness in the bearing. This test side-loads the roller bearings and checks their condition.

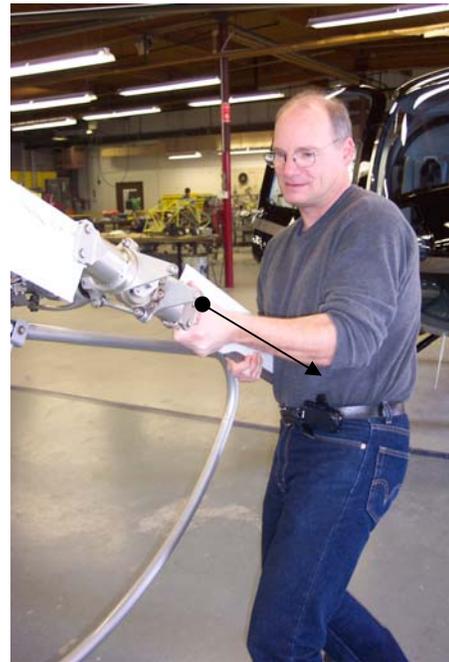
Next, pull out on the blade in the direction of centrifugal force while rotating the blade, feeling for roughness in the nested ball bearings.
