SERVICE DIRECTIVE BULLETIN

SERVICE DIRECTIVE BULLETIN NO. T-036
Revision 1

1. SUBJECT: Drive System Flex Packs

2. MODEL: TH-28, 480, and 480B

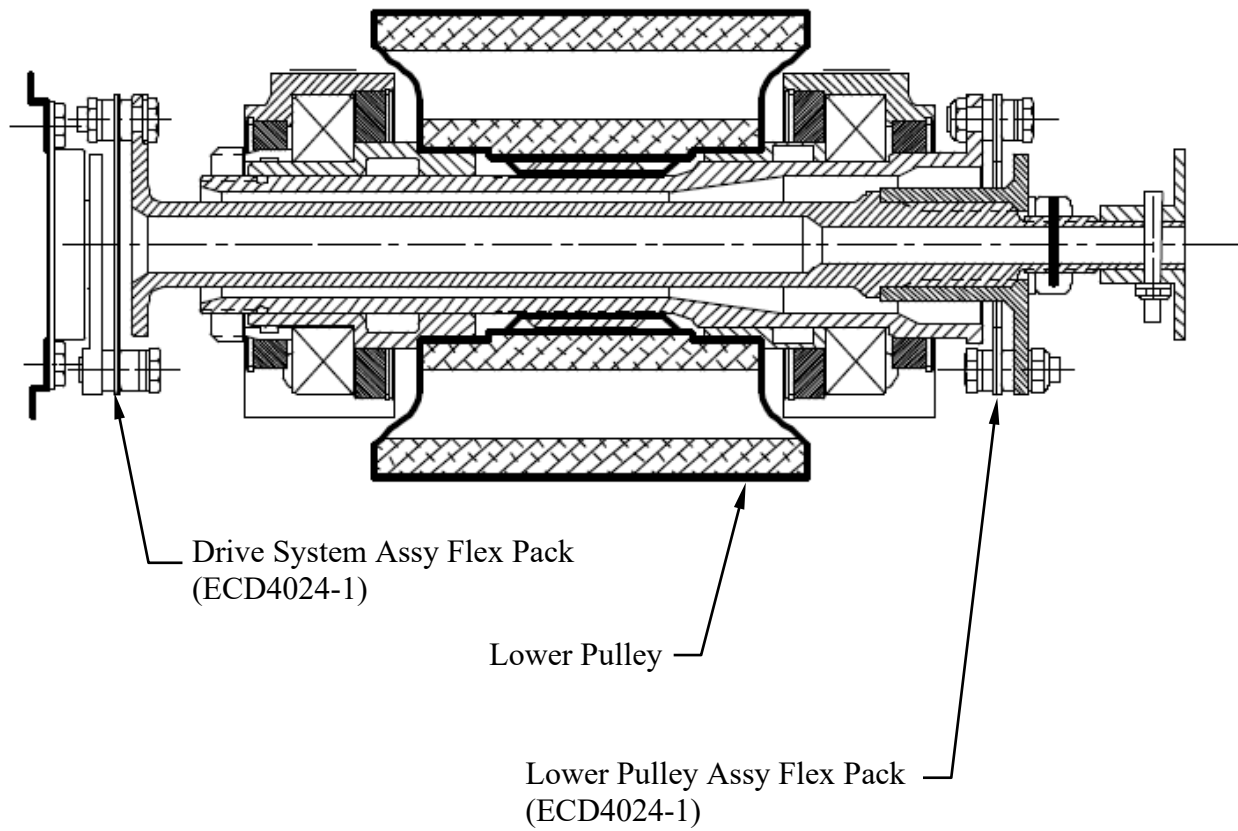
- A. Count the number of elements in each flex pack. There are two flex packs: one on the drive system assembly (forward) and the second is on the lower pulley assembly (aft). Refer to Figure 1. Each flex pack must contain eight (8) elements.

- A. Replace the flex pack(s) with a set of eight elements IAW TH-28/480 Series Maintenance Manual paragraphs 11-19 and 11-20. If the aft flex pack is replaced, the lower pulley assembly must be removed from the aircraft.

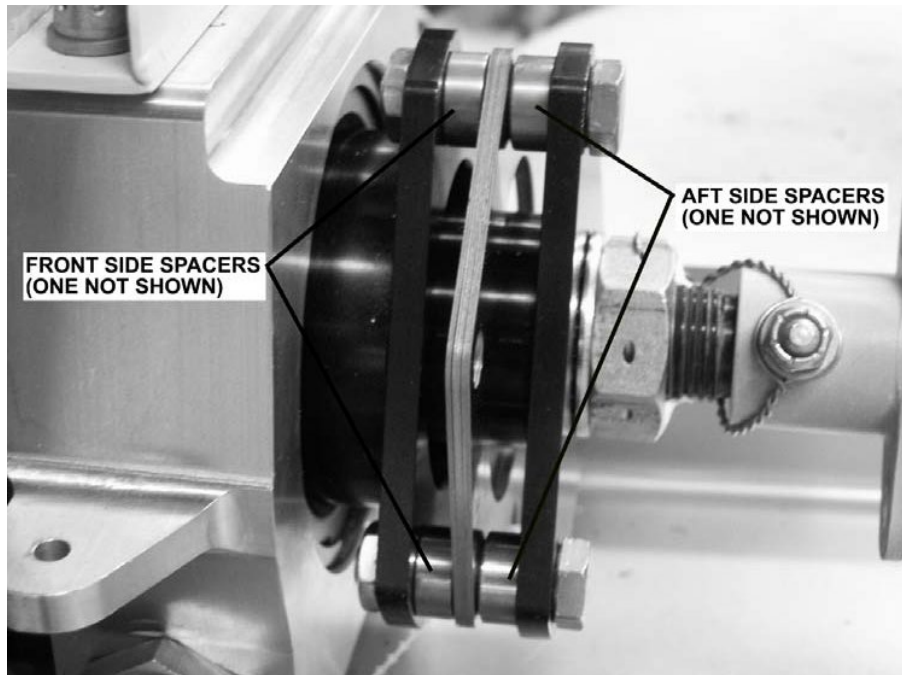
3. When reassembling the aft coupling for alignment, all three spacers on the front side of the flex pack must be of equal thickness, and all three spacers on the aft side of the flex pack must be of equal thickness (See Figure 1).

Figure 1 - Aft Coupling Assembled for Alignment

4. Depending on the measuring tools used to determine the flange spacing for axial alignment, use thinner spacers (of equal thickness) on one side of the aft flex pack to move the power output shaft flange and the lower pulley drive shaft flange closer together. Use thicker spacers to move the flanges farther apart.

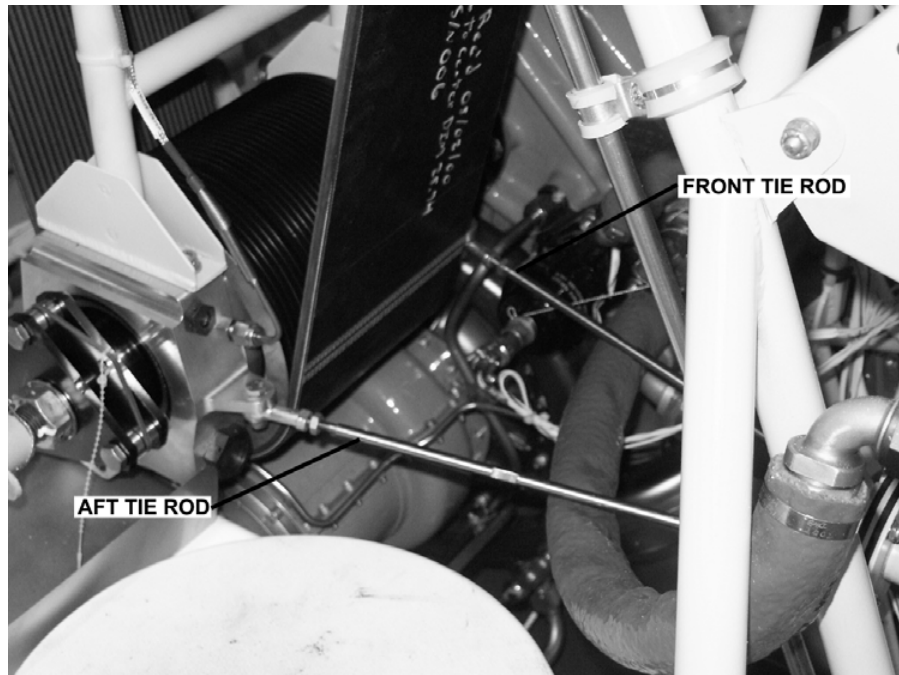
5. Disconnect the tie rods from the lower pulley assembly (See Figure 2).

Figure 2 - Lower Pulley Tie Rods

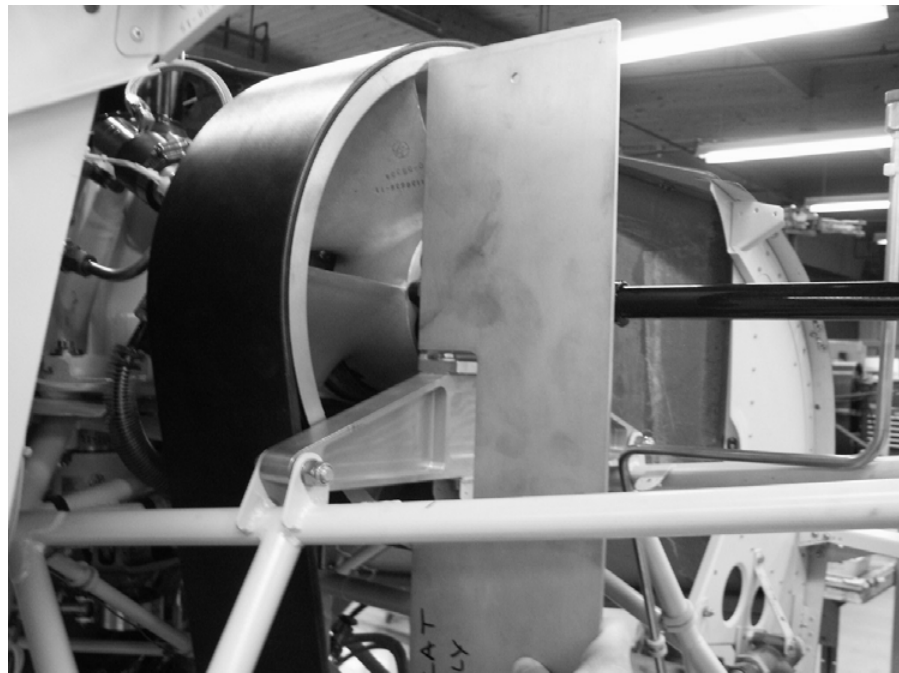
Figure 3 - Alignment Tool at Upper Pulley

1. Using a combination square and a piece of chalk, mark an indexing line across the belt for checking belt tension during the tension and alignment procedure. Do not put the indexing line near the part number/serial number markings.
2. Rotate the pulley system a minimum of one complete belt rotation after making a tension adjustment before checking belt tension.
3. Belt tension range is 1,750 - 2,500 pounds (Refer to paragraph 11-29,E). Tension on the front side of the belt must be within ± 250 pounds of the aft side.
4. Ensure the alignment tool is contacting the upper pulley and lower pulley (See Figures 3 and 4).

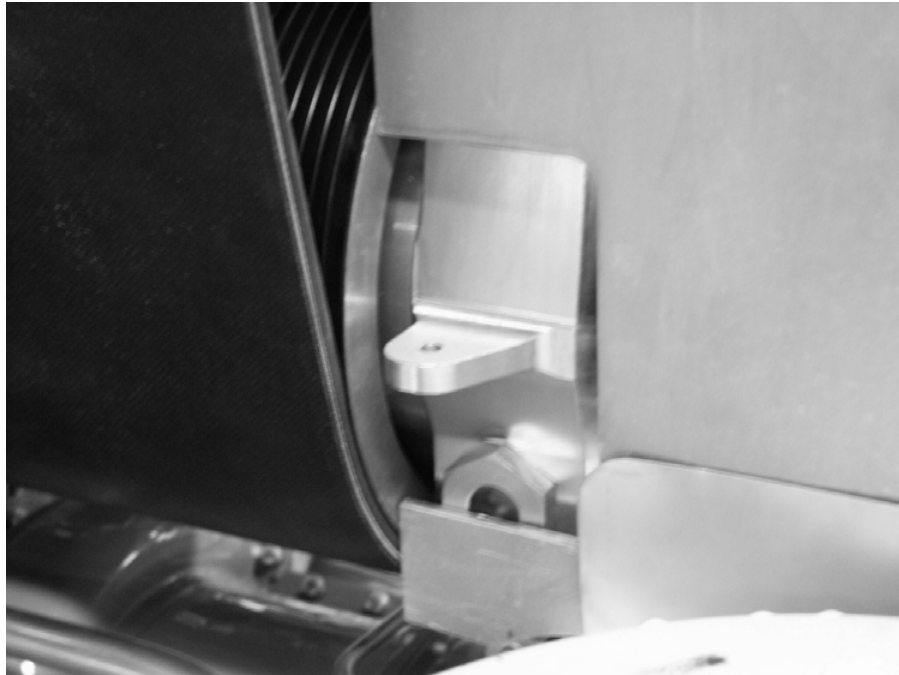
Figure 4 - Alignment Tool at Lower Pulley

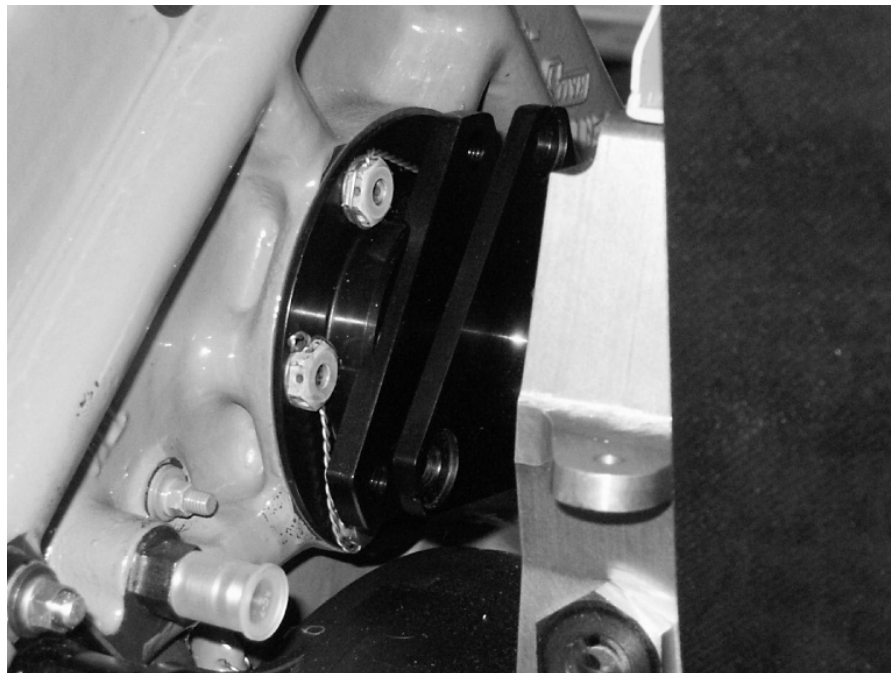
Figure 5 - Engine to Lower Pulley Alignment (Engine Low)

1. The lower pulley system is a pendulum and movement is in an arc.
2. Acceptable alignment is achieved when the bolt can be threaded into the power output shaft flange using finger pressure (See Figures 5 and 6).

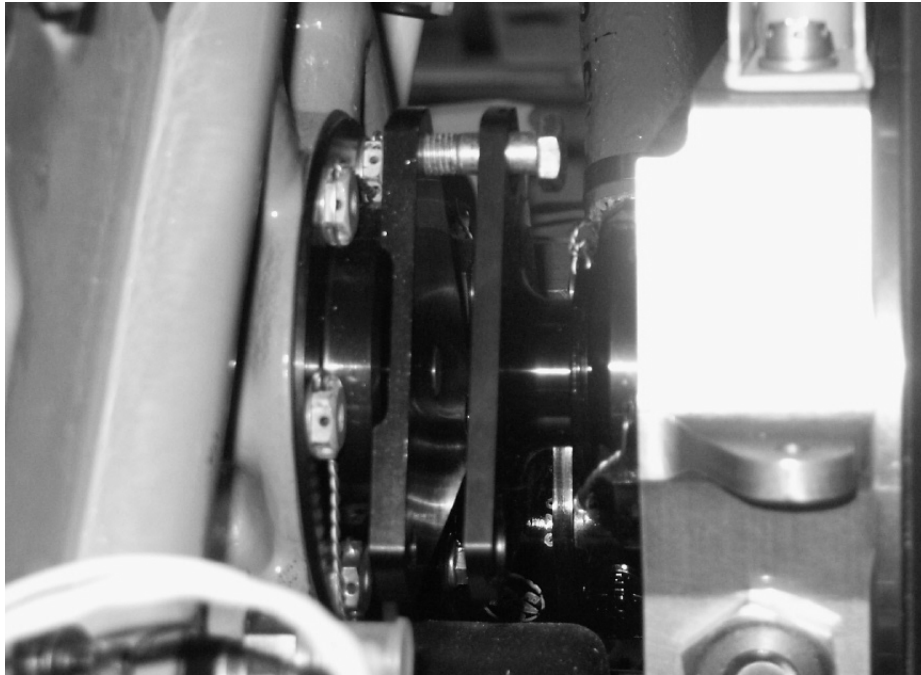
Figure 6 – Engine to Lower Pulley Alignment (Aligned)

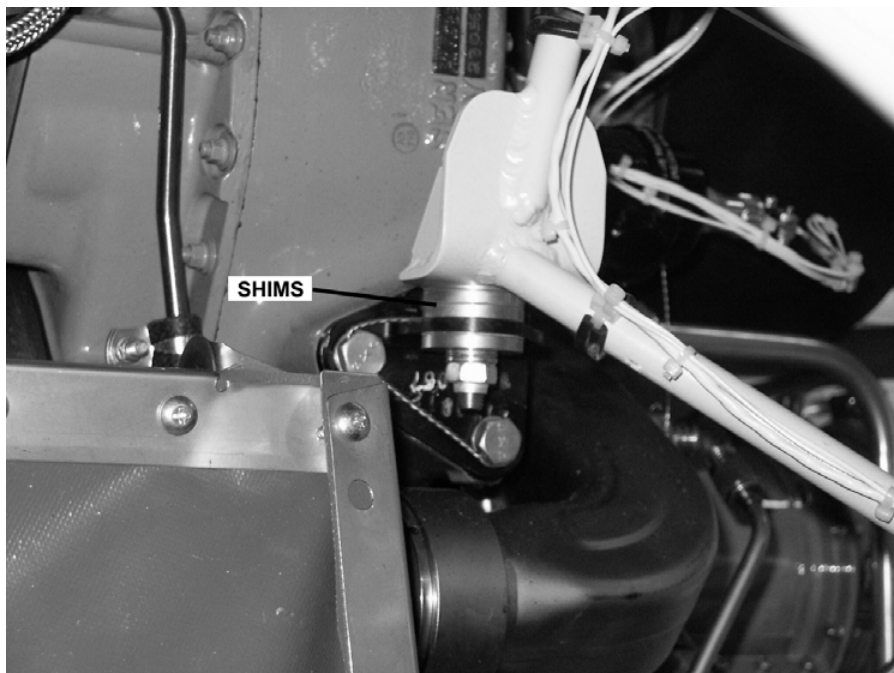
Figure 7 - Engine Bi-Pod Mount

3. The engine hangs from the engine mounts. The vertical position of the engine is changed by adjusting the shim thickness between the pylon mounts (bi-pod on the left side and tri-pod on the right side) and the mounts installed on the engine (See Figures 7 and 8). The upper engine mount will support the weight of the engine; however, the purpose of the mount is to maintain the parallel alignment of the engine to the main rotor transmission and the lower pulley drive system.

5. Adjust the shimming on the bi-pod mount (left side) before adjusting the tri-pod mount. Push on the engine fire pan in the area of the droop compensator bracket to help get the mount bolt installed or removed. Once the shims and the mount bolt are reinstalled, tighten the mount bolt assembly and then loosen one or two turns of the nut - the tri-pod mount does not allow much movement of the engine; loosening the bi-pod mount helps when adjusting the shimming on the tri-pod mount.

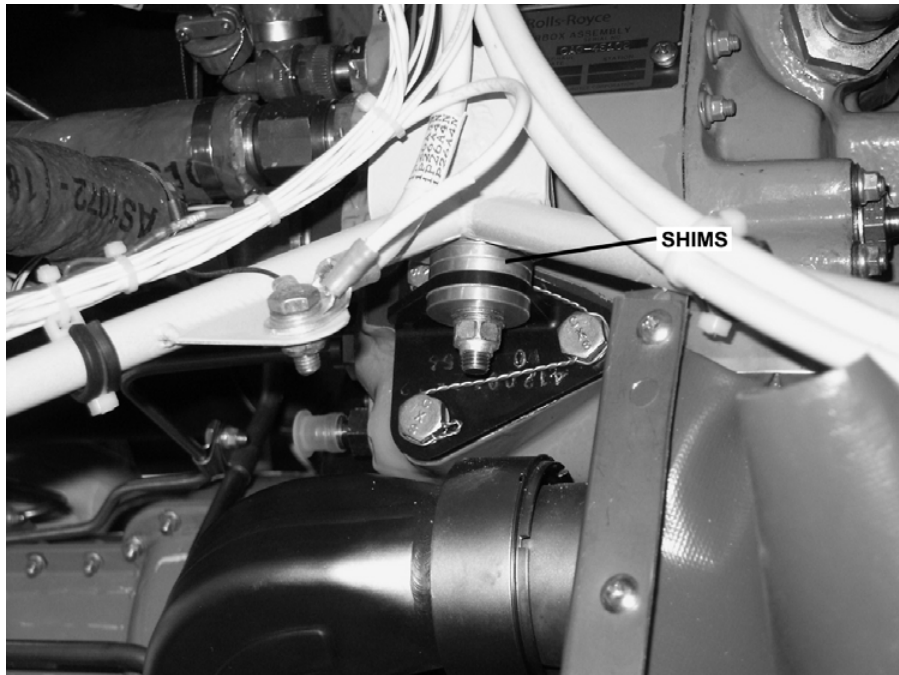
Figure 8 - Engine Tri-Pod Mount

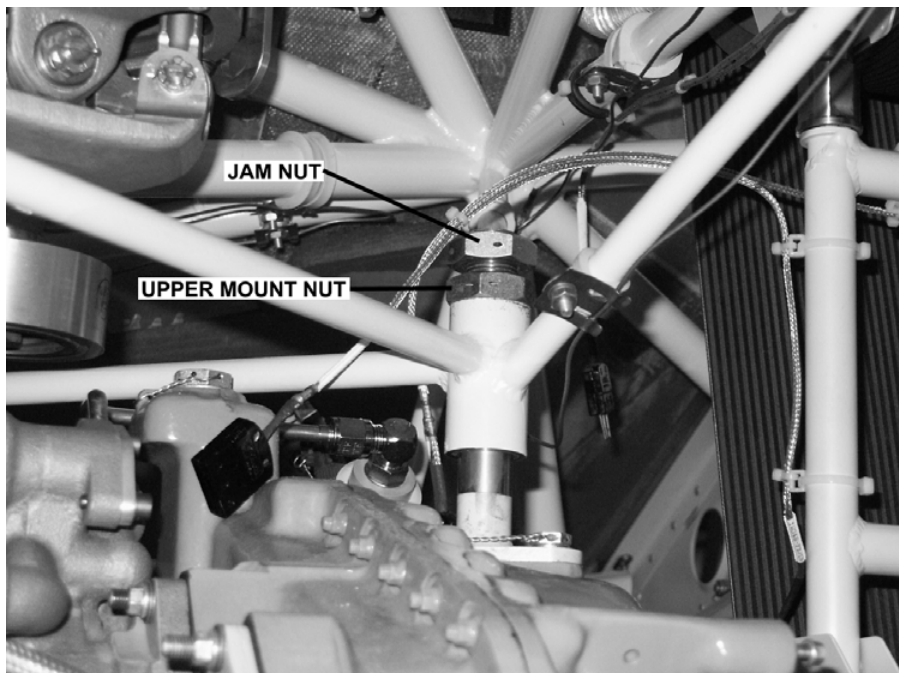
Figure 9 - Engine Upper Mount

4. When adjusting the engine position, loosen the nut and jam nut on the top engine mount enough to allow the engine to drop approximately .060 inches before loosening the side mounts (See Figure 9).

6. When the shimming is correct, torque the side mount bolt assemblies. Turn the top engine mount nut until it contacts the top pylon mount and then tighten one more flat. Tighten the jam nut against the mount nut and lock wire to the nuts to the engine mount (See Figure 9).

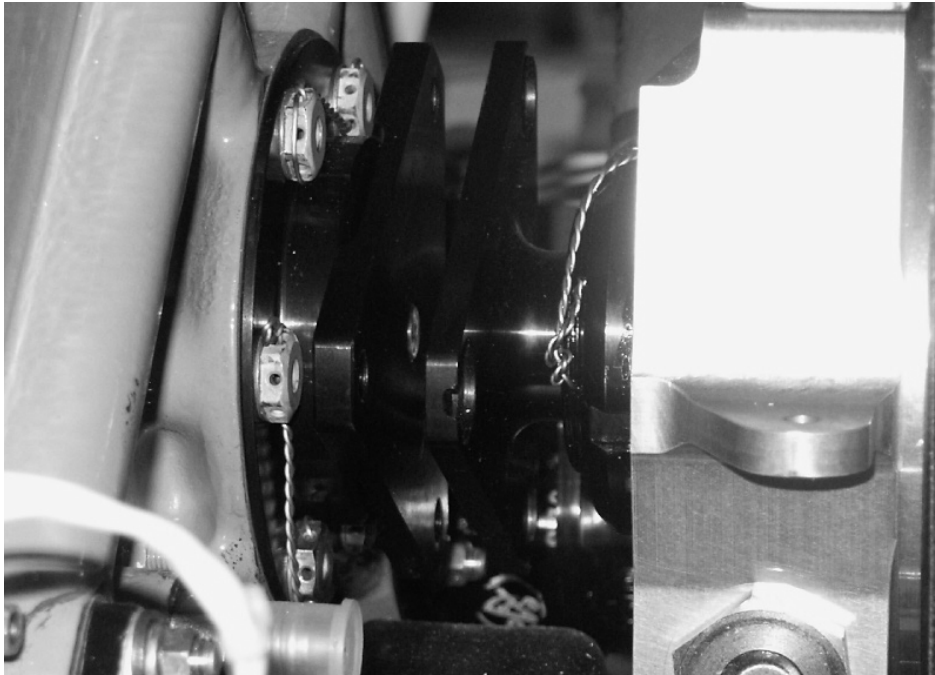
Figure 10 - Flange Position for Lateral and Axial Alignment Check

7. Use both tie rods when adjusting the lateral alignment of the lower pulley drive shaft to the power output shaft. Once the bolt can be threaded into the power output shaft, fine adjustments can be made with the help of a second person. As the bolt is slowly being threaded into the power output shaft, the second person slight adjusts the front tie rod as required for the bolt to freely thread into the power output shaft (See Figures 10 and 11).

8. Axial alignment between the power output shaft and the lower pulley drive shaft is obtained by adjusting the aft tie rod. Use feeler gauges, telescoping gauges, gauge blocks, or other measuring device to determine the distance between the flanges at the 9 o'clock and 3 o'clock positions (See Figure 10 for 9 o'clock position; 3 o'clock position opposite).

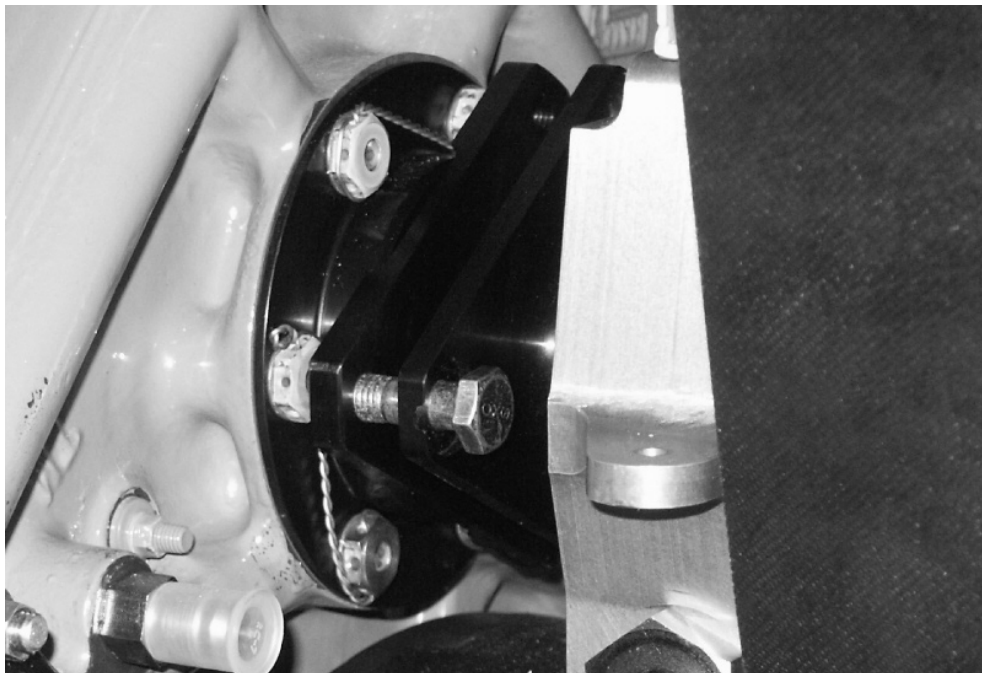
Figure 11 - Lateral Alignment (Aligned)

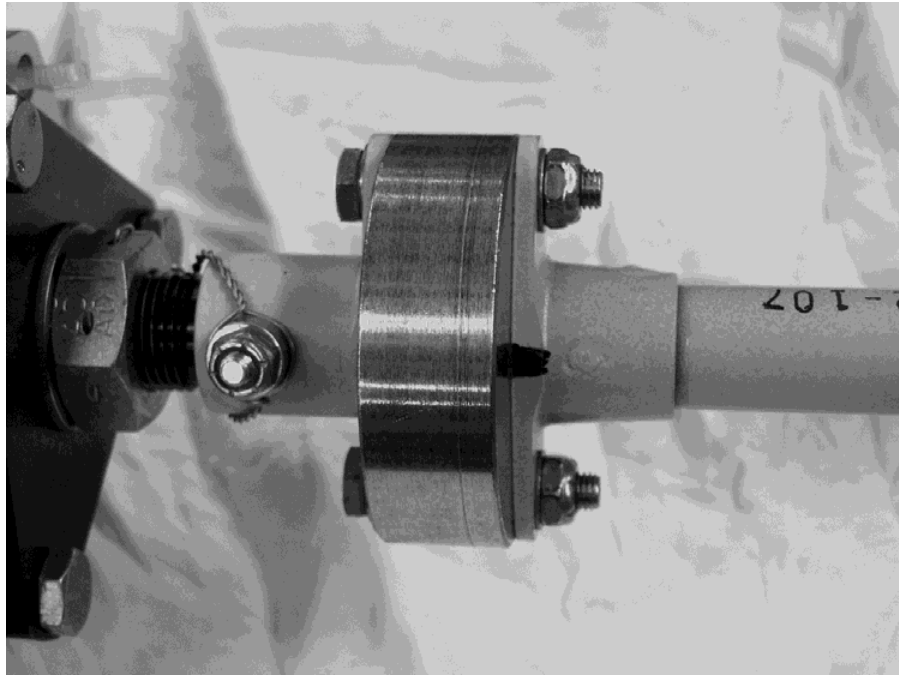
Figure 12 - Intermediate Shaft Installed with T-0166-11, Alignment Spacer

1. Install the intermediate drive shaft onto the end of the lower pulley assembly using the T-0166 - Alignment Spacer(special tool) instead of the flex pack assembly (See Figures 12, 13, 14, 15, and 16).
2. The slots on the bearing housing supports may be elongated if more lateral adjustment is required for alignment (See Figure 18).
3. The tolerance for the distance between the flange faces ($\leq .005$ inches) is the same for the lateral position and vertical position.

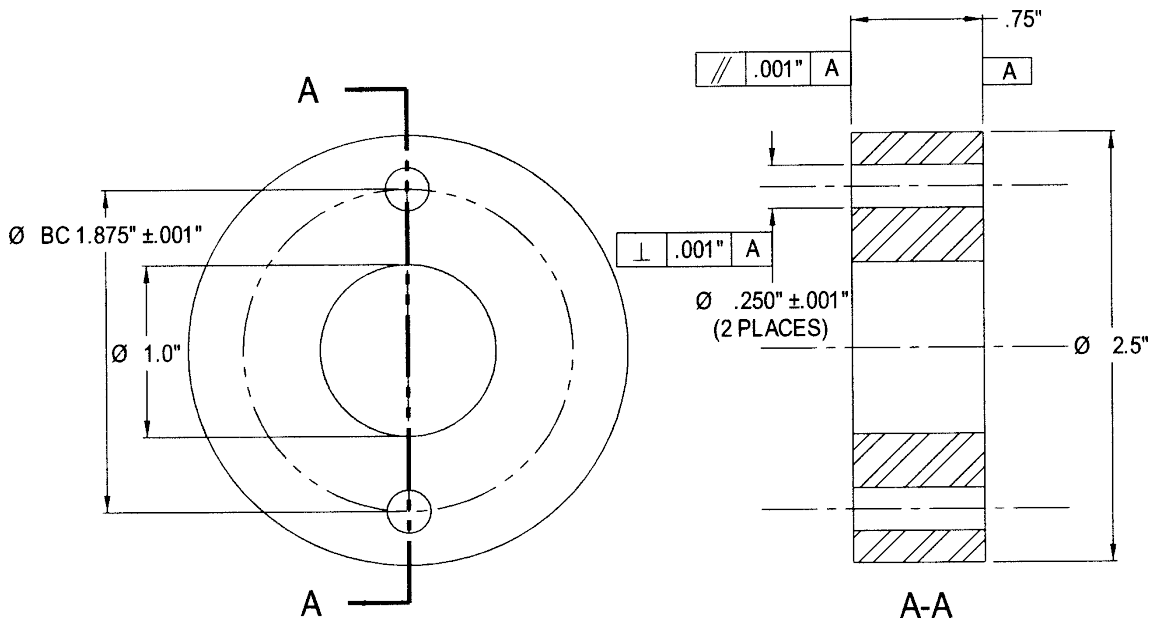
- 1. Make from steel or aluminum.
- 2. Break all sharp edges.

Figure 13 - T-0166-11, Alignment Spacer

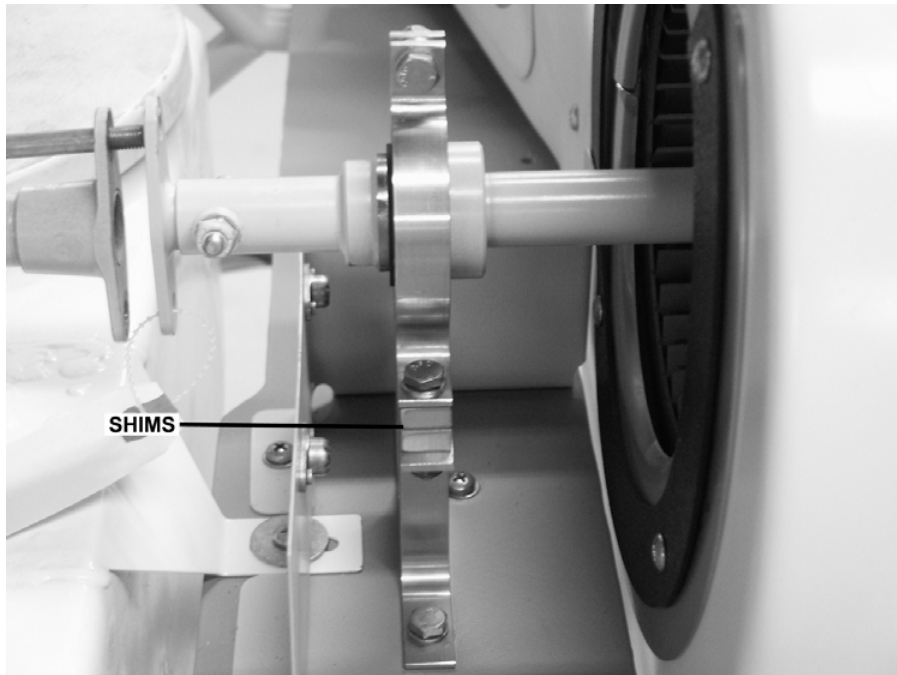
(Note vertical misalignment)

Figure 14 - Oil Cooler Blower Forward Mount

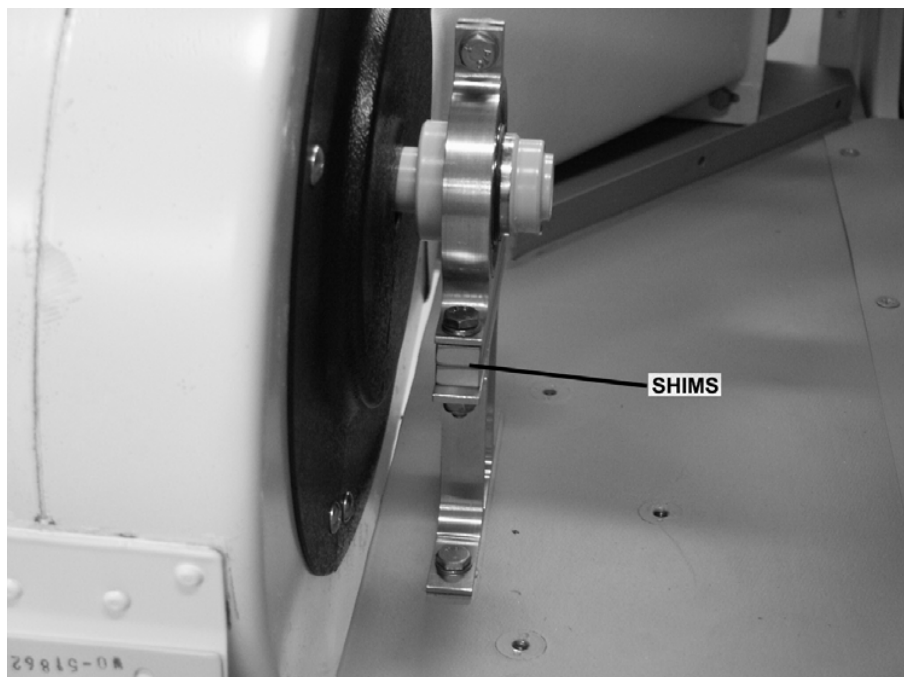
Figure 15 - Oil Cooler Blower Aft Mount

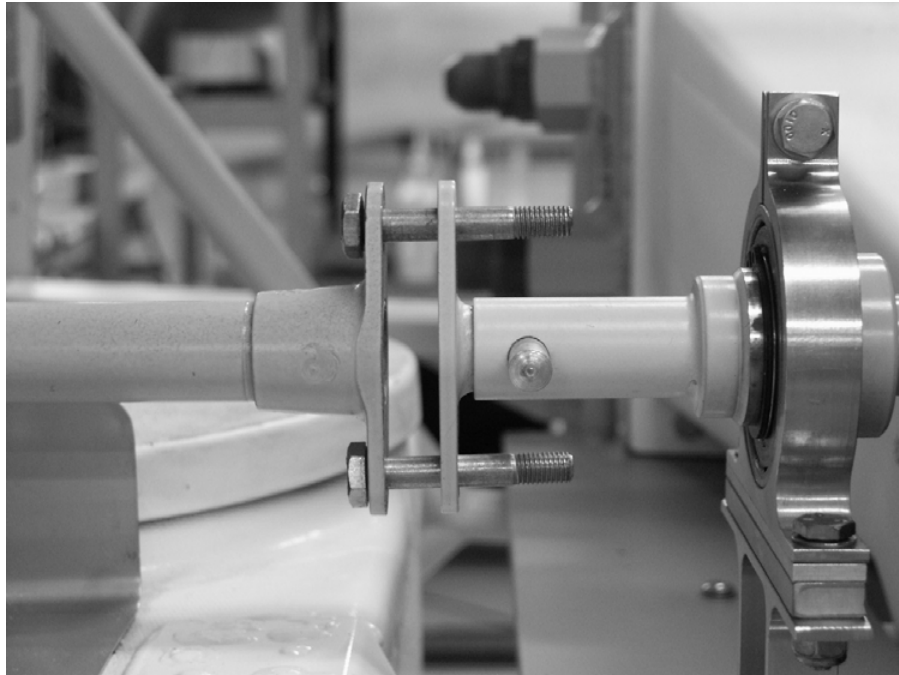
Figure 16 - Oil Cooler Blower Shaft Vertically Aligned

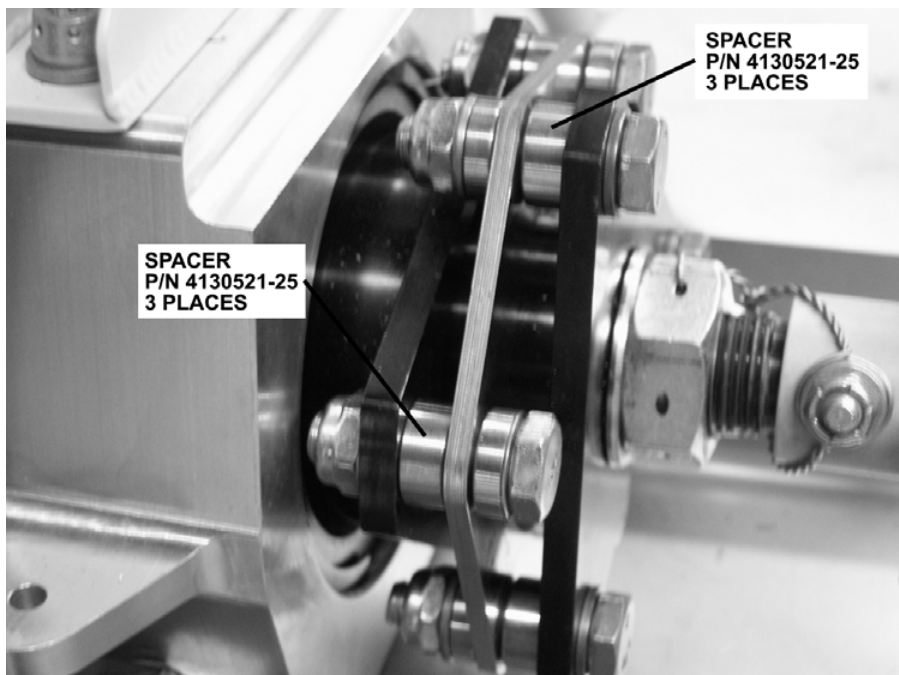
Figure 17 - Aft Coupling Normal Installation

4. Adjust the position of the blower shroud as required after completing the oil cooler blower shaft alignment.
6. Lower Drive System Reassembly (Refer to paragraph 11-17,E):
 1. Reassembly the lower pulley aft coupling using .250 inch spacers, P/N 4130521-25, between the flex pack and the flanges of the hub and the pulley shaft (See Figure 17).
 2. Determine the spacer thickness required between the forward flex pack and the flanges on the shafts using the following formula:

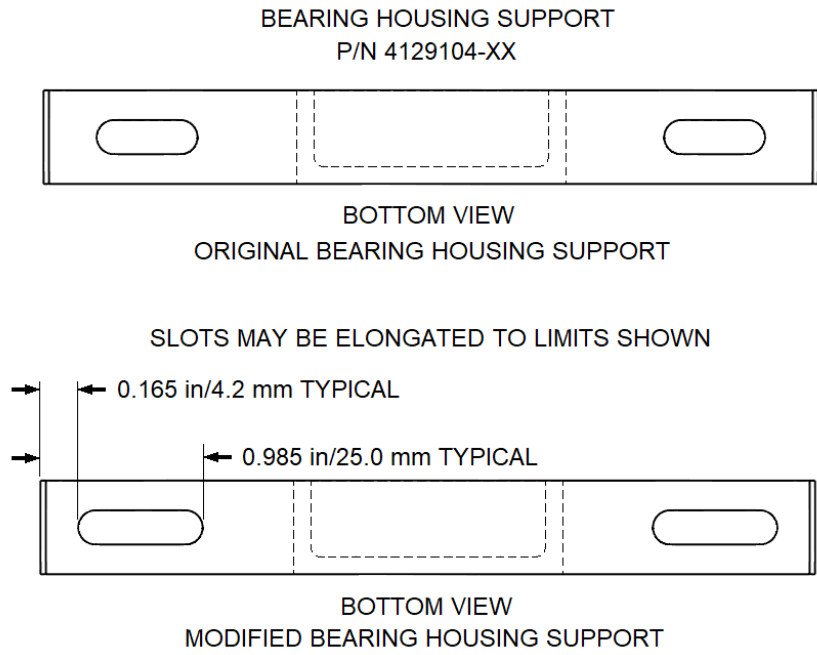
Figure 18 - Elongation Limits of Oil Cooler Bearing Housing Supports
