SERVICE INFORMATION LETTER (SIL) NO. 0074  
Revision 3

1. SUBJECT: Drive Belt Inspection Requirements

2. MODEL: F-28A, F-28C, F-28C-2, F-28C-2R, F-28F, 280, 280C, 280F, and 280FX

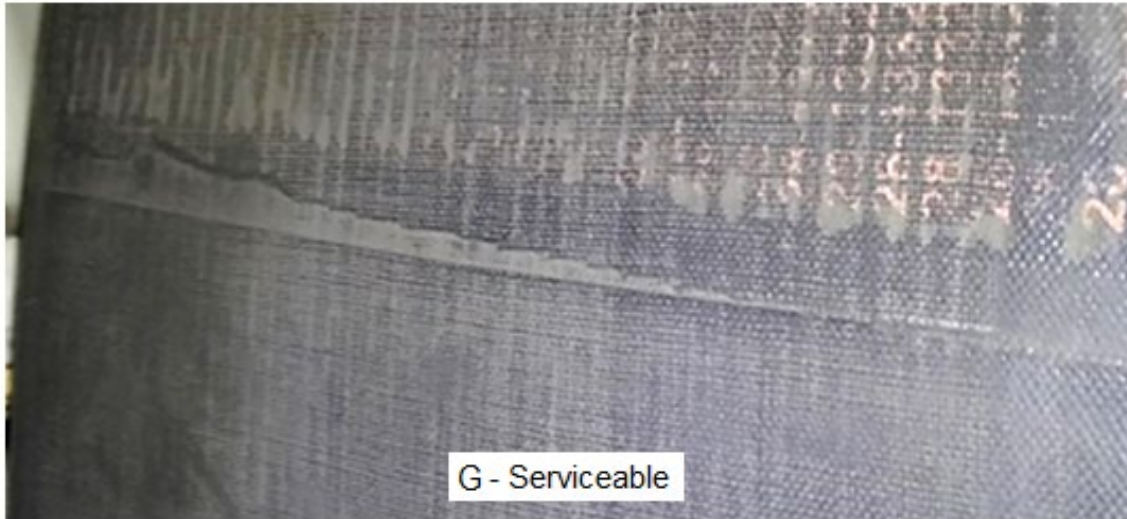
**Figure 2. Back of Belt**

1. Examine the back of the belt for cuts or damage and blisters. Replace the belt if there is any damage which appears to penetrate the fabric cover or if any blisters are present.
2. Examine the back of the belt at the fabric splice. The belt should be removed if there is any loosening or peeling of the fabric in the splice areas. Examples of fabric splices are depicted in Figure 2. Photograph G and Photograph H are examples of a serviceable belt. Photograph I is an example of an unserviceable belt.

- Back of belt – cuts, damage, blisters, peeling, or cracks
  - The back of the belt should be examined for cuts or damage and blisters which may indicate separation of the fabric plies. The belt should be replaced if there is any damage which appears to penetrate the fabric cover or if any blisters are present. A small crack in the back of the belt at the fabric splice is not significant, and often this is the fabric overlap created during manufacture of the belt. The belt should be replaced, however, if there is any loosening or peeling of the fabric in the splice area. The backing will take a long time to peel and, if this happens, it will cause vibrations, make a mess, and probably cause a “burning rubber” odor. The vibrations and the flapping backing material might damage some of the surrounding parts but normally not to the point where they will fail. This will also happen a long time before the belt fails completely.

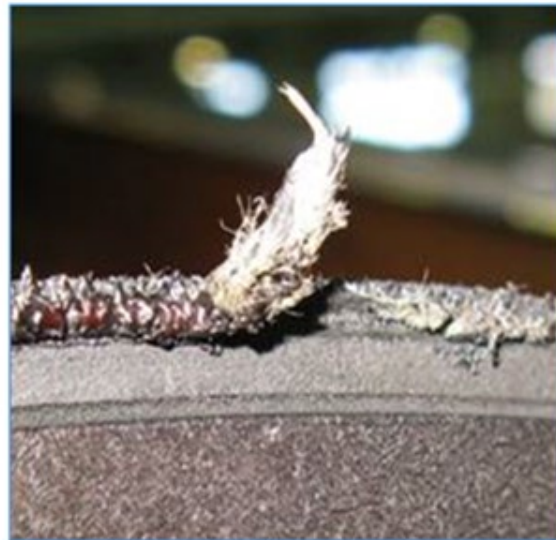
**Figure 5. Edge of Belt – Cord Tail**

Serviceable if trimmed in accordance with SDB 0117

- a. Replace the belt if it has been determined that cord failure exists.
  - b. Refer to SDB 0117 for exposed cord limits. Remove the belt if exposed cord exceeds the limits and seal the edge in accordance with SDB 0117.
  - c. An example of a sealed edge is depicted in Figure 6.
4. Examine the belt edge for a cord tail. An example of a cord tail is depicted in Figure 5.
- a. Remove the belt if it has cord tail. Trim the cord tail and repair the belt in accordance with SDB 0117.
