Enstrom Maintenance Alert

Part number: 28-11307-1

Part description: MOUNT CABIN SEAT LT

Enstrom: 280C; S/N 1069, Time in Service 1190

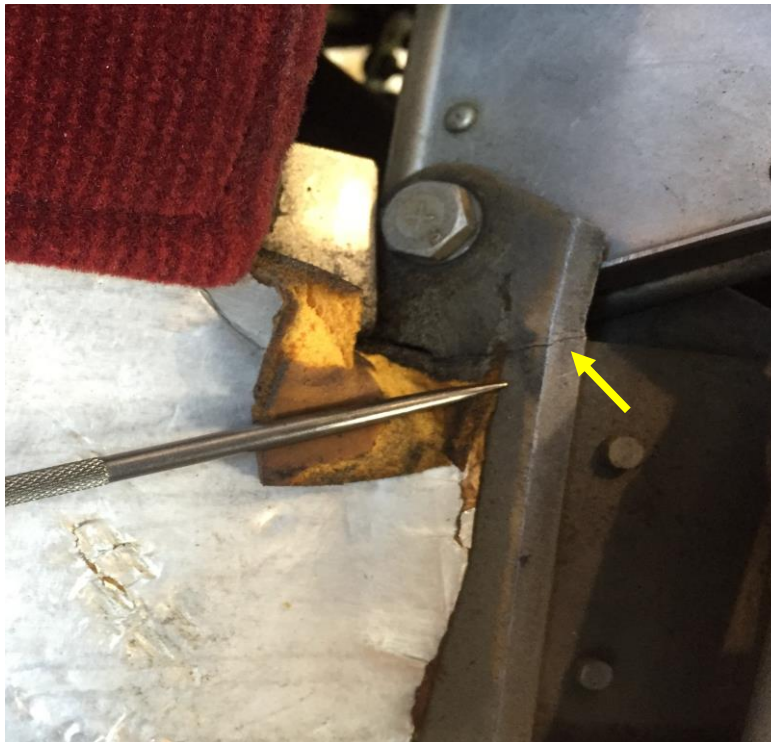
It was reported that a technician found a cracked pilot's side cabin cyclic bell crank mount (P/N 28-11307-1) on a 280C helicopter. Enstrom recommends inspecting both co-pilots, and pilot's side mounts carefully during scheduled inspections or any time the seat deck is removed.
