SERVICE DIRECTIVE BULLETIN

SERVICE DIRECTIVE BULLETIN NO. 0117
Revision 4

1. SUBJECT: Main Rotor Drive Belt
2. MODEL: F-28A, 280, F-28C, F-28C-2, F-28C-2R, 280C, F-28F, F-28F-R, 280F,
 and 280FX
3. EFFECTIVITY: All S/N
4. BACKGROUND:

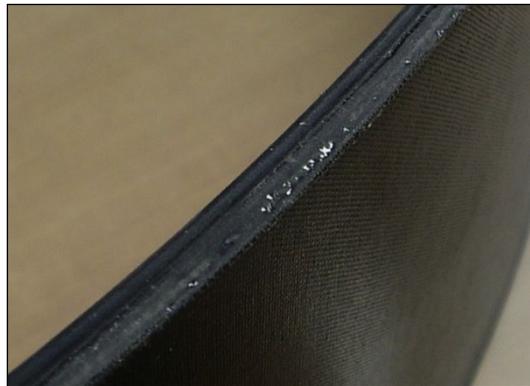
Figure 1. Sealed belt edge

6.1 Inspect the belt for sealed edges, checking for any loose or protruding cord. See the example shown in Figure 1.

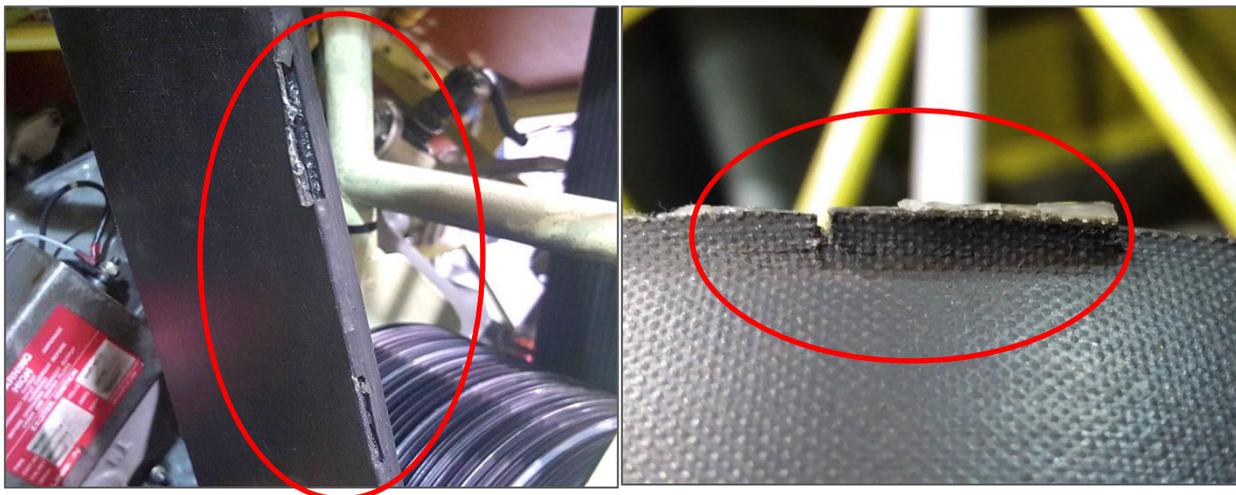
Figure 2. Deteriorated sealed belt edge (Turbine model drive system shown)

6.1.1 If the belt edge was previously sealed but the belt edge has deteriorated as shown in Figure 2 or if any loose or protruding cords are found, remove the belt and send back to Enstrom for warranty. Install a new airworthy belt.

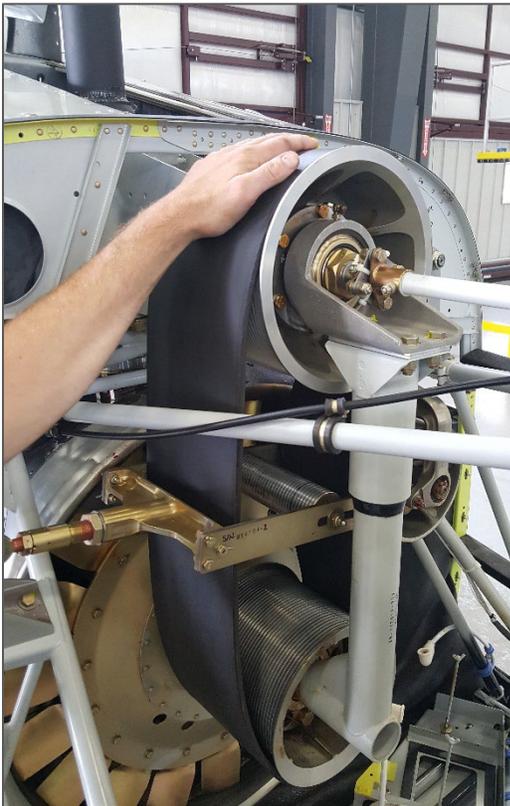
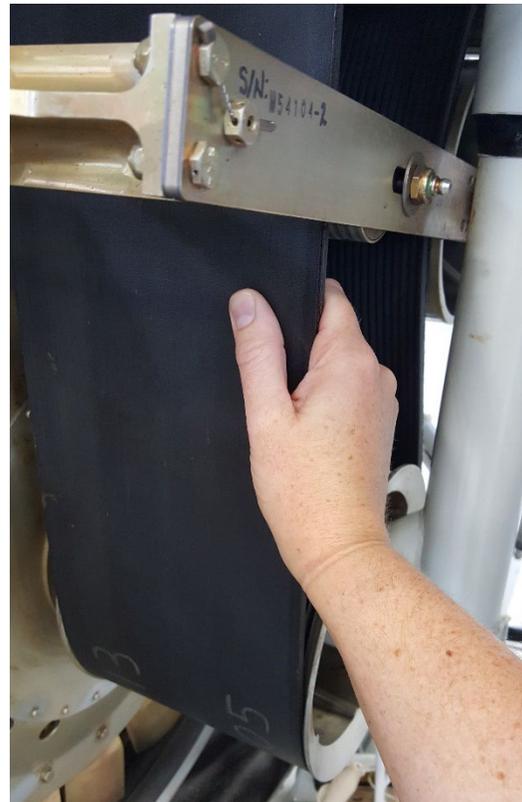
Figure 3. Proper and Improper Belt Rotation

WARNING: Do not grip edge of belt to rotate. Gripping the edge may result in fingers being pinched in bottom pulley, causing serious injury.

- 6.1.3 With the clutch disengaged, slowly rotate the belt around the diameter of the upper pulley by placing a hand flat against the belt surface, as shown in Figure 3. Check for protruding cord around the circumference of the upper and lower pulleys on both the forward and aft sides of the belt.

Proper Method –
Hand flat against belt surface

Improper Method –
DO NOT grip edge of belt

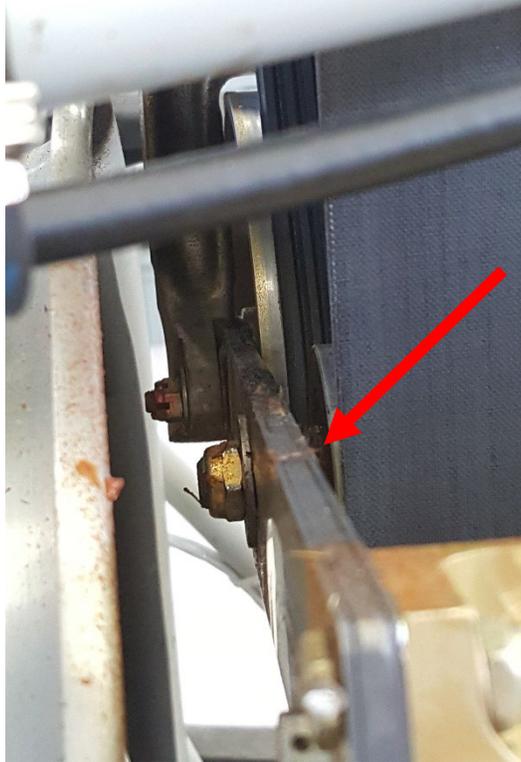
Figure 4a. Inspection point – Center pulley, forward edge

- 6.1.4. While checking for loose cord, inspect areas where the belt comes into close contact with adjacent structures such as the lower pulley assembly. The presence of rubber residue at these points may indicate breakdown of the belt. Refer to Figures 4a and 4b for examples.
- 6.1.5 If the belt edges are sealed and the condition of the existing adhesive is satisfactory and there is no loose or protruding cord, no further action is required.

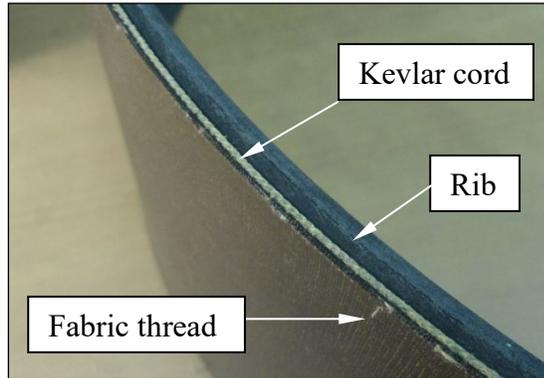
Figure 5. Visible Kevlar cord on the belt edge

NOTE: Loose fabric threads (Figure 5) are not significant. The threads may be trimmed but do not require sealing.

6.3 Inspect the belt edge for exposed cord. See the example shown in Figure 5.

6.3.2 The belt edges may be sealed in accordance with paragraph 7 and then returned to service.

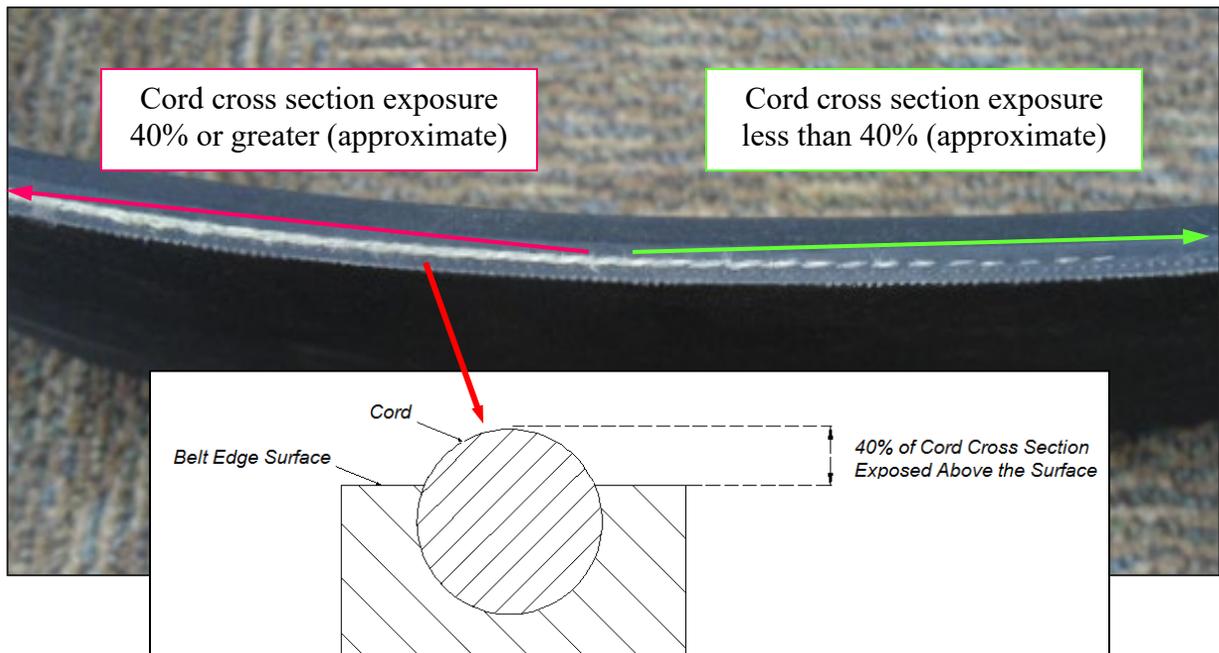
Figure 6. Cord exposure limits

6.3.1 Seal any portion of the Kevlar cord that is exposed greater than 40% of the cross section thickness (Figure 6).

6.3.3 For belts with cord exposure less than 40%, the belt may be returned to service. No further action is required.

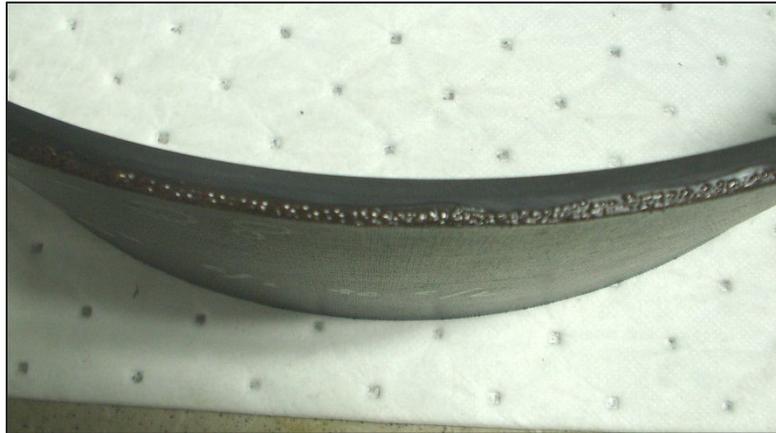
Figure 7. Sealed belt edge surface

7.3.2 Apply a bead of 3M 847 on the belt edge surface ensuring the exposed Kevlar cord is covered with adhesive (*Figure 7*).

7.3.3 Remove any adhesive from the rib edge and the back of belt using a clean cloth wetted with solvent (ref. 7.1).

7.3.4 Allow the adhesive to dry for three hours, turn over and repeat the application for the edge on the other side of the belt.
