SERVICE DIRECTIVE BULLETIN NO. T-046

Revision 3

1. SUBJECT: Main Rotor Drive Belt

2. MODEL: 480 and 480B

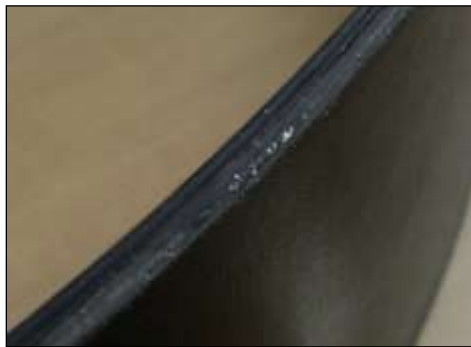
6.1 Inspect the belt for sealed edges, checking for any loose or protruding cord. See the example shown in Figure 1.

Figure 1. Sealed belt edge

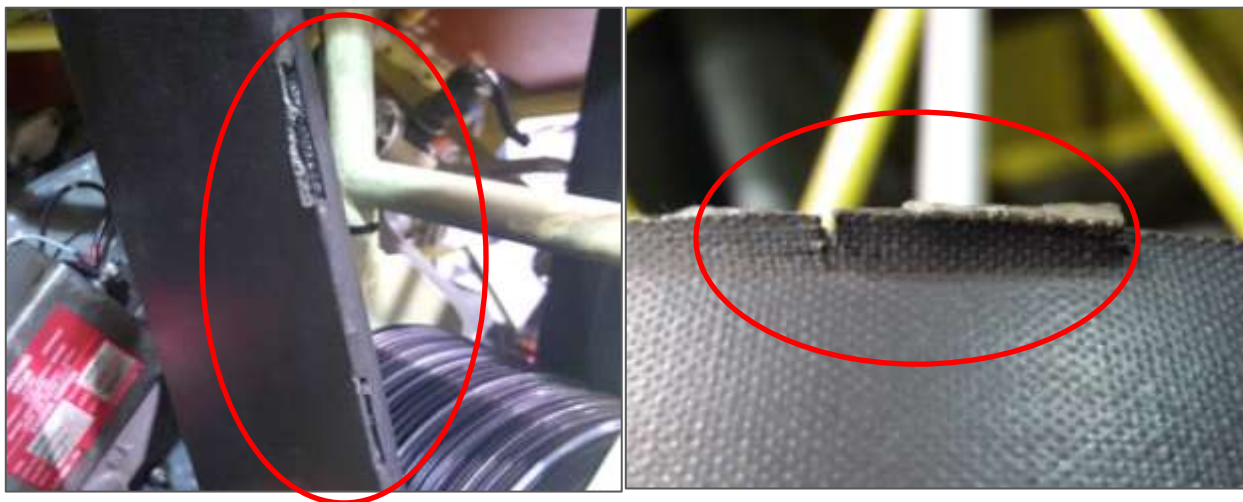
6.1.1 If the belt edge was previously sealed but the belt edge has deteriorated as shown in Figure 2 or if any loose or protruding cords are found, remove the belt and send back to Enstrom for warranty. Install a new airworthy belt.

Figure 2. Deteriorated sealed belt edge

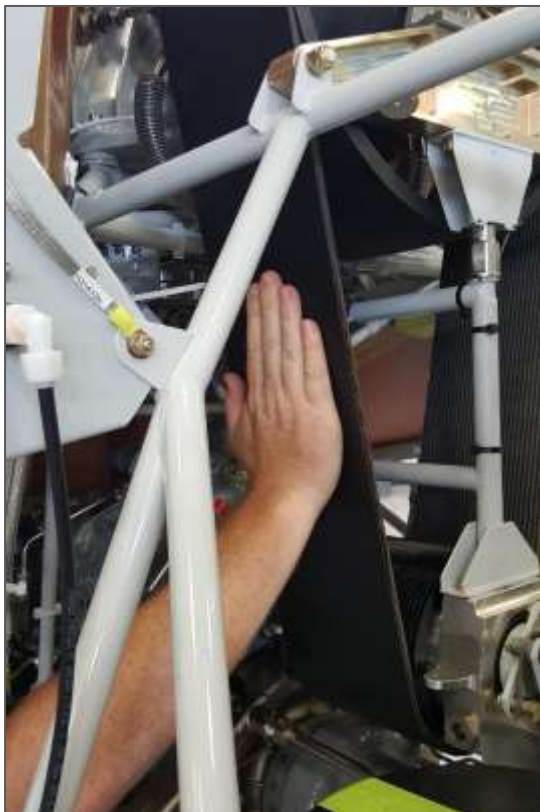
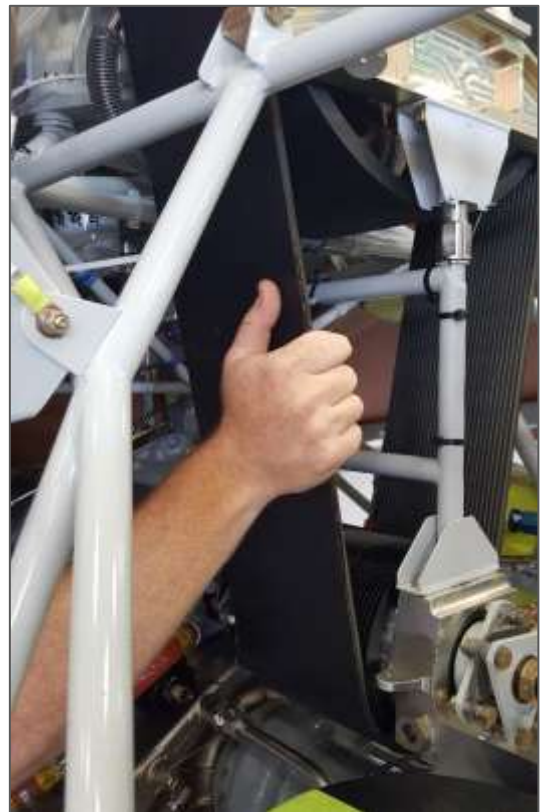
Figure 3. Proper and Improper Belt Rotation

WARNING: Do not grip edge of belt to rotate. Gripping the edge may result in fingers being pinched in bottom pulley, causing serious injury.

- 6.1.3 Slowly rotate the belt around the diameter of the pulley by placing a hand flat against the belt surface, as shown in Figure 3. Check for protruding cord around the circumference of the lower pulley on both the forward and aft sides of the belt.

Proper Method –
Hand flat against belt surface

Improper Method –
DO NOT grip edge of belt

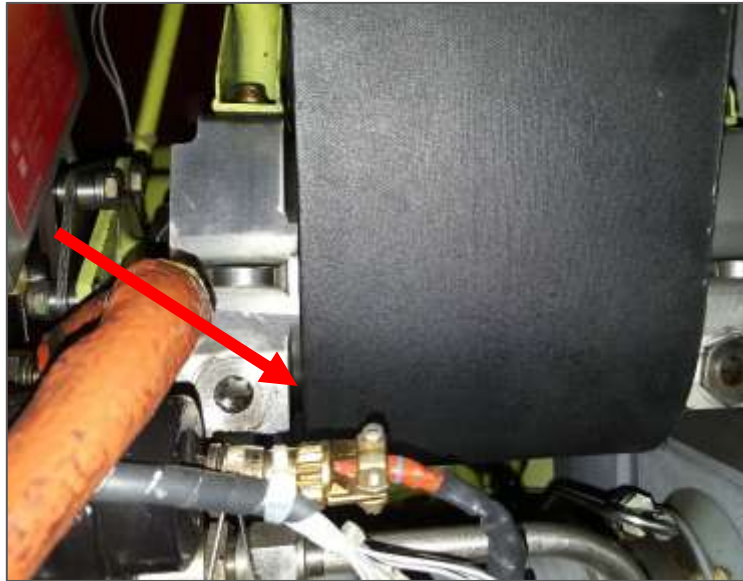
- 6.1.4. While checking for loose cord, inspect areas where the belt comes into close contact with adjacent structures, such as the lower pulley assembly and trusses. The presence of rubber residue at these points may indicate breakdown of the belt. Refer to Figures 4a through 4d for examples.

Figure 4a. Inspection point – Lower pulley, forward edge

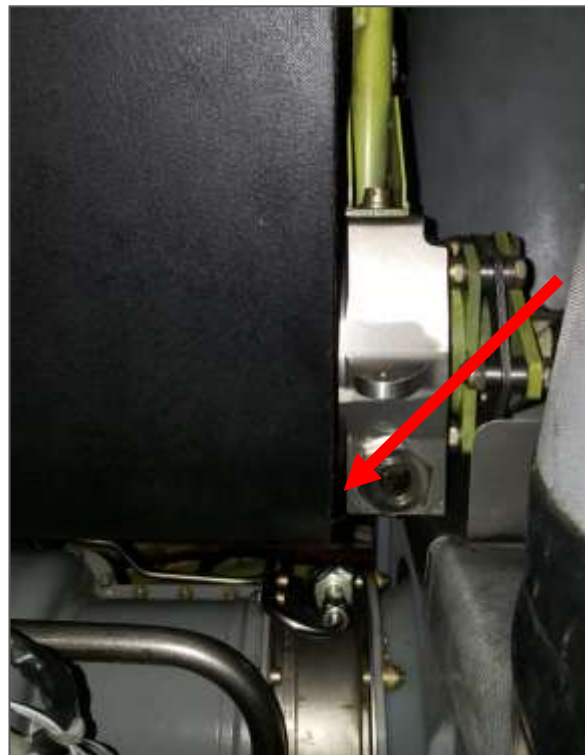
Figure 4b. Inspection point – Lower pulley, aft edge

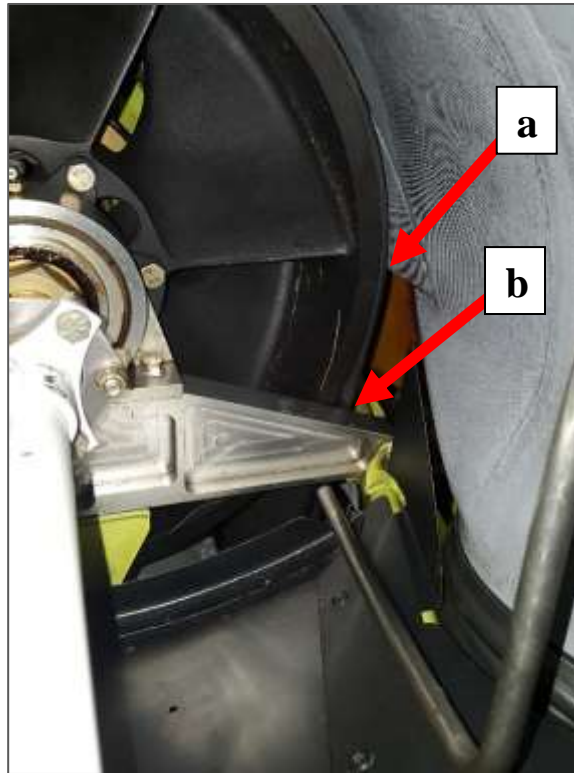
Figure 4c. Inspection points – a) Edge of upper plenum/air inlet, right side; b) Right truss

Also, within the next 5 hours and at every 50 hours, inspect the upper plenum/air inlet in accordance with the TH-28/480 Series Maintenance Manual Paragraph 13-29, B for possible contact with the drive belt, and adjust as necessary to prevent contact in accordance with Paragraph 13-31, B.

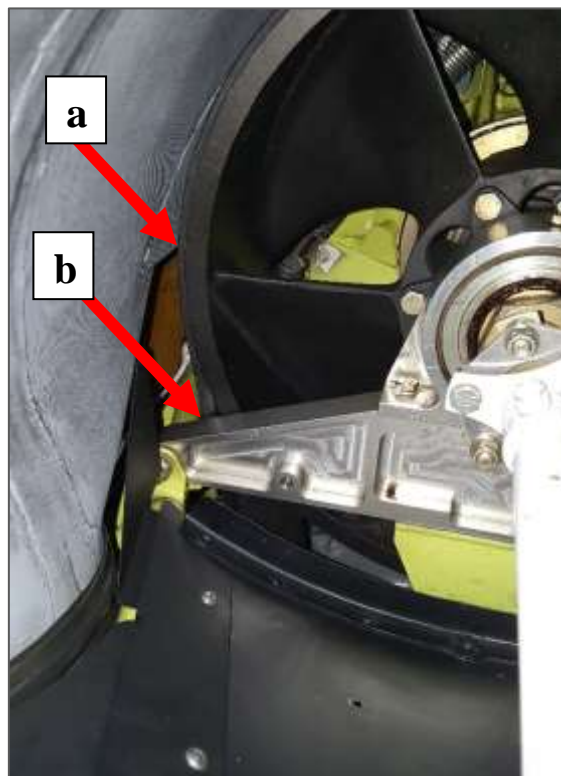
Figure 4d. Inspection points – a) Edge of upper plenum/air inlet, left side; b) Left truss

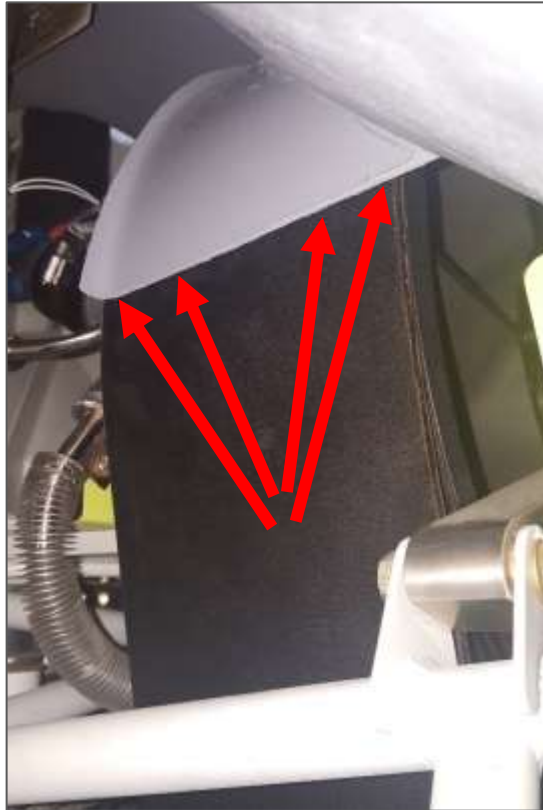
- 6.1.5 Check for rubber transfer on the lower edge of the upper plenum/air inlet (Figure 4e). This may indicate that the belt edge seal is breaking down and loose belt cords are snagging on the edge of the plenum.

Figure 4e. Inspect upper plenum/air inlet edge for rubber transfer

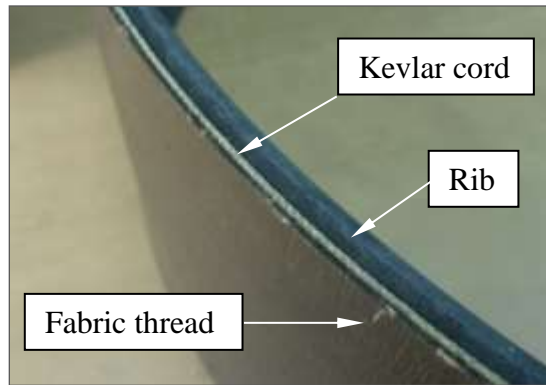
NOTE: Loose fabric threads (Figure 5) are not significant. The threads may be trimmed but do not require sealing.

Figure 5. Visible Kevlar cord on the belt edge

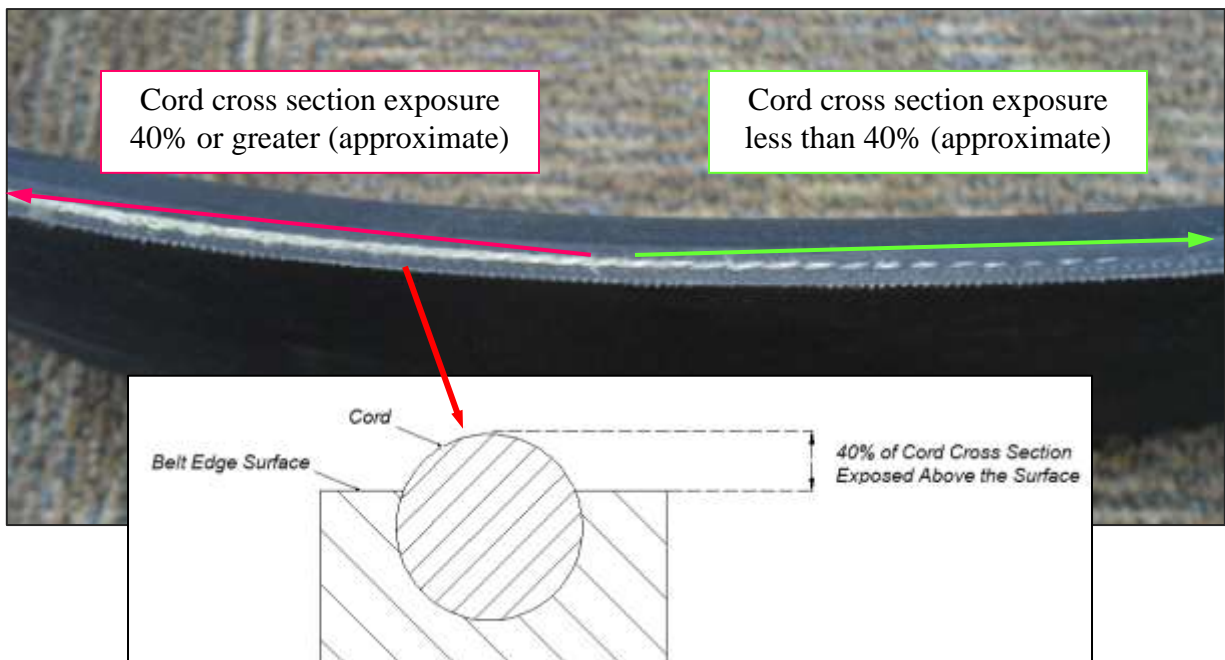
6.3.3 For belts with cord exposure less than 40%, the belt may be returned to service. No further action is required.

Figure 6. Cord exposure limits

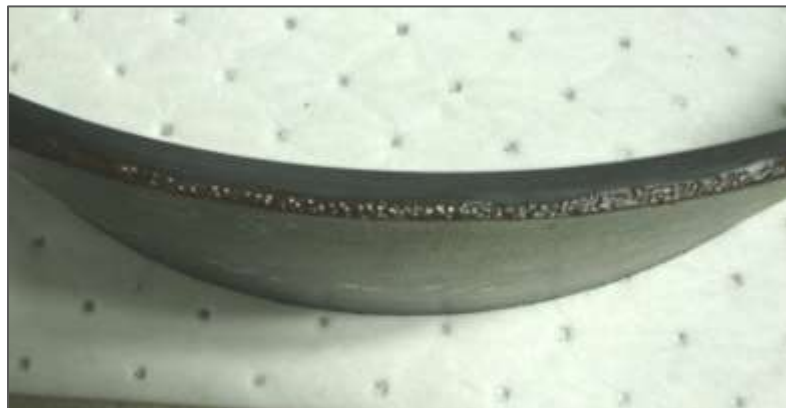
Figure 7. Sealed belt edge surface

7.3.2 Apply a bead of 3M 847 on the belt edge surface ensuring the exposed Kevlar cord is covered with adhesive (*Figure 7*).

7.3.3 Remove any adhesive from the rib edge and the back of belt using a clean cloth wetted with solvent (ref. 7.1).

7.3.4 Allow the adhesive to dry for three hours, turn over and repeat the application for the edge on the other side of the belt.

7.3.5 Hang the belt on a rack and allow the adhesive to cure for a minimum of 12 hours.
