# ENSTROM HELICOPTER CORPORATION

## Piston Engine Exhaust Leaks

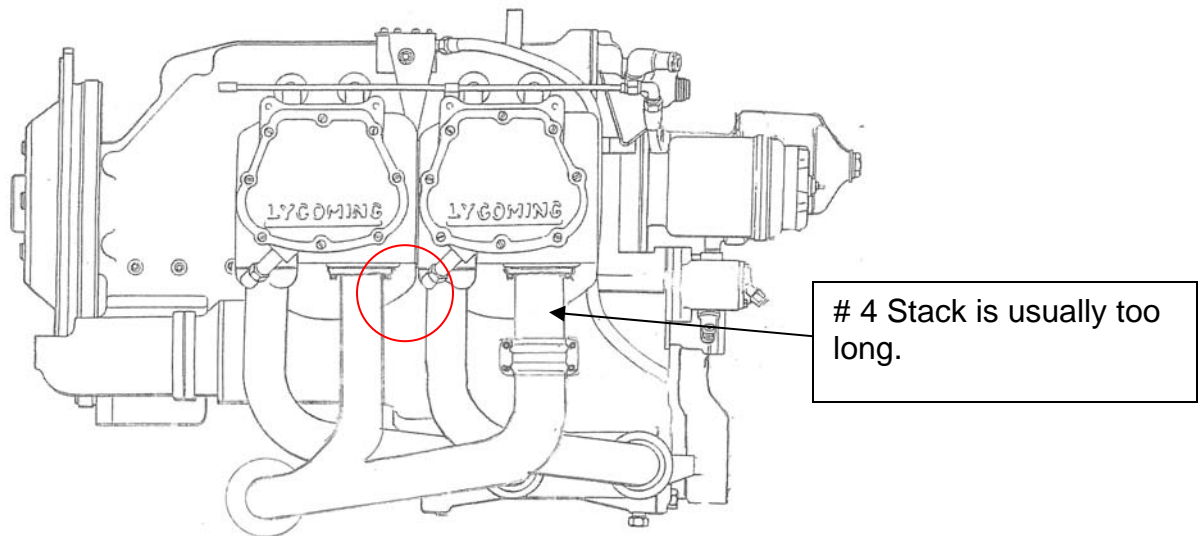
Most exhaust leaks are found where the exhaust pipe is bolted to the #2 cylinder port and this usually indicates a fitting problem caused by the #4 exhaust stack being a bit too long.

If you are seeing indications of exhaust leakage in the area shown by the red circle, the issue most likely is caused by the 4 stack being too long. A second cause can be a warped flange on the exhaust pipe.

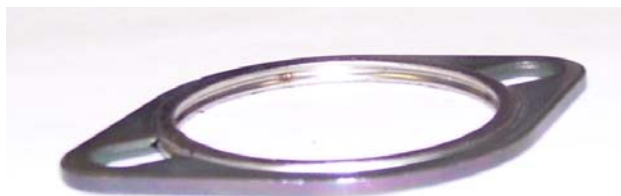
The warped flanges are usually caused by over-tourquing the retention nuts. This is because the center part of the gasket is thicker than the flange around the outside edge.

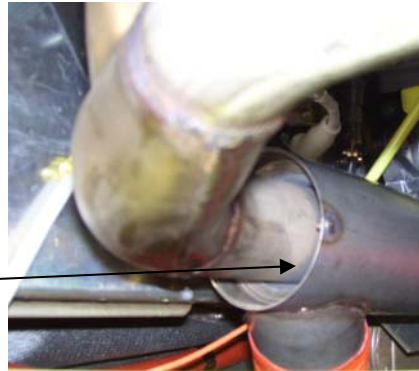
Slipjoint

1. Loosen the four exhaust nuts on the pilot's side of the engine (the right side).
2. Remove the clamp on the #4 stack, and the nuts holding the #2 exhaust pipe to the cylinder.
3. Spray some lubrication oil into the area where the stack inserts into the muffler, this is a slip joint.

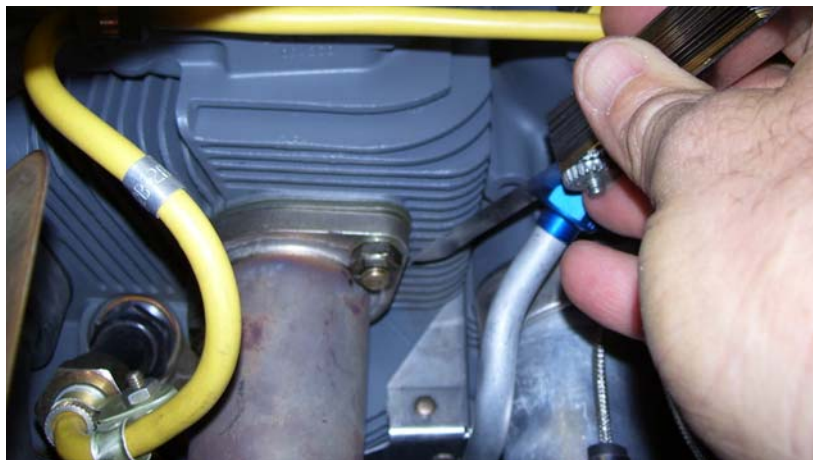
4. Disconnect the wires for the EGT probes under the blue insulation tubes. **Do not try to remove the probes from the exhaust pipes.**
5. Remove the #4 exhaust stack and re-install it without the gasket.
6. Re-install the #2 exhaust stack without the gasket.
7. Use a .001" feeler gauge to measure the gap between the exhaust pipe flange and the cylinder exhaust port, especially around the back side of the exhaust port

8. if the feeler gauge can be inserted between the exhaust port and the exhaust pipe on the back side, but not on the near side, then the #4 exhaust stack is too long and is preventing the exhaust pipe from sealing against the exhaust port.
9. There is no way to adjust the length of the #4 exhaust stack so the only remedy is to adjust the relative length of the two exhaust pipes by shimming with gaskets.

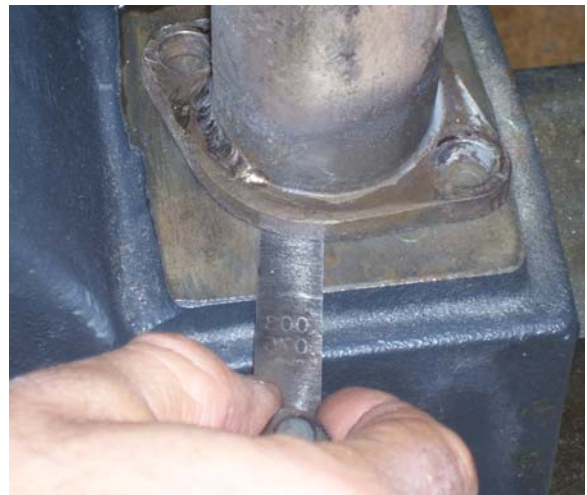
10. The first step is to check the exhaust pipe flanges for straightness and to repair them if they are not straight.
11. Place the flange on a flat surface such as the anvil surface of a vise.
12. If a .001" feeler gauge can be inserted between the flange and the flat surface, then the flange is warped.

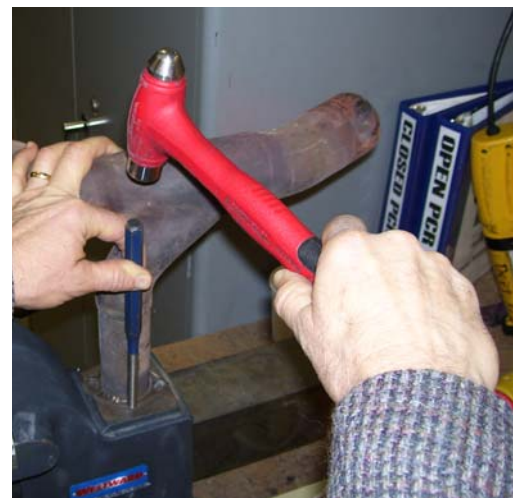
13. A large punch and hammer can be used to tap the flange against the flat surface of the vise to straighten the flange. The stainless steel is quite soft and can normally be re-shaped to repair the warpage.

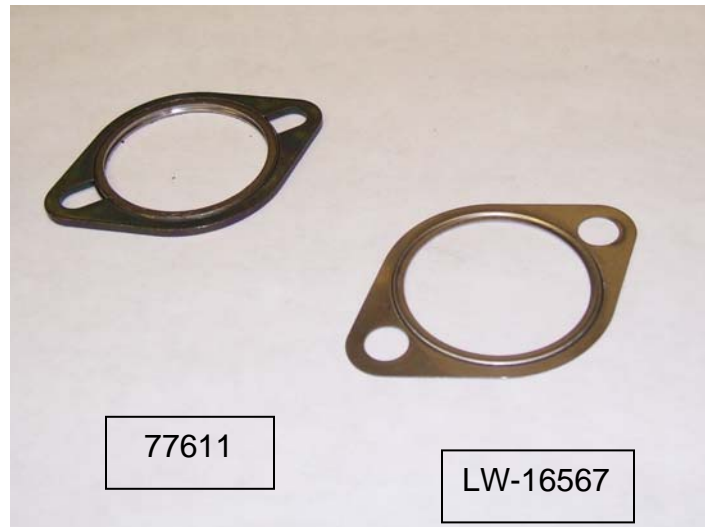
Lycoming makes two types of gaskets that can be used on the exhaust pipes of turbo-charged engine. By using a combination of these two gaskets, the problem of the #4 exhaust stack being too long can usually be fixed.

14. Clean the exhaust ports on the cylinders using a wire brush or sandpaper and reassemble the two exhaust stacks using two of the LW-16567 gaskets under the #4 exhaust pipe and one 77611 and one LW-16567 gasket under the #2 exhaust pipe.
15. Use anti-seize compound in the slip fit area of the heat exchanger and between the stack slip joints.
16. Use the feeler gauge to determine if the exhaust pipe flanges are sealing all the way around the exhaust port.
17. Correct gaps between the exhaust port and the exhaust pipe by varying the stack up of the two types of gaskets.
18. Torque all of the nuts to 90 in/lbs.
19. Connect the EGT Probes
20. Run the engine, check for leaks and re-torque the exhaust nuts.
