## SERVICE DIRECTIVE BULLETIN

SERVICE DIRECTIVE BULLETIN NO. T-025

1. SUBJECT: Inspect Main Rotor Control Rods, P/N 4140532-5, For Loose Upper Fittings.
2. MODEL: TH-28, 480, 480B
3. EFFECTIVITY: 480B; S/N 5084 through 5090, 5092  
All TH-28/480 Series Models that have had new main rotor control rods, P/N 4140532-5, installed between August 17, 2005, and May 16, 2006.
4. BACKGROUND:

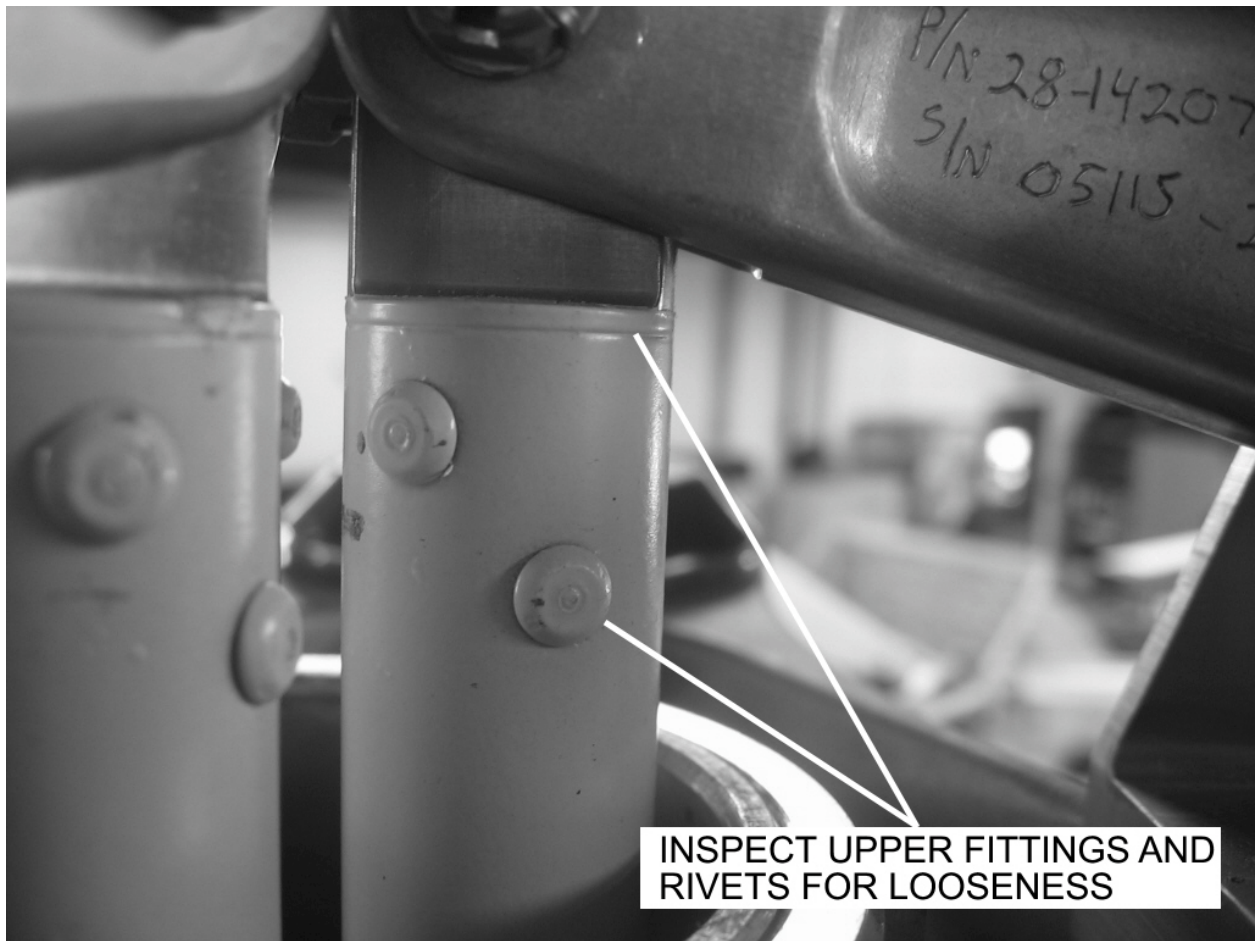
Figure 1.

- A. Gain access to the main rotor hub either by using the steps on the right side of the aircraft or an appropriate maintenance stand/platform.
- B. Visually and by feel inspect each main rotor control rod upper fitting and rivets for looseness by moving the trailing edge of the corresponding main rotor blade up and down at the drag link attachment area (Refer to Figure 1).

- C. If no loose upper fittings or rivets are found, return the aircraft to service.
- D. If looseness is found in any of the upper fittings or rivets, remove and replace the main rotor control rods with airworthy units.
