## **Enstrom 480B S/N 5134 Leak Repair Procedure**

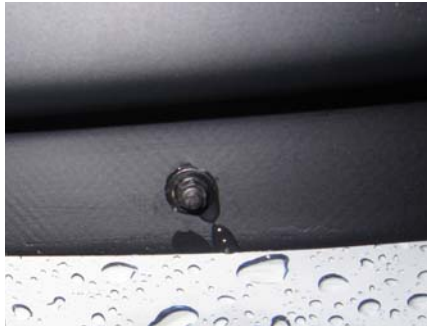
### **A. Leaking screws at windshield**

1. Remove the leaking screws, nuts and washers.
2. Install screws in wet Dow Corning 732 clear silicone sealer or any similar commercially available silicone sealer.
3. Install washers and nuts. CAUTION, do not over tighten the hardware.
4. Tape the line between the acrylic windshield and the cabin with masking tape along the entire top seam and the bottom seam just under the center window strip..

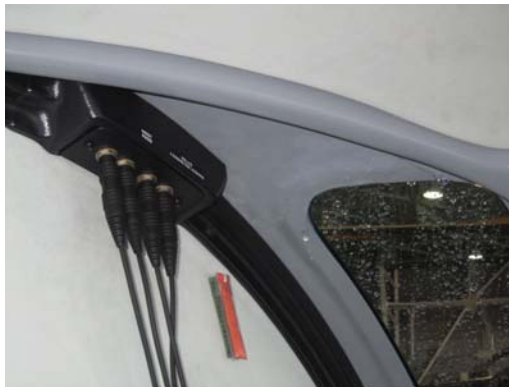
- B. Leaks at the opera window fasteners;

1. Drill out any rivets that are leaking using a #30 drill.
2. Install a new P/N CR91484-4-3 rivet, setting it in wet Dow Corning 732 clear silicone.
3. Seal the center hole in the rivet with poly-urethane putty or epoxy.
4. Touch up the paint on the rivet head.
