SERVICE DIRECTIVE BULLETIN NO. 0118

1. SUBJECT: Idler Yoke Inspection, P/N 28-13299-3 (Machined Component)
2. MODEL: F-28A, 280, F-28C, 280C, F-28F, 280F, and 280FX
3. EFFECTIVITY: All S/N excluding F-28F S/N 831 and subsequent and 280FX S/N 2146 and subsequent.
4. BACKGROUND:

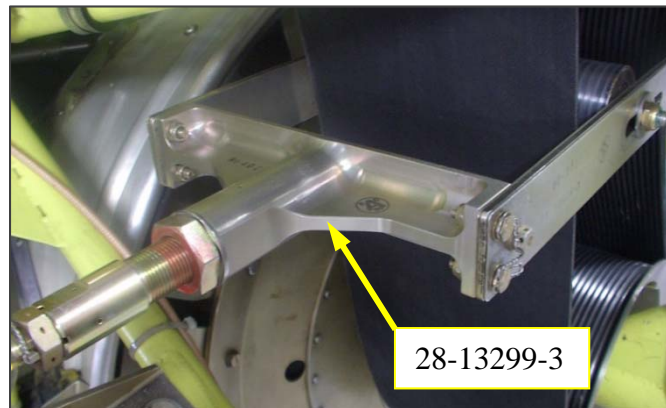
Figure 1 – Idler Yoke, P/N 28-13299-3

- 6.1 Inspect for cracks (reference Figure 1 and Figure 2) using dye penetrant method. Follow the dye penetrant manufacturer's instructions.

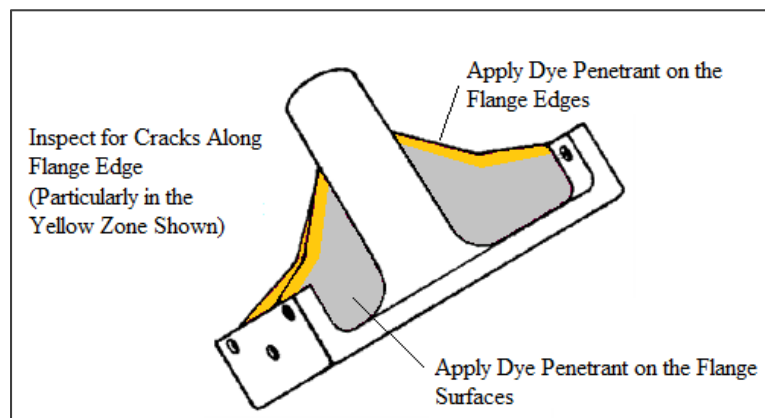
Figure 2 – Idler Yoke Dye Penetrant Inspection Areas

6.1.1 A heavy, solid line bleed-back indicates a crack. Reject the idler yoke and replace with an airworthy idler yoke, P/N 28-13299-3.

6.1.2 If no bleed-back indications are present, the inspection is satisfactory. Thoroughly clean the idler yoke per the penetrant kit instructions.
