SERVICE DIRECTIVE BULLETIN

SDB T-066

SUBJECT: Pulley Shroud Assembly Inspection and Modification

MODEL: 480 and 480B

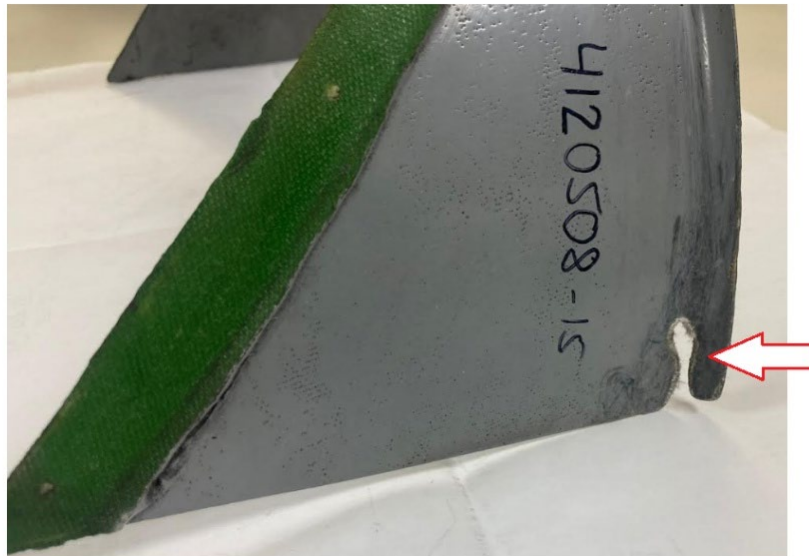
Enstrom has received a report of an unraveled main rotor drive belt combined with the finding of substantial wear damage to the forward flange of the pulley shroud assembly. The profile and location of the wear damage indicates that an exposed, loose and/or frayed segment of the main rotor drive belt cord had been abrading the flange.

*Figure 2. Wear damage to flange
(Flange shown disassembled from pulley shroud assembly)*

- 1) Inspect the upper plenum/air inlet assembly in accordance with MM paragraph 13-29.
- 2) Inspect for the presence and condition of the spacer (shim) bonded to the bottom of the upper plenum/air inlet assembly (Item 35 IPC Figure 6-3).
- 3) Inspect the pulley shroud assembly for wear damage (Figure 2).
- 4) If the inspection procedures are satisfactory and no damage is detected, proceed to step E.

- 1) Refer to MM paragraph 13-30 step A.
- 2) If required, install or replace the spacer (MM paragraph 13-30 step B).
- 3) If the flange of the pulley shroud assembly exhibits wear damage similar to the pattern of the wear damage shown in Figure 2:
 - a) Inspect the condition of the belt cord and seal the belt edge, as required, in accordance with SDB T-046.
 - b) Proceed to step E.

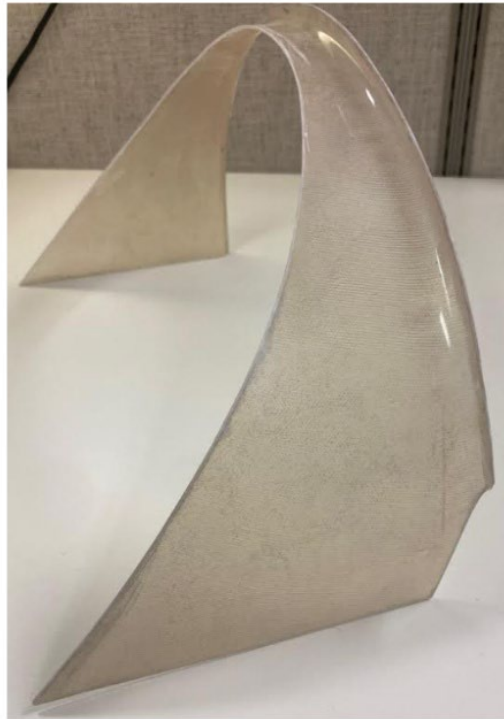
Figure 4. Finished appearance of modified pulley shroud flange; shown unpainted and uninstalled

- 1) If not already accomplished, cover the upper plenum openings and the air particle separators to prevent contamination.
- 2) Mark the corner of the forward right side of the pulley shroud assembly per the dimensions in step a) below. This represents the area that will be trimmed.
 - a) The dimensions are defined as 1.0 in/2.5 cm back from the forward edge and 2.0 in/5 cm up from the bottom of the shroud (Figure 3).
- 3) Use a cutting tool (multi-tool (oscillating) or a bone saw) to cut along the mark.
- 4) Sand the edge to a smooth finish (80 to 150 grit).
 - a) Refer to Figure 4 for the finished appearance.
