ENSTROM HELICOPTER CORPORATION

SERVICE DIRECTIVE BULLETIN

SERVICE NOTE NO. 0026

Subject: Cooling Air Turning Vane - P/N 280-126001-9

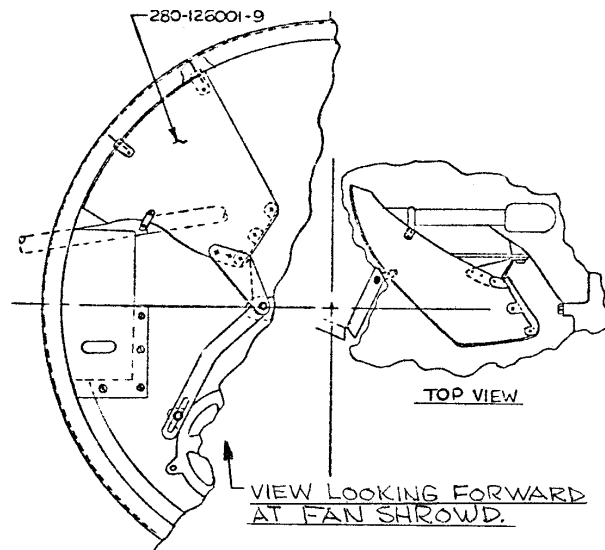
We have had a report from field service of one instance where the cooling air turning vane attachment failed. Separation of this attachment will allow the turning vane to shift and possibly come in contact with the cooling fan. The location of the turning vane P/N 280-12~001-9 is shown in the illustration below:

Immediate visual inspection of the turning vane P/N 280-126001-9 should be accomplished. This inspection is to be repeated at 5-hour intervals thereafter. Access for inspection can be made through upper left engine cooling shroud panel. It is further recommended that a new turning vane (P/N 280 -126001 -9, Rev. A) be installed to eliminate this inspection requirement. This component is available through Enstrom Customer Service.
