SERVICE DIRECTIVE BULLETIN 0079

1. SUBJECT: Landing Gear Leg Cracks, Enstrom P/N 28-17132-1 thru -4
2. MODELS: F-28A, 280, F-28C, 280C, F-28F, 280F, and 280FX
3. EFFECTIVITY: Prior To The Next Flight And As Noted Under Compliance Section
4. BACKGROUND:

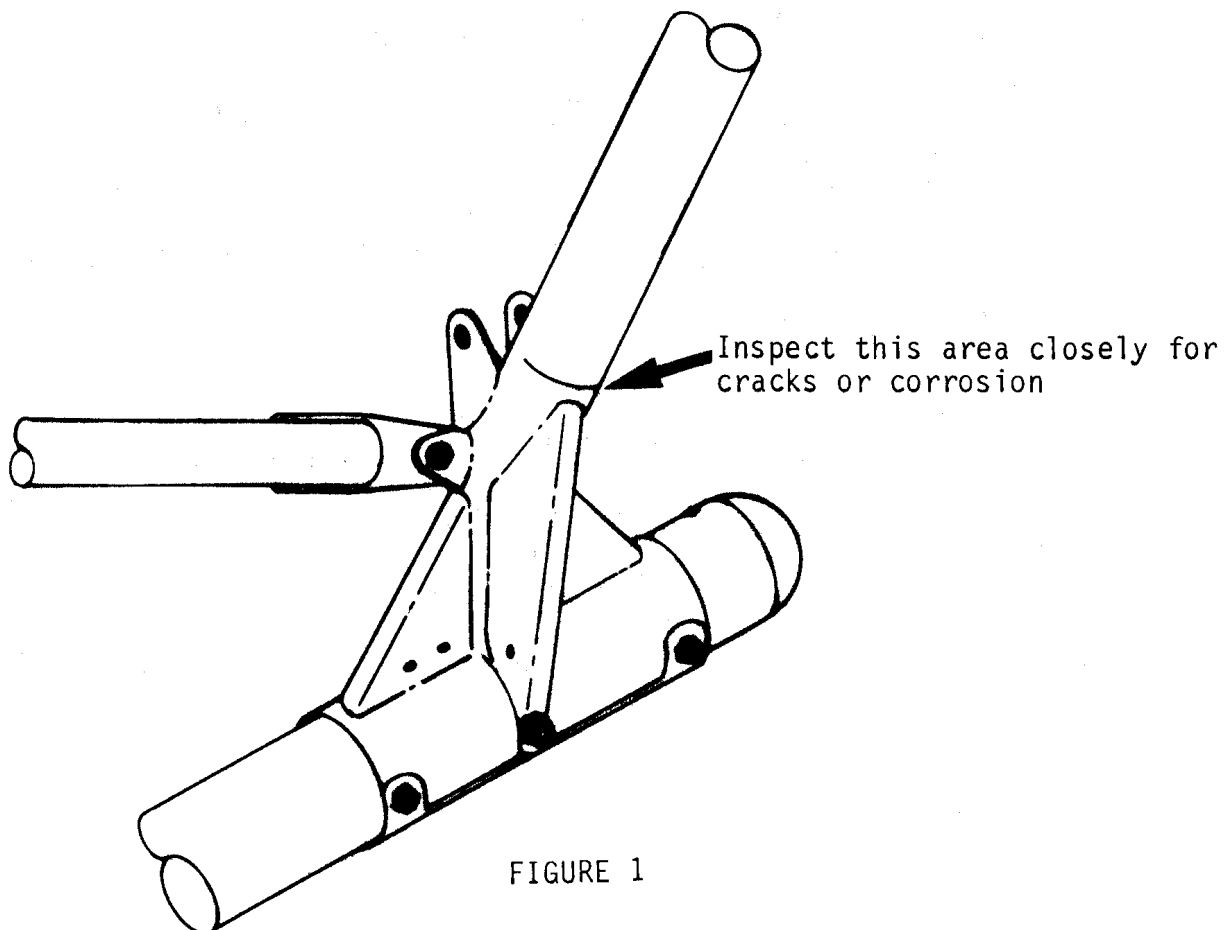
Several instances of landing gear legs (P/N 28-17132) have been found with cracks opposite the lower oleo fitting and adjacent to the upper portion of the bottom gusset. In some instances the gear leg failed at this point during around handling of the helicopter.

In reviewing the failed landing gear legs, it appears that internal corrosion is probably the major contributing factor to these failures. The investigation also indicated that ships that are trailered frequently, utilized in training, utilized on floats at one time or another, or which are not hangared, may be at high risk for this condition. The following mandatory inspection is required by all owner operators.

Prior to the next flight and as a daily preflight thereafter, a close visual inspection of each landing gear leg in the area as noted in figure 1 must be made. Additionally, this inspection must be repeated at 100 hours intervals utilizing a tapping procedure in any area that may exhibit surface blisters or roughness. Any components found with indicated cracks or heavy corrosion must be replaced by an airworthy landing gear leg assembly prior to the next flight
