# SERVICE INFORMATION LETTER

SERVICE LETTER NO. 0009

SUBJECT: Belt Idler Shaft

MODELS: F-28A

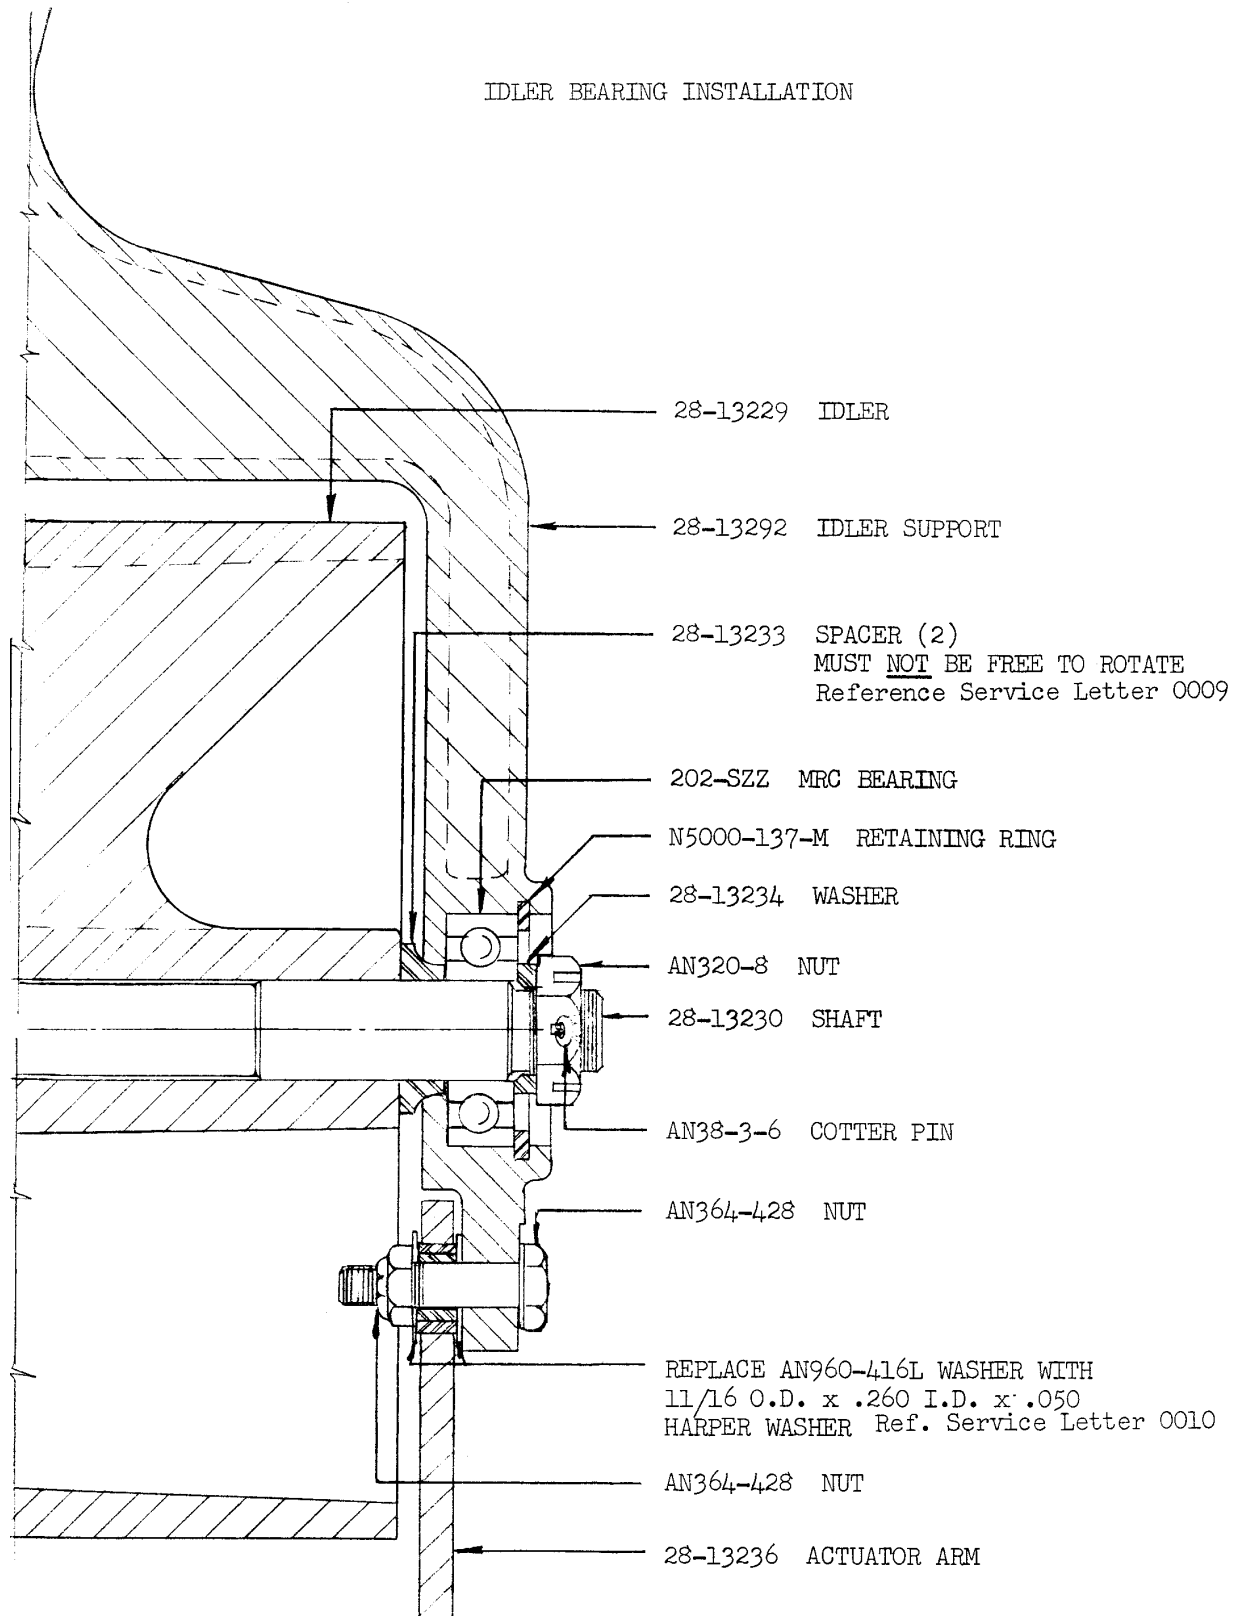
IDLER BEARING INSTALLATION

Several instances have been noted in service in which the belt idler shaft, P/N 28-13230, has shown considerable wear at the inner race of the MRC #202-SZZ bearings. This does not occur when proper torquing of the AN320-8 nut clamps up on the bearing inner races.

See the attached sketch for location to these parts.

It is recommended that the idler assembly be inspected to determine if the 28-13233 spacers are free to turn at either end of the idler pulley. If this condition is found, the nut must be properly torqued to assure clamping of the bearing races and the spacers. If the pulley is heated to properly draw up on the spacer and bearing race under the head end of the shaft (toward the engine cooling fan), then final torquing of the nut must be done after the pulley has cooled.
