## SERVICE INFORMATION LETTER

SERVICE INFORMATION LETTER (SIL) NO. 0074  
Revision 3

1. SUBJECT: Drive Belt Inspection Requirements
2. MODEL: F-28A, F-28C, F-28C-2, F-28C-2R, F-28F, 280, 280C, 280F, and 280FX
3. EFFECTIVITY: All Serial Numbers
4. BACKGROUND:

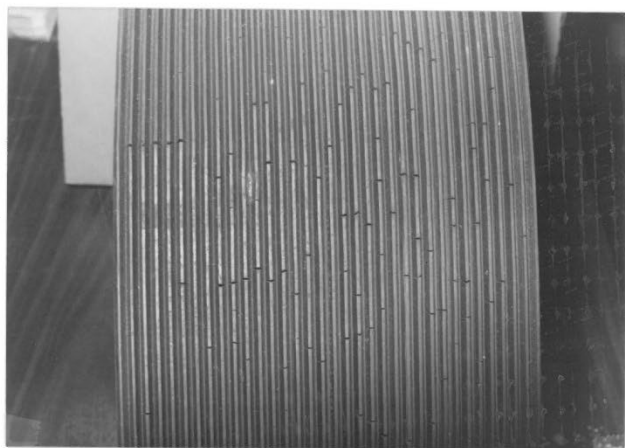
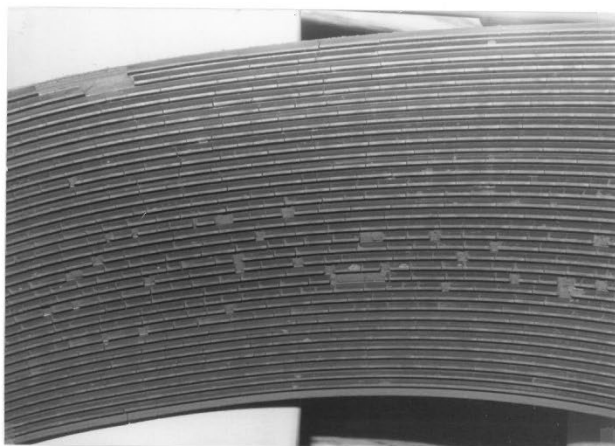
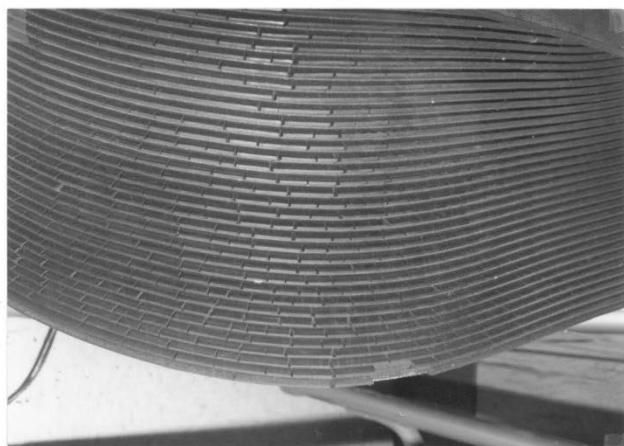
A

1. Examine the belt for cracks which have extended below the base of the ribs. If this has occurred, and the cords are exposed, the belt should be removed. Examples of rib cracks are depicted in Figure 1. Photographs A, B, and C are examples of serviceable belts.
  - a. Replace the belt if rib cracks extend below the base of the ribs.

**Figure 1. Belt Rib Surface**

- Belt rib surface – rib cracking or missing rib section
  - Rib cracking is a normal occurrence on this belt. The cracks normally extend to the base of the rib and go no further. Numerous cracks of this type are not significant. The belt should be examined for cracks which have extended below the base of the ribs and, if this has occurred, the belt should be removed. This is very important if the cracks extend to the cord line and the cord is exposed when the crack is opened.

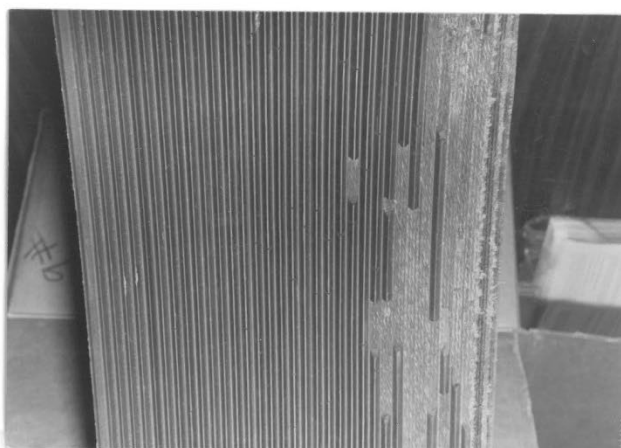
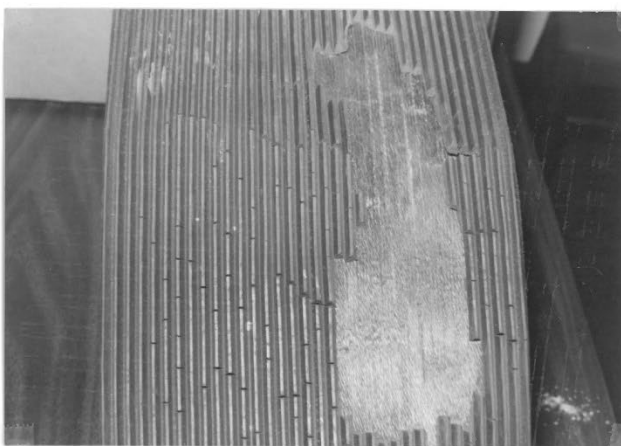
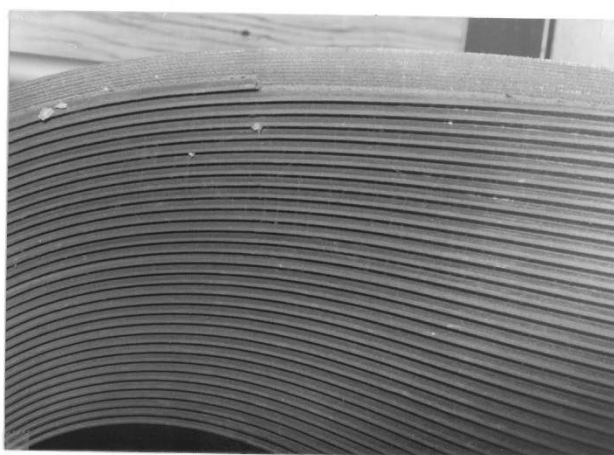
D

- b. Replace the belt if it has been determined that cord failure exists.
- 2. Examine the belt for loss of pieces of rib section that may accompany the rib cracking. Examples of loss of pieces of rib section are depicted in Figure 1. Photographs D, E, and F are examples of unserviceable belts which should be replaced.
  - a. Replace the belt if there is a loss of three or more adjacent ribs for a length of two inches or more.
  - b. Replace the belt if there is any piece of rib missing which is of sufficient depth to leave the cord exposed.
  - c. Replace the belt when the area of missing ribs becomes large enough to cause vibration in the drive system.
  - d. Replace the belt if it has been determined that cord failure exists.

- Loss of small pieces or rib section may accompany the rib cracking. This is normally a random occurrence. The belt should be replaced if there is a loss of three or more adjacent ribs for a length of two inches or more. The belt should be replaced if there is any piece of rib missing which is of sufficient depth to leave the cord exposed. A missing belt rib piece can eventually cause the belt to slip. Usually, the belt will cause vibrations because it becomes unbalanced, and these vibrations are noticed a long time before the belt starts to slip.

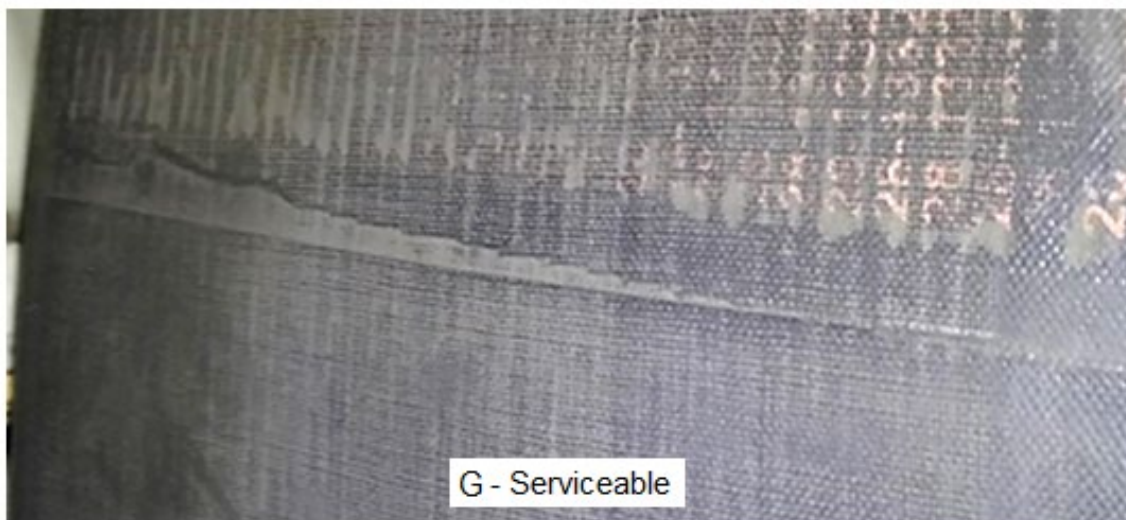
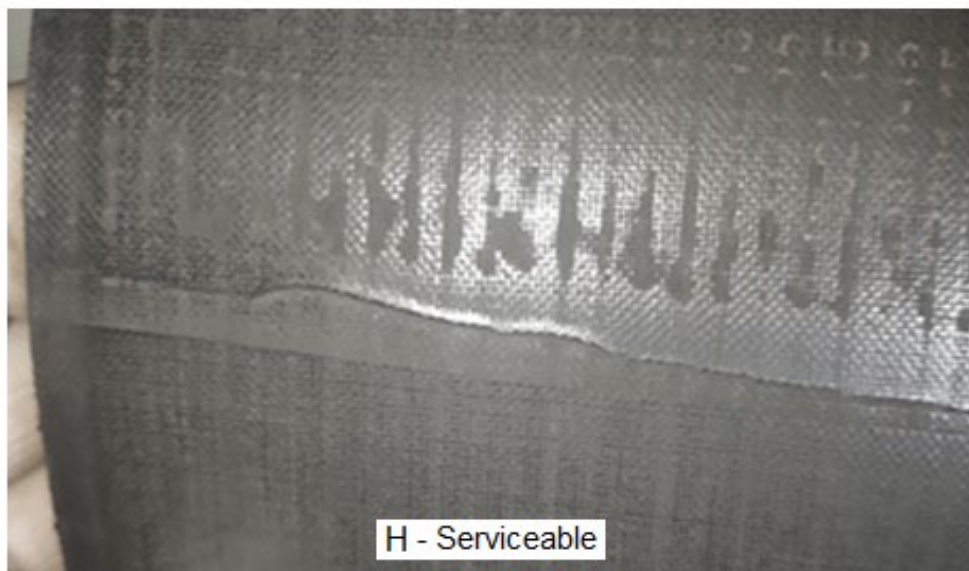
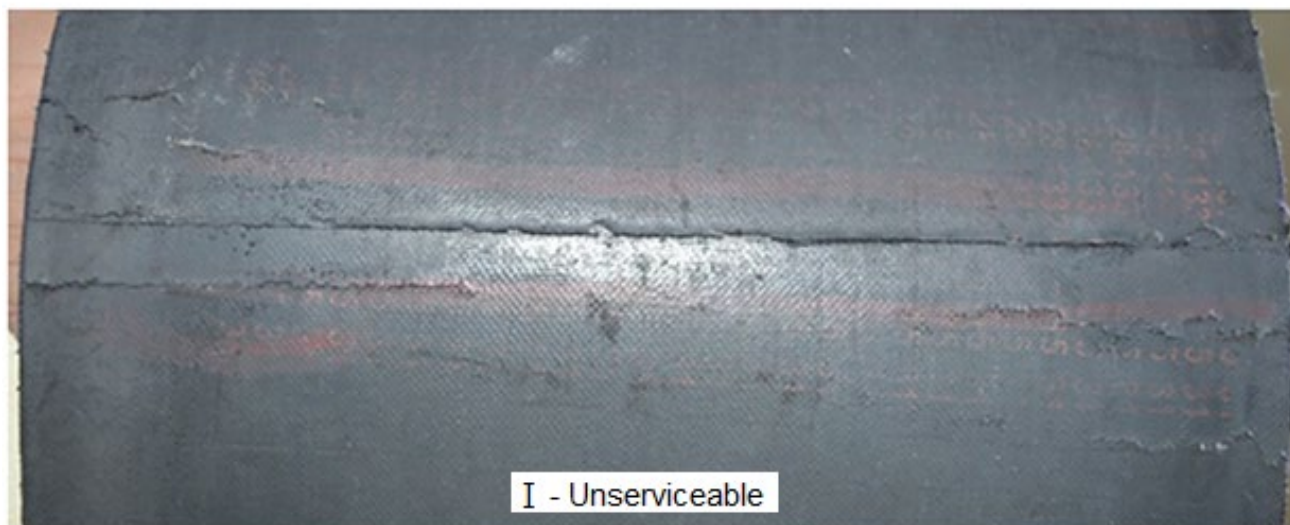
**Figure 2. Back of Belt**

- 1. Examine the back of the belt for cuts or damage and blisters. Replace the belt if there is any damage which appears to penetrate the fabric cover or if any blisters are present.
- 2. Examine the back of the belt at the fabric splice. The belt should be removed if there is any loosening or peeling of the fabric in the splice areas. Examples of fabric splices are depicted in Figure 2. Photograph G and Photograph H are examples of a serviceable belt. Photograph I is an example of an unserviceable belt.

- Back of belt – cuts, damage, blisters, peeling, or cracks
  - The back of the belt should be examined for cuts or damage and blisters which may indicate separation of the fabric plies. The belt should be replaced if there is any damage which appears to penetrate the fabric cover or if any blisters are present. A small crack in the back of the belt at the fabric splice is not significant, and often this is the fabric overlap created during manufacture of the belt. The belt should be replaced, however, if there is any loosening or peeling of the fabric in the splice area. The backing will take a long time to peel and, if this happens, it will cause vibrations, make a mess, and probably cause a “burning rubber” odor. The vibrations and the flapping backing material might damage some of the surrounding parts but normally not to the point where they will fail. This will also happen a long time before the belt fails completely.

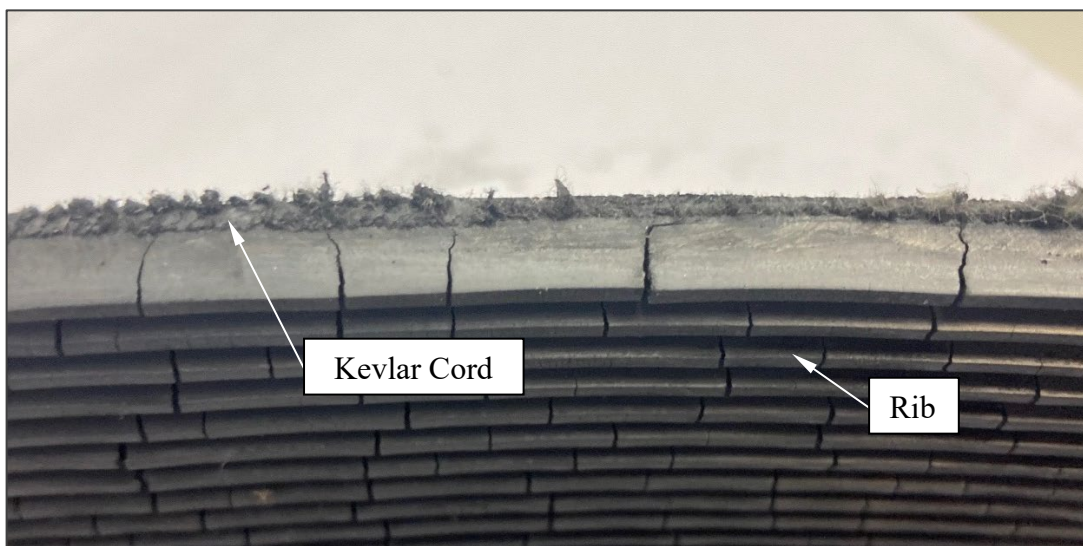
**Figure 3. Edge of Belt – Frayed Cord and Cracked Ribs**

- 1. Examine the edge of the belt for signs of wear. This does not affect the belt directly but would indicate that there is a tracking or interference problem. An example of light wear (cord fraying) is depicted in Figure 3.

- a. Replace the belt whenever the operator deems it necessary.
  - b. Refer to SDB 0117 for inspecting possible interference areas.
- 2. Examine the belt edge for signs of separation. The belt should be removed if there is any sign of separation of rubber from the cord. An example of slight rib separation is depicted in Figure 3.

Unserviceable

- a. Replace the belt if edge damage goes beyond the first “V” groove.
  - b. Refer to SDB 0117 if the separation is the result of a deterioration of a sealed belt edge. Repair the belt in accordance with SDB 0117.

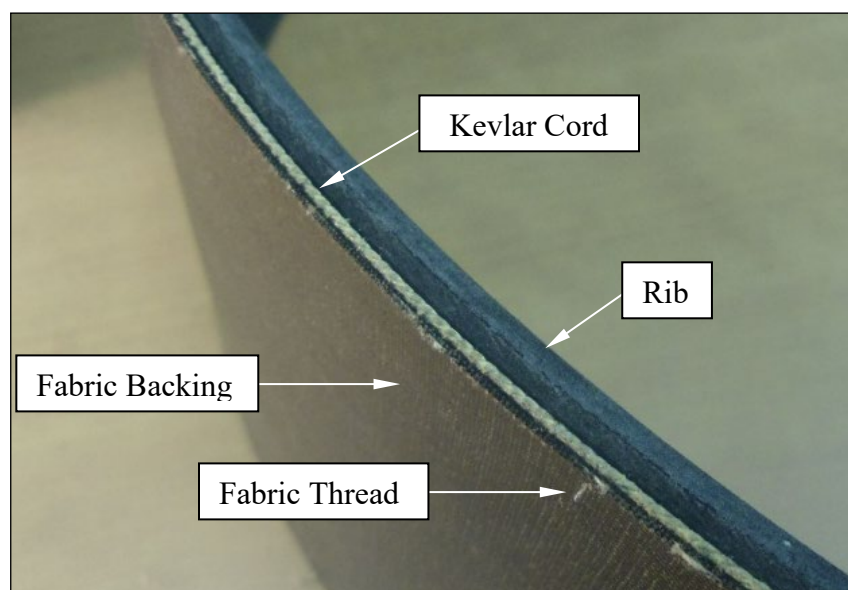
**Figure 4. Edge of Belt – Frayed Fabric and Exposed Cord**

- 3. Examine the belt edge for exposed or emerging cord. An example of exposed cord is depicted in Figure 4. The belt should be removed if an entire cord is beginning to emerge from the belt.

Serviceable if sealed in accordance with SDB 0117

- a. Replace the belt if it has been determined that cord failure exists.
  - b. Refer to SDB 0117 for exposed cord limits. Remove the belt if exposed cord exceeds the limits and seal the edge in accordance with SDB 0117.
  - c. An example of a sealed edge is depicted in Figure 6.
4. Examine the belt edge for a cord tail. An example of a cord tail is depicted in Figure 5.
    - a. Remove the belt if it has cord tail. Trim the cord tail and repair the belt in accordance with SDB 0117.

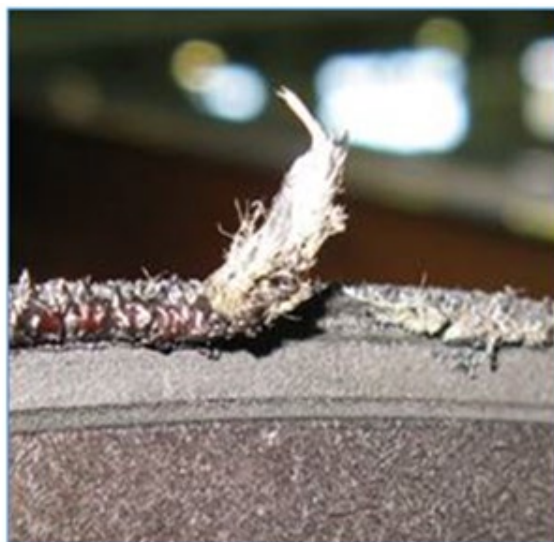
**Figure 5. Edge of Belt – Cord Tail**

Serviceable if trimmed in accordance with SDB 0117
