SERVICE INFORMATION LETTER NO. 0084

Subject: Inspection, Pinion Shaft Run-Out

Model: F-28A, F-28C, 280, 280C

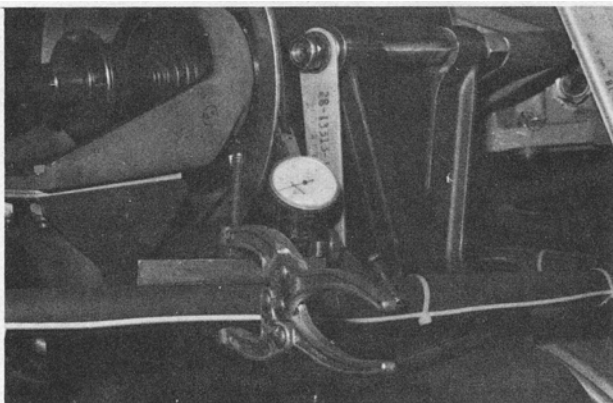
A

- a. Check that clutch is disengaged.
- b. Clamp a suitable dial indicator holding tool to the pylon. Ref. Picture A.
- c. Position pointer of indicator in the center of aft edge of upper pulley. Reference: Picture B.
- d. Zero indicator
- e. Turn main rotor blades in the direction of normal rotation and observe indicator for total indicated run-out. (T.I.R.) maximum allowed .009".

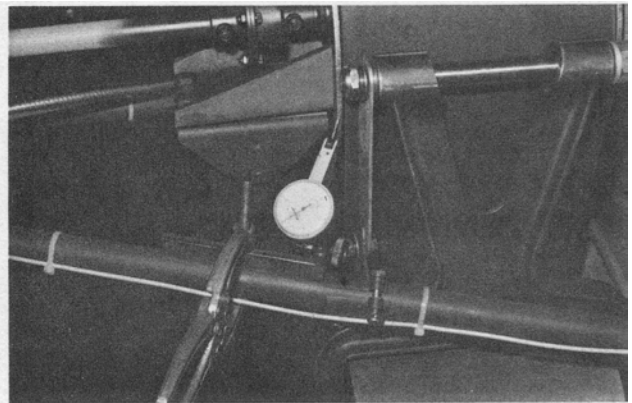
B

NOTE: Upper pulley should remain stationary with pinion shaft rotating in the clutch as blades are turned.

If all external parts are in good condition and T.I.R. exceeds .009", then there may be internal damage and the factory should be notified.
