SERVICE DIRECTIVE BULLETIN

SERVICE DIRECTIVE BULLETIN NO. 0126

DATE: July 6, 2023

1. SUBJECT: Cabin Bellcrank Mounts and Bellcrank Attachment Inspection
2. MODEL: F-28A, 280, F-28C, F-28C-2, F-28C-2R, 280C, F-28F, F-28F-R, 280F, and 280FX
3. EFFECTIVITY: All S/N (Note special exclusion in paragraph 5.3.)

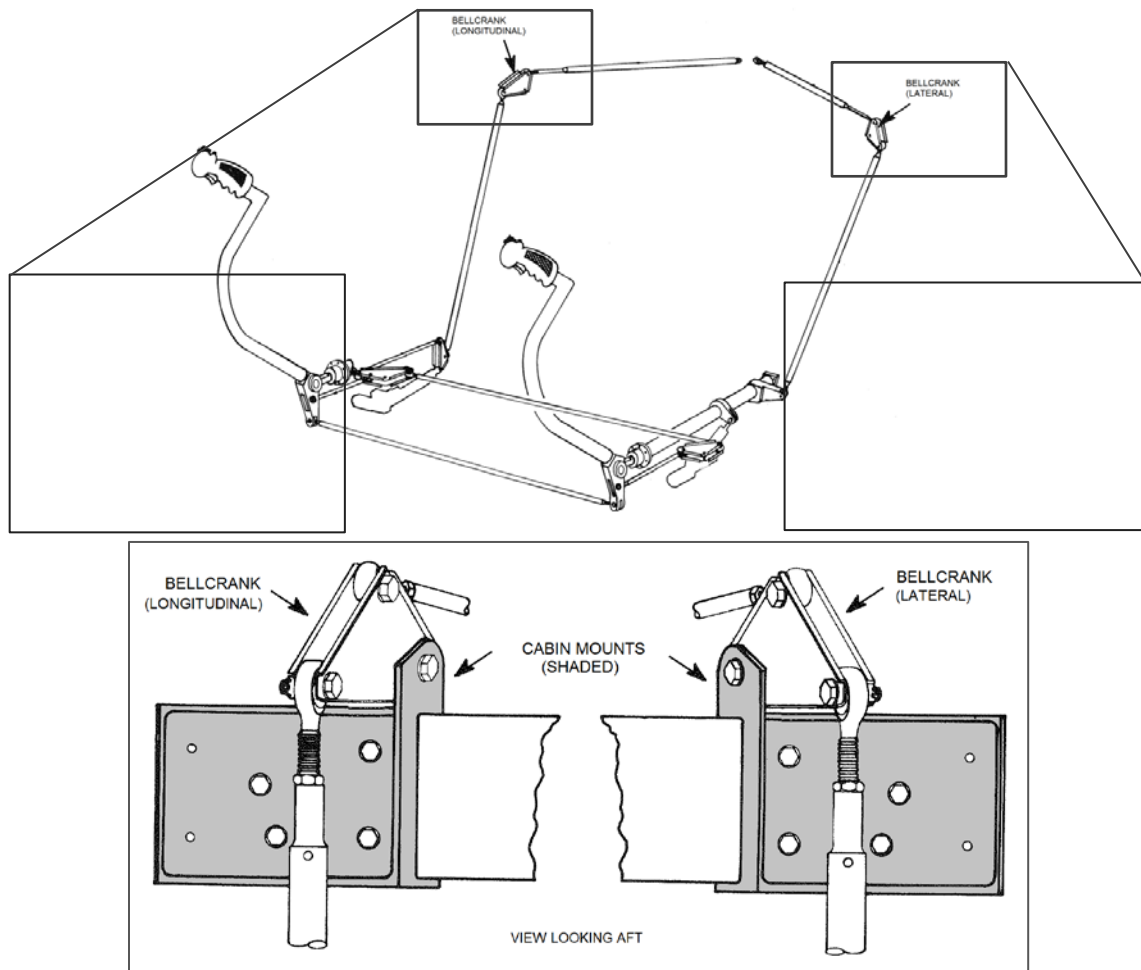
Figure 1. Cyclic Control System Schematic (Top); Bellcrank Cabin Mounts (Bottom)

The schematic of the cyclic control system and the relative location of the upper cabin mounts are shown in Figure 1.
