### SERVICE DIRECTIVE BULLETIN NO. 0124

DATE: February 3, 2017

1. SUBJECT: Landing Gear Assembly - Clamp Inspection

2. MODEL: F-28A, F-28C, F-28C2, F-28F, 280, 280C, 280F, 280FX

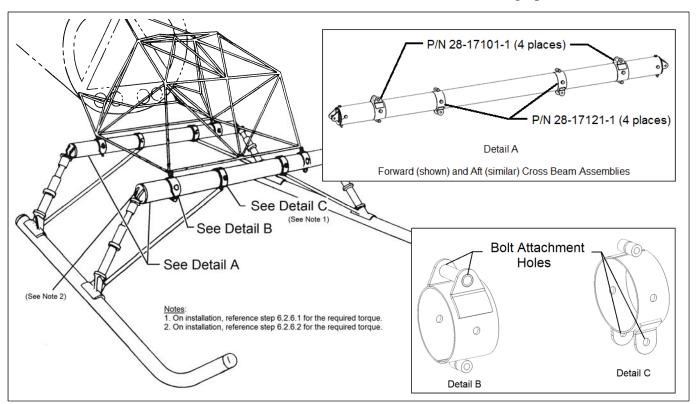
Figure 1. Clamp Installation Detail

See Figure 1 for the clamp locations on the cross beam assemblies and Figures 2 and 3 for examples of a failed clamp and cracked weldments, respectively.

- 6.1 Perform a close, visual inspection of the drag strut and pylon attachment clamps for elongated bolt holes, cracked weldments, corrosion, and security of attaching hardware.
  - 6.1.1 Replace clamps that exhibit any of the following: cracks, elongated bolt holes, and corrosion greater than .010 inch/0.25 mm deep.
  - 6.1.2 Corrosion equal to or less than .010 inch/0.25 mm deep may be blended and polished smooth.
  - 6.1.3 Secure loose attachment hardware (standard torque).
  - 6.1.4 Cross tubes with a bow greater than 0.5 inches/12.7 mm must be replaced.

- 6.2.6 Reinstall the cross tubes assemblies. Torque all hardware.
  - 6.2.6.1 Center strut attachment, 60 in-lb/6.8Nm (Detail C)
  - 6.2.6.2 Oleo assembly attachment, torque in accordance with F-28F/280F Series Maintenance Manual, Paragraph 8, D, (5).
