SERVICE INFORMATION LETTER

SIL T-064
Page 1 of 5

- DATE: December 10, 2015
1. SUBJECT: Main Rotor Transmission 600-Hour Inspection
2. MODEL: 480B
3. EFFECTIVITY: All S/N
4. REFERENCE: Enstrom TH-28/480 Series Maintenance Manual
5. BACKGROUND:

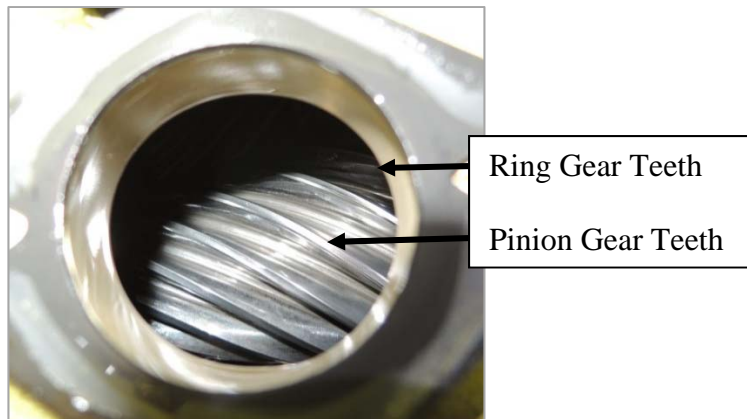
Figure 2. Main Rotor Transmission As Viewed Through the Inspection Port

C. Inspect the ring and pinion gear teeth (refer to Figure 1 and Figure 2).

1) Using a bright light source, inspect ring and pinion gear teeth for cracks, any pitting, any spalling (frosting), or hard wear lines. Turn the transmission by turning the upper pulley or the tail rotor.

- 2) If any defective teeth are detected contact Enstrom Product Support.
- 3) If no defective teeth are detected, no further action is required.
