SERVICE INFORMATION LETTER NO. 0129  
Page 1 of 16

SUBJECT: Minor Maintenance & Repair of Main & Tail Rotor Blades

MODEL: F-28A, 280, F-28C, 280C, F-28F & 280F Helicopters

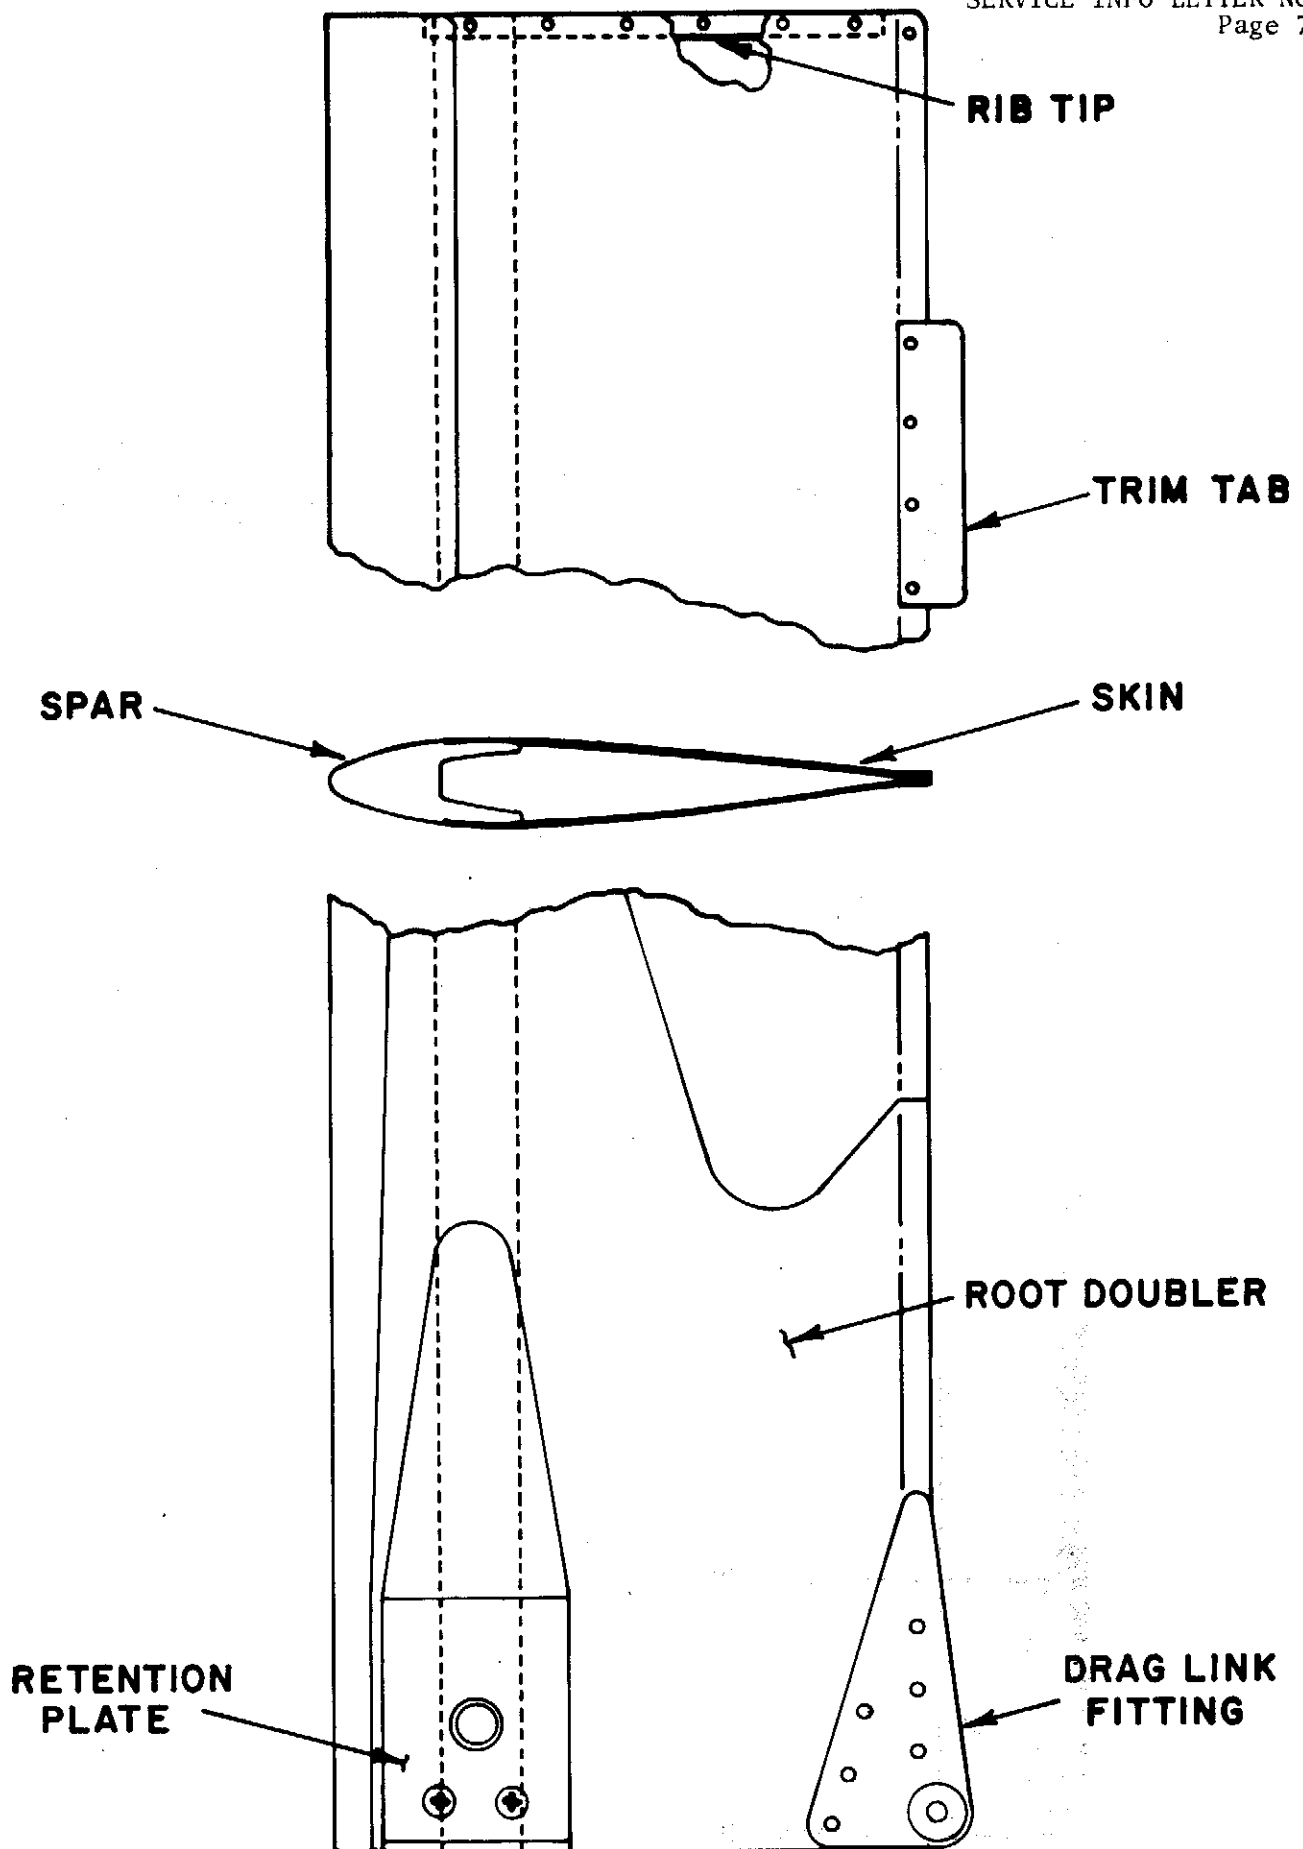
**FIGURE 1**  
**MAIN ROTOR BLADE ASSEMBLY**

- A. Inspect the main rotor blade, spar, skins, trim tabs, retention plates, drag link fittings, and root doublers for any mechanical damages such as nicks, scratches, dents and cracks. Inspect the blade tip rib, trim tab and drag link fittings for loose rivets. Reference Figure 1 for component definition.

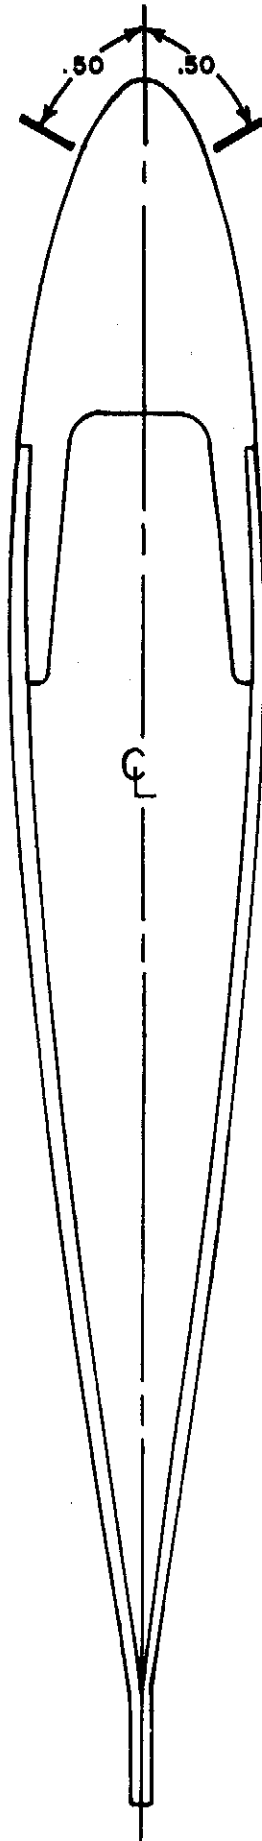
FIGURE 5.  
Spar Rejection Criteria - Sharp Dents at Leading Edge

- a. Nicks and scratches greater than the limits on Figure 2 are cause for rejection.
- b. Leading edge dents with smooth surfaces greater than the limits shown on Figures 3 and 4 are cause for rejection.
- c. Leading edge dents with sharp width to depth ratios (i.e., less than 3:1), or with torn, nicked, scratched or creased surfaces greater than the limits in Figure 5 are cause for rejection.

- a. Nicks and scratches within repairable limits should be polished out and blended smooth as shown in Figure 6.
- b. Sharp dents within the permissible limits shown in Figure 5 must be blended as noted in Figure 7.

NOTE: 1. Sharp dents less than these limits must be repaired using approved procedure (see Figure 7).

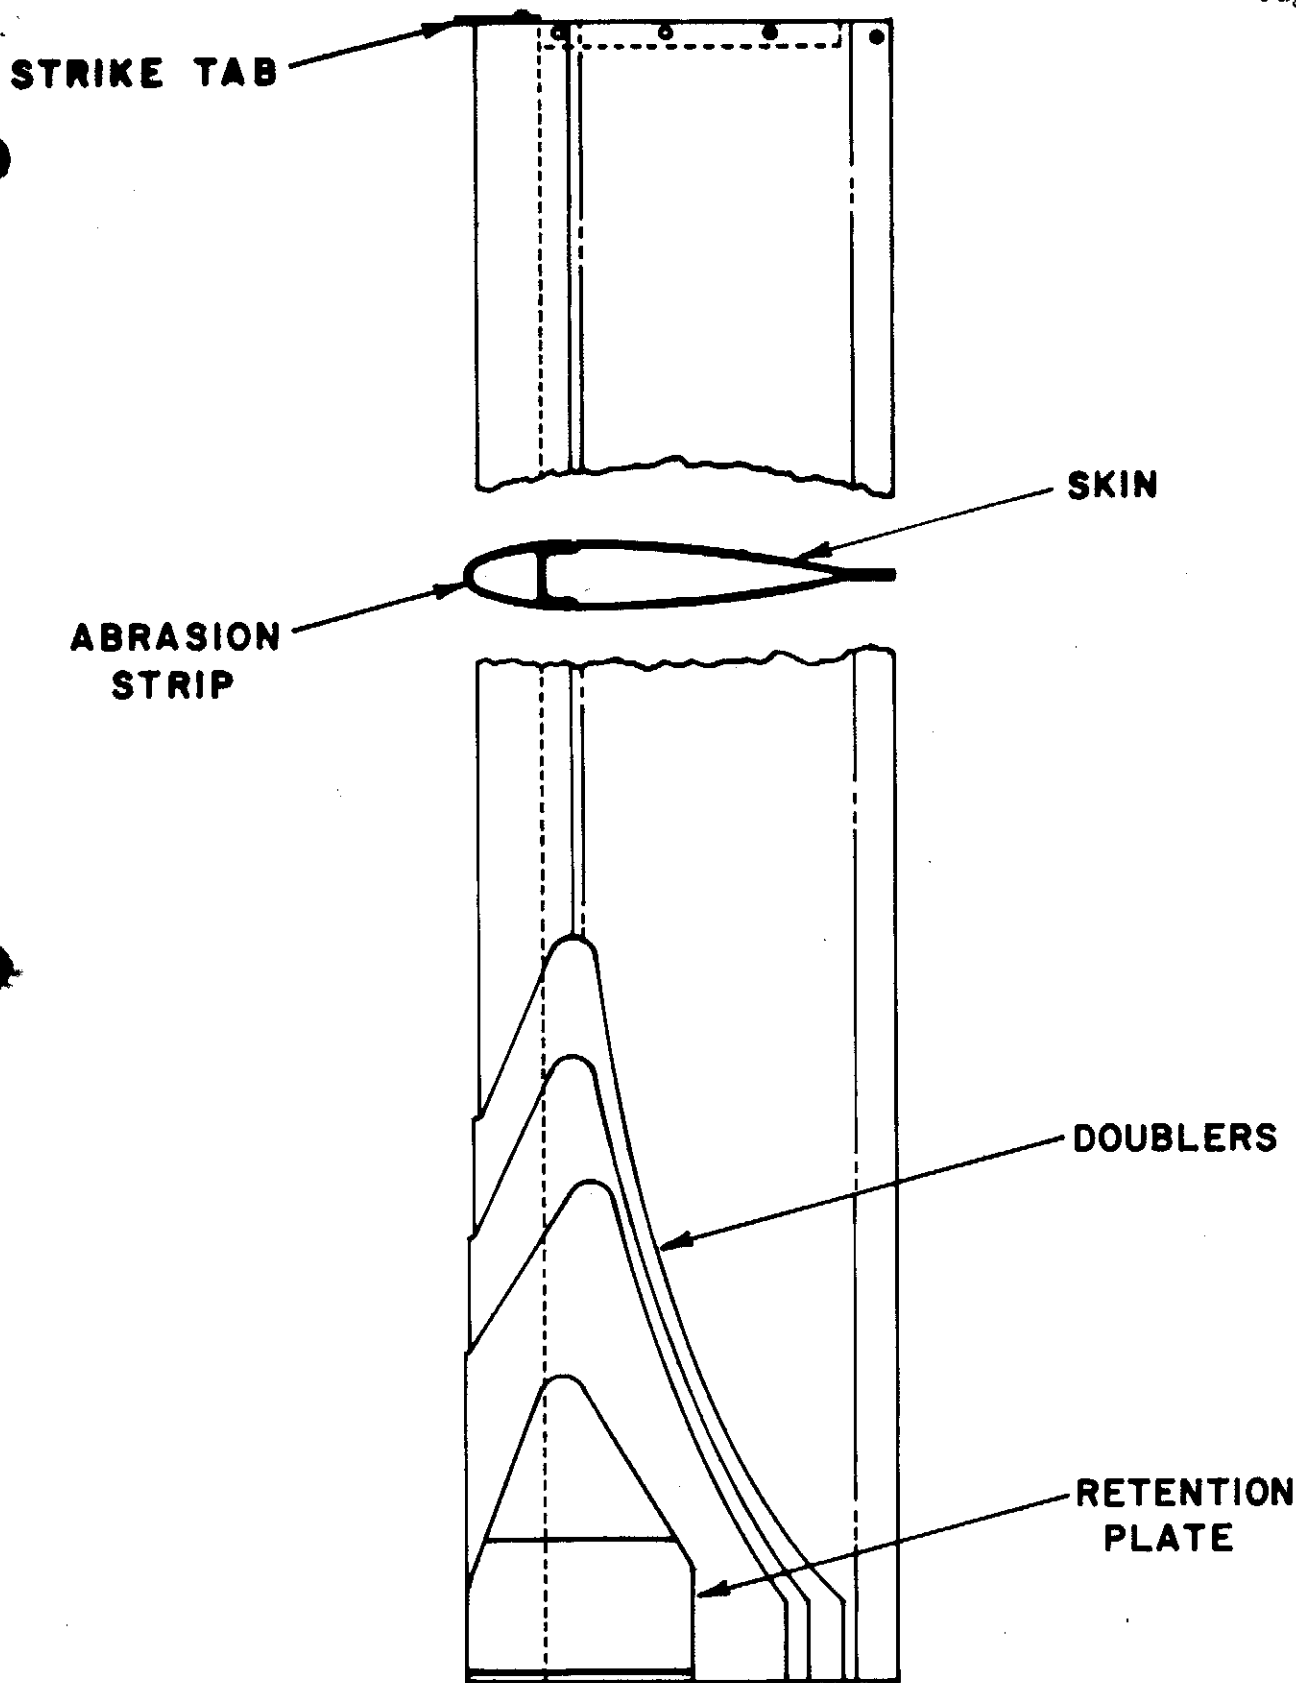
**FIGURE 9**  
**BLADE ASSEMBLY**  
**(TAIL ROTOR)**

Inspect the tail rotor blade, skins, abrasion strip, retention plates and root doublers for nicks, scratches, dents and cracks (see Figure 9). Check the tip rib for loose rivets and strike tab for damage.
