# SERVICE DIRECTIVE BULLETIN

SERVICE DIRECTIVE BULLETIN NO. 0126

Revision 1

1. SUBJECT: Cabin Bellcrank Mounts and Bellcrank Attachment Inspection
2. MODEL: F-28A, 280, F-28C, F-28C-2, F-28C-2R, 280C, F-28F, F-28F-R, 280F, and 280FX
3. EFFECTIVITY: All S/N (Note special exclusion in paragraph 5.3.)

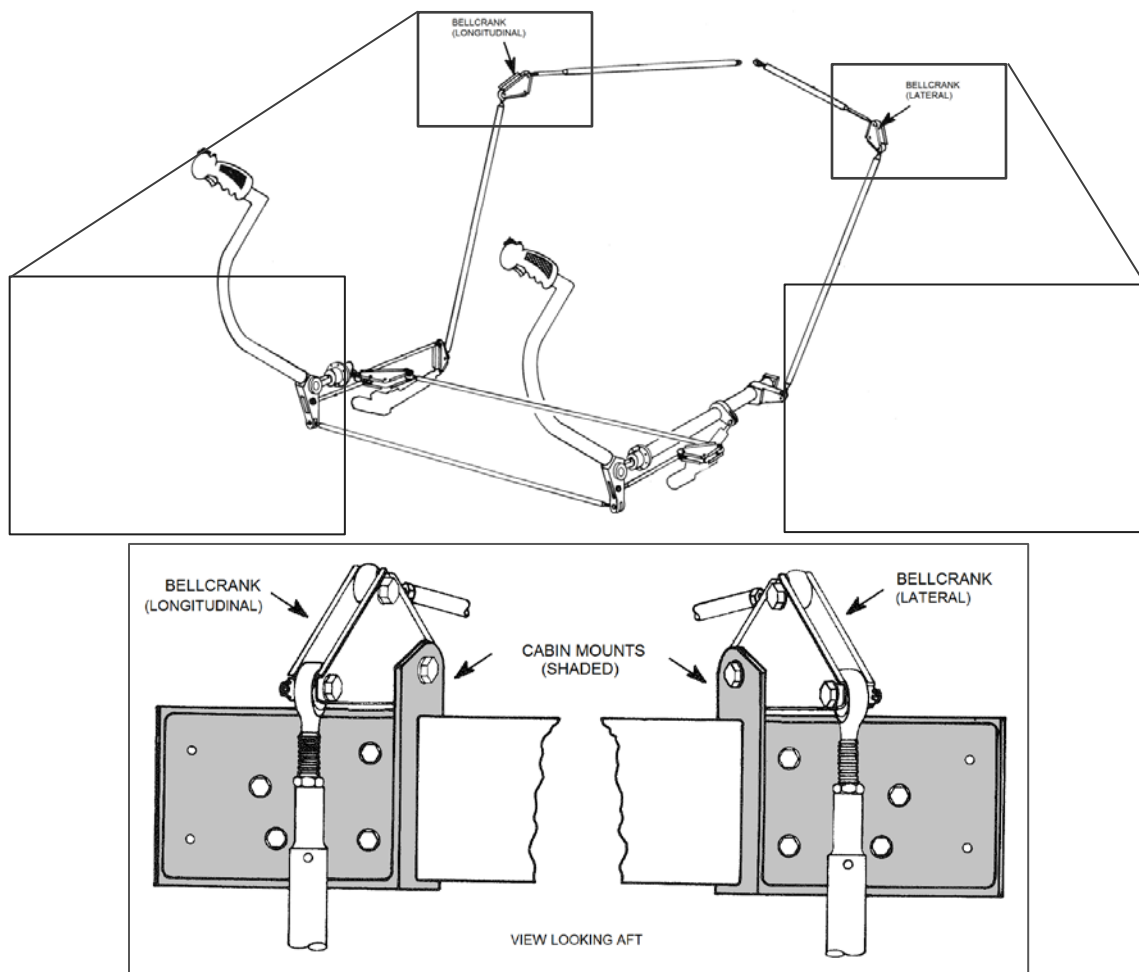
*Figure 1. Cyclic Control System Schematic (Top); Bellcrank Cabin Mounts (Bottom)*

**The schematic of the cyclic control system and the relative location of the upper cabin mounts are shown in Figure 1.**

- 6.1 Perform NDT inspection of the upper cabin mounts (lateral and longitudinal) (Figure 1 and Figure 4-a, 4-b).
  - 6.1.1 Remove the seat structure cover.
  - 6.1.2 Remove the left and right fuel tanks.
  - 6.1.3 Detach the control tube backwall cover, if equipped (Figure 2).
    - 6.1.3.1 Remove the four screw fasteners.
    - 6.1.3.2 Cut the cable ties on both ends of the rubber boot.
    - 6.1.3.3 Break the seal between the cover and the backwall and the fire curtain.
    - 6.1.3.4 Move the boot and cover aft to gain direct access to the cabin mount.
