# **SERVICE INFORMATION LETTER**

SERVICE INFORMATION LETTER NO. 0129  
Page 1 of 16

SUBJECT: Minor Maintenance & Repair of Main & Tail Rotor Blades

MODEL: F-28A, 280, F-28C, 280C, F-28F & 280F Helicopters

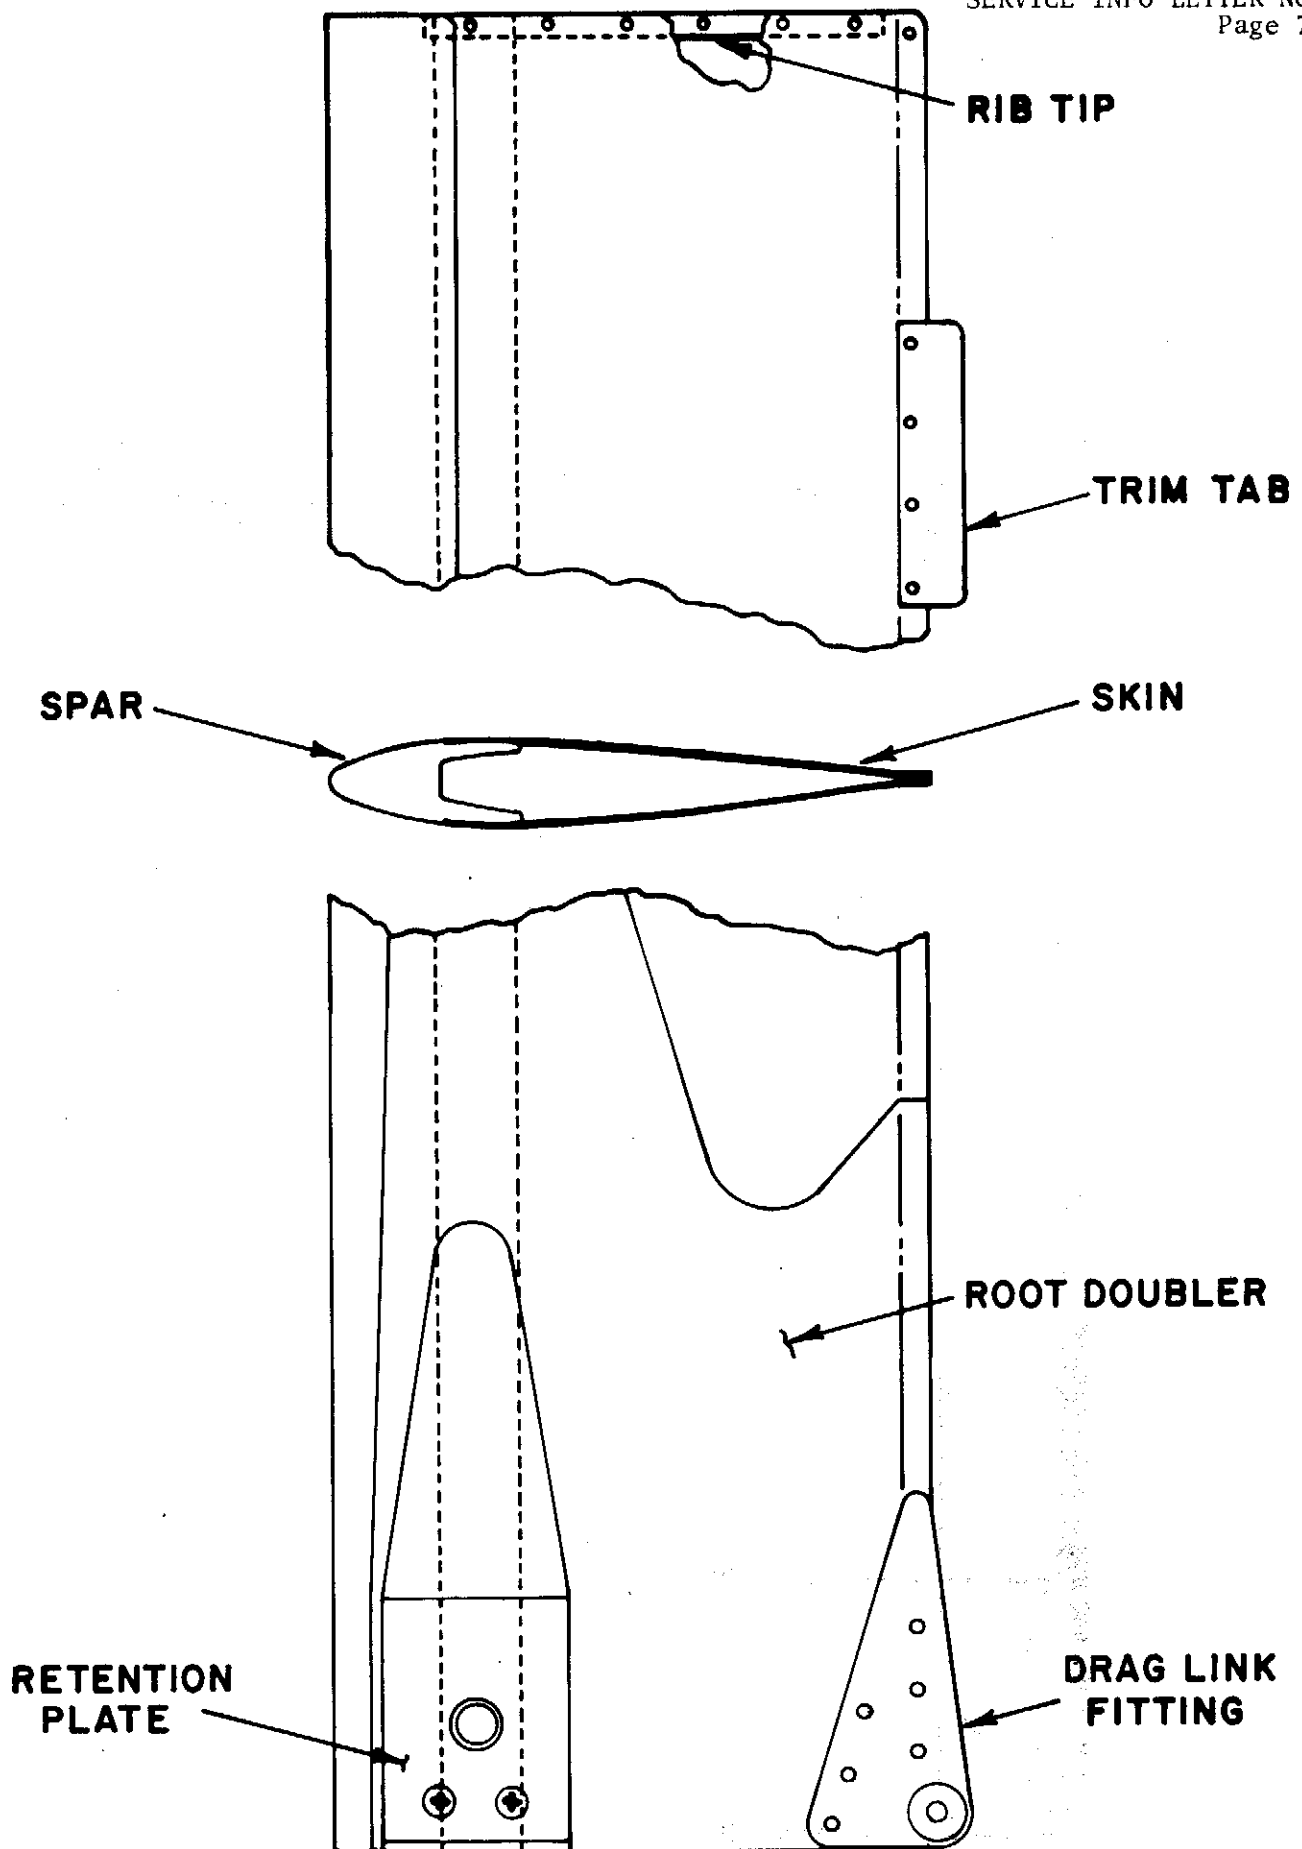
**FIGURE 1**

- A. Inspect the main rotor blade, spar, skins, trim tabs, retention plates, drag link fittings, and root doublers for any mechanical damages such as nicks, scratches, dents and cracks. Inspect the blade tip rib, trim tab and drag link fittings for loose rivets. Reference Figure 1 for component definition.

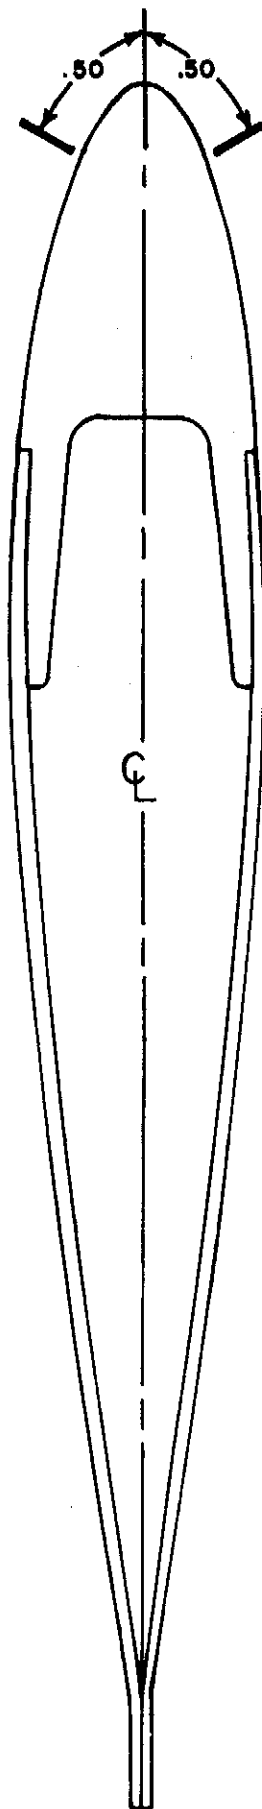
FIGURE 5.  
Spar Rejection Criteria - Sharp Dents at Leading Edge

- a. Nicks and scratches greater than the limits on Figure 2 are cause for rejection.
- b. Leading edge dents with smooth surfaces greater than the limits shown on Figures 3 and 4 are cause for rejection.
- c. Leading edge dents with sharp width to depth ratios (i.e., less than 3:1), or with torn, nicked, scratched or creased surfaces greater than the limits in Figure 5 are cause for rejection.

NOTE: 1. Sharp dents less than these limits must be repaired using approved procedure (see Figure 7).

- a. Nicks and scratches within repairable limits should be polished out and blended smooth as shown in Figure 6.
- b. Sharp dents within the permissible limits shown in Figure 5 must be blended as noted in Figure 7.

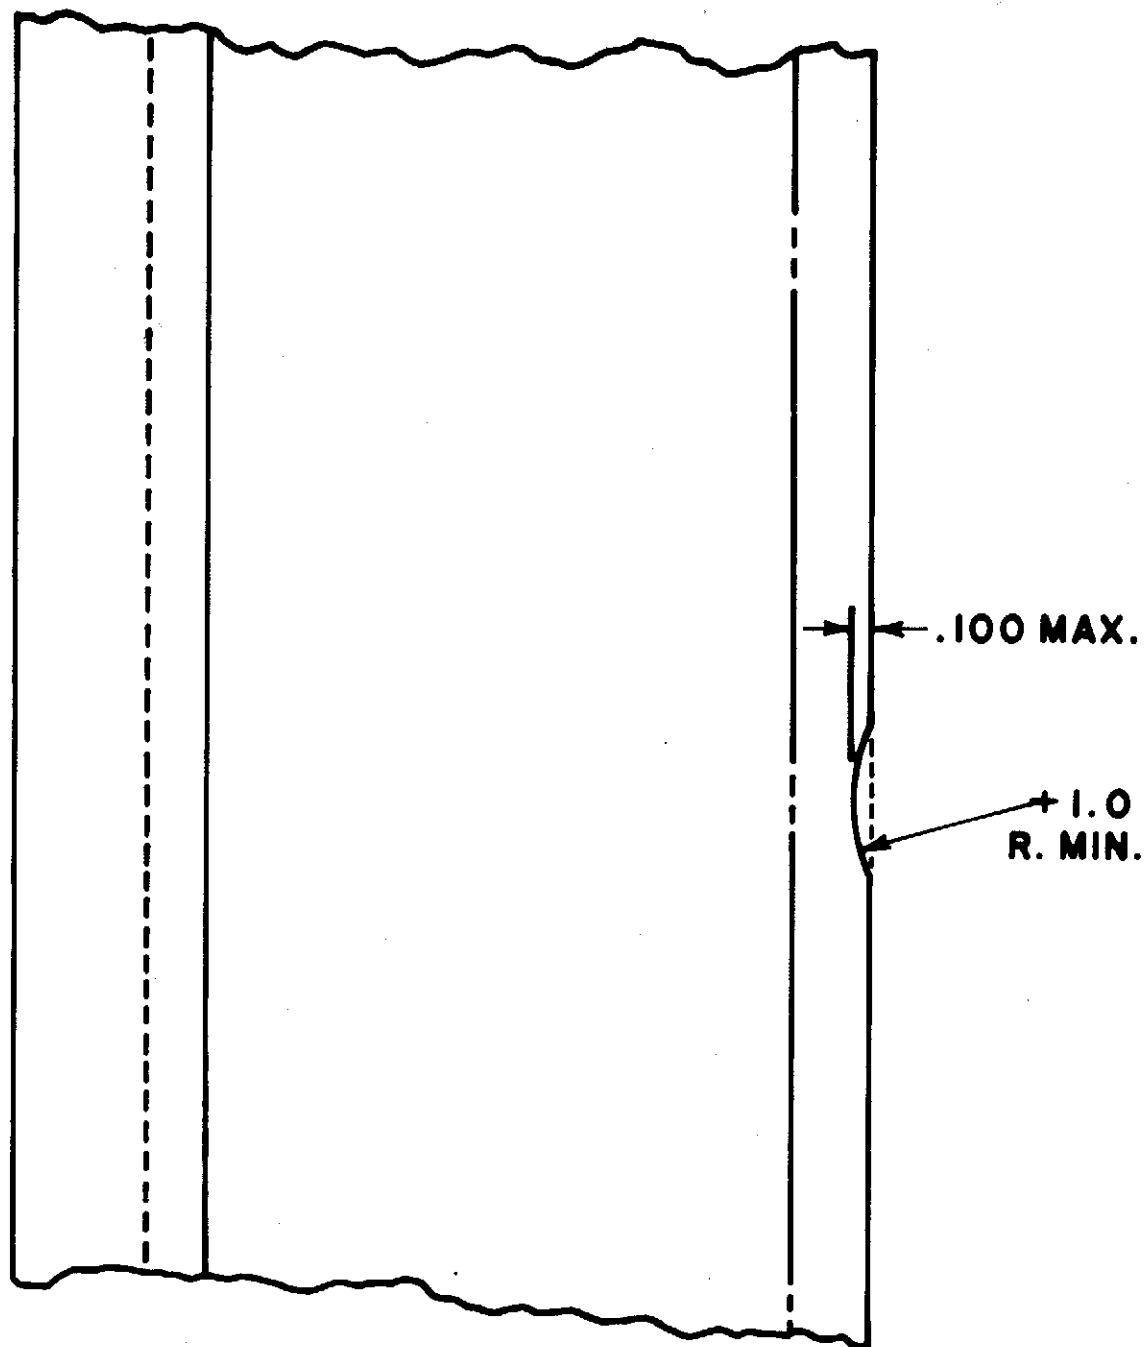
**FIGURE 10**  
**TRAILING EDGE DAMAGE REMOVAL**  
**(TAIL ROTOR)**

- a. Buff out all scratches not deep enough to penetrate the clad material.
- b. Polish out all deeper scratches to a depth not exceeding .010 inch. Blend smooth over an area 2.00 inches in diameter. Scratches deeper than noted are cause for rejection.
- c. Blend out nicks in the trailing edge to a depth (chordwise) not to exceed .100 inch, in a circular arc, not less than 1.00 inch in radius. (See Figure 10.) Any nicks in the trailing edge in excess of the noted depth are cause for rejection.
- d. Sharp dents exceeding .010 inch are cause for rejection.
- e. Smooth dents exceeding .025 inch are cause for rejection.
- f. Cracks in any direction are cause for rejection.
