Maintaining the Teledyne Bendix D-3200 series Magneto

BACKGROUND: To provide additional information for aiding technicians in maintaining the Teledyne Bendix D-3200 Magneto.

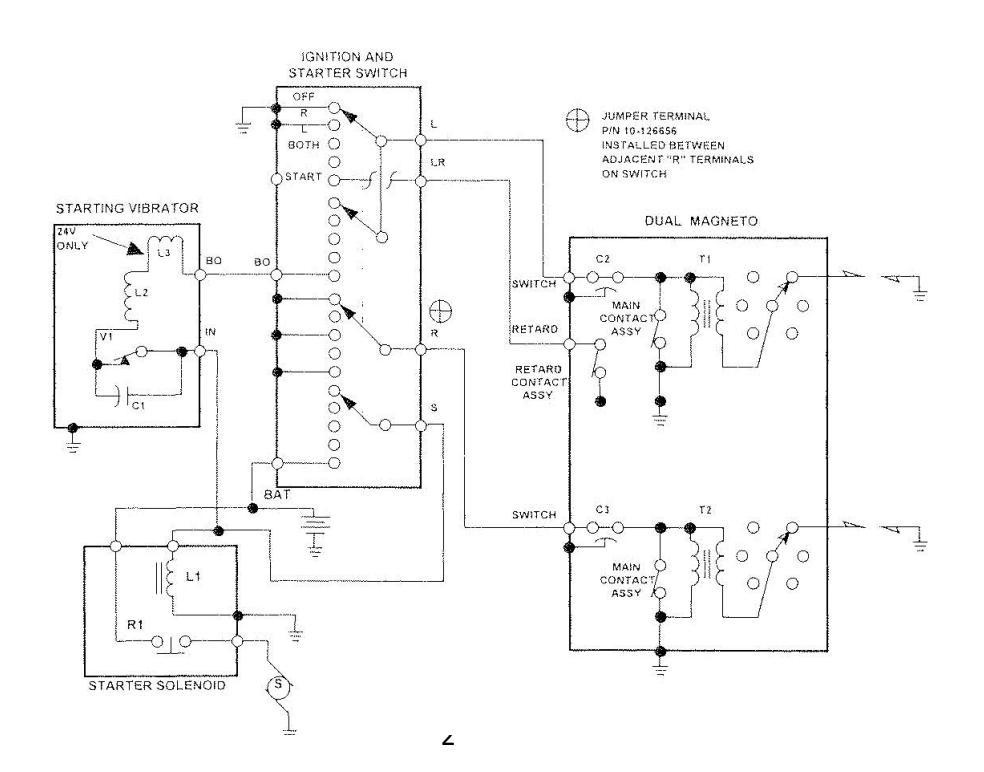
- F. 3200- Shower-of-sparks starting system.
- III. Shower-of-sparks Starting system description
 - A. The shower-of-sparks starting system uses a vibrator/relay that is mounted on the firewall behind the co-pilot seat. When the pilot presses the starter switch mounted on the collective the vibrator/relay performs the following functions.

- 1. Grounds the right magneto P lead.
 - 2. Switches the left magneto P lead to the retard P lead position on the magneto.
 - 3. Energizes the vibrator and sends the current into the retard P lead.

THIS IS NOT AN ACTUAL DIAGRAM OF THE ENSTROM INSTALLATION AS THE ENSTROM HAS A SEPARATE STARTER SWITCH THAT IS NOT INCORPORATED INTO THE MAGNETO SWITCH

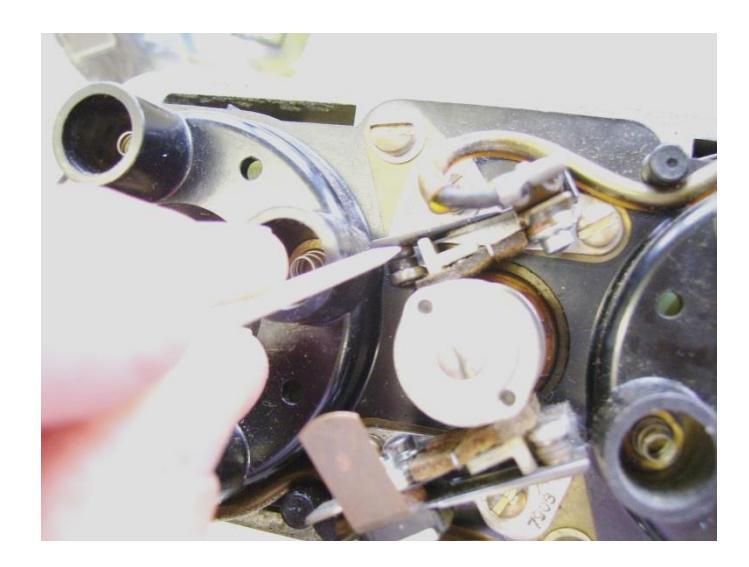
- V. Inspection of contact assemblies.
 - A. Remove the cover assembly remove the 4 corner screws and wiggle the cap assembly while withdrawing it from the magneto. The ignition wire insulators may stick in the distributer block making the cap initially difficult to remove.
 - B. When the cover is loose reach in and remove the upper (right magneto) cover P lead from the contactor terminal.
 - C. Open the cover and twist it downwards to expose the left side P lead contact and remove it from the contactor terminal.
 - D. Push the cover down so that it is out of the way, the wire bundle clamps may have to be loosened to achieve enough wire slack to move the cover away from the magneto.
 - E. Turn the engine by the fan so that the contactor cam followers are on a cam high point.

- F. Use a .14 feeler gauge as a go-no-go gauge. The Teledyne tolerance for the left points is .16 ±.002 and ±.004 for the right mag but Enstrom has determined that -.002, is the minimum point gap acceptable for the engine to deliver best power and operation time between magneto maintenance.
- G. If the gaps are less than .014 remove the magneto to readjust the contactors. This process cannot be accomplished with the magneto installed on the engine.
- H. Inspect the condition of the contactor in accordance with 6-2 of the Teledyne maintenance manual.
- I. Remove the magneto for contactor replacement if the parameters of the MM are not met.

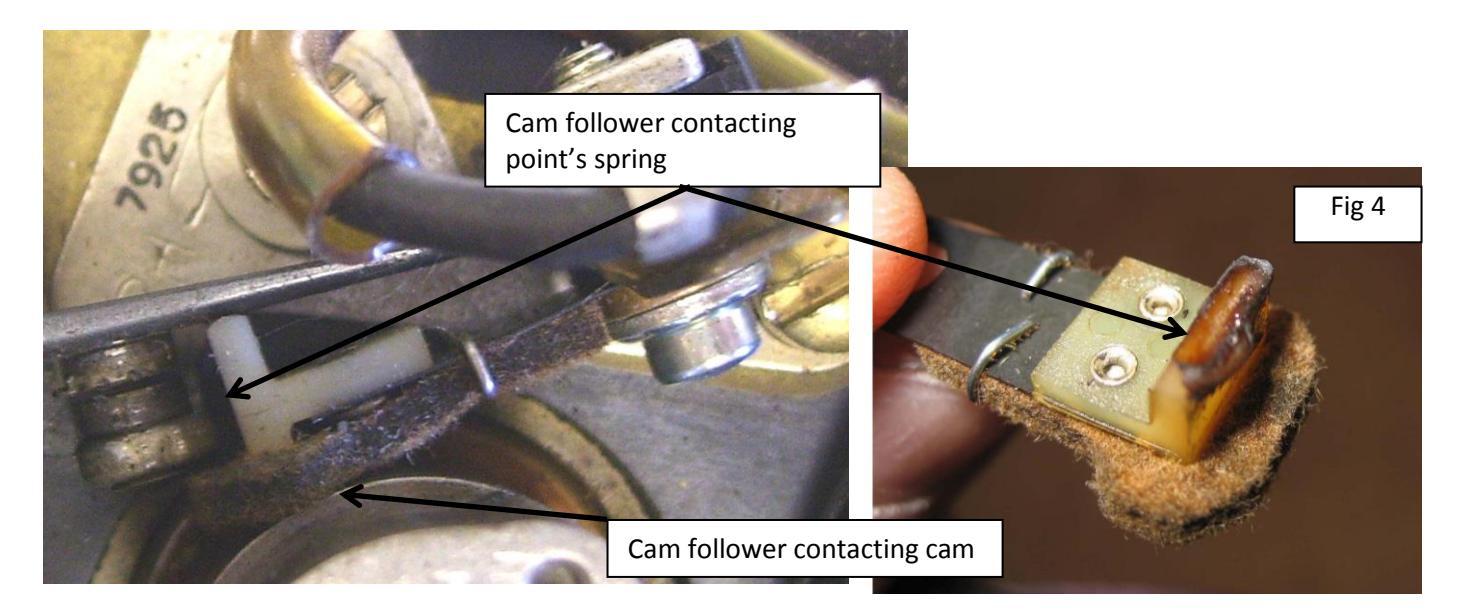
J. Contact condition:

- i. Inspect the contact surface carefully to determine cause of the points closing. It is normal for the cam follower to wear some where it rubs on the cam.
- ii. If the points show signs of arcing, or the cam follower is melted where it pushes on the spring (Fig 4) the capacitor is most likely faulty and should be replaced.
- iii. If the cam follower is excessively worn where it rubs on the cam, the felt may be dry, the cam may need replacement, or the shaft bearing may be running hot in the distributer block.

- 1. Replace capacitors.
- E. Cam follower is melted where it touches the contact spring. (Fig 4)
 - i. Capacitor has failed, arcing has overheated point spring.

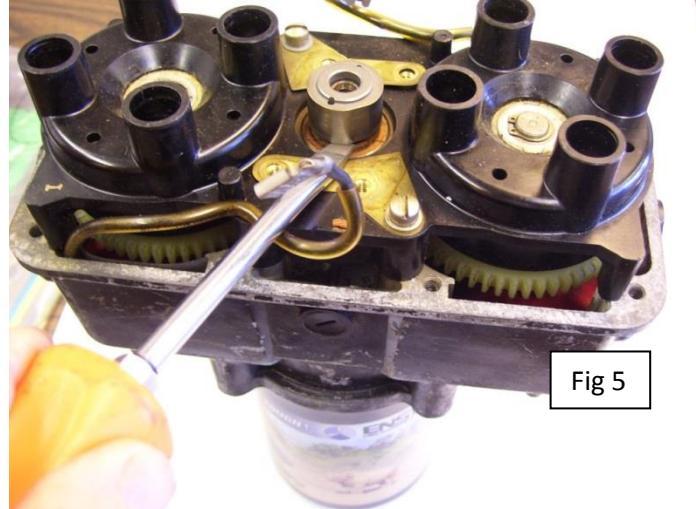
- VI. Replacing contacts and Internal Magneto Timing.
 - A. Remove both sets of contacts, and both cams. The bottom cam can be removed by inserting a flat blade screw driver between the cam and the bearing and prying the cam off the shaft. (Fig 5)

Fig 5. Removing the cam with a flat blade screwdriver.

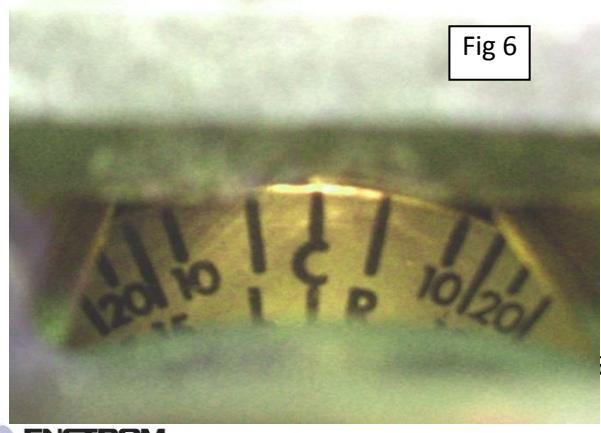
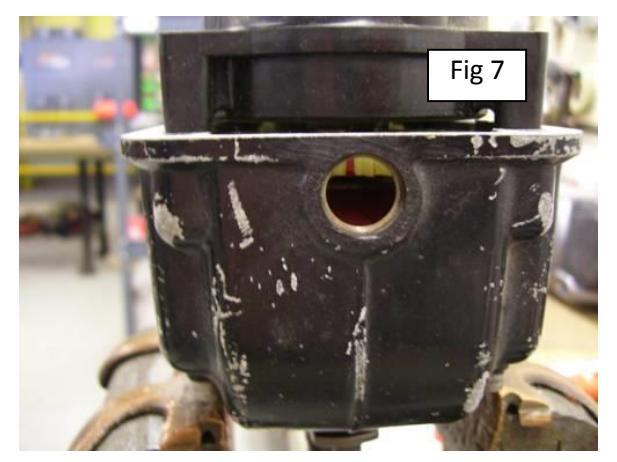
- D. Position the rotating magnet so that the 'C' is adjacent to the mark cast into the housing (Fig 6), the magneto is in the neutral position, and the two chamfered teeth are showing in the windows in the ends of the magneto (Fig 7). (When the "L" is adjacent to the mark cast in the housing, one chamfered gear will be centered in the window and the other will be about one tooth off from centered).

- VII. Installing the magneto onto the engine.
 - A. Set the engine to the firing positon for #1 cylinder. (20° BTDC)
 - B. Set the magneto to the firing position for the #1 cylinder.
 - i. The C in the top window, the two red chamfered teeth in the side windows, and the label up. (Fig 6 & 7)
 - C. Check the alignment of the drive adapter on the magneto to the adapter inside the engine. On older magnetos, the drive adapter was installed with the connector palls horizontal and on the newer magnetos it is installed with the palls vertical. (Fig 10, item 1)

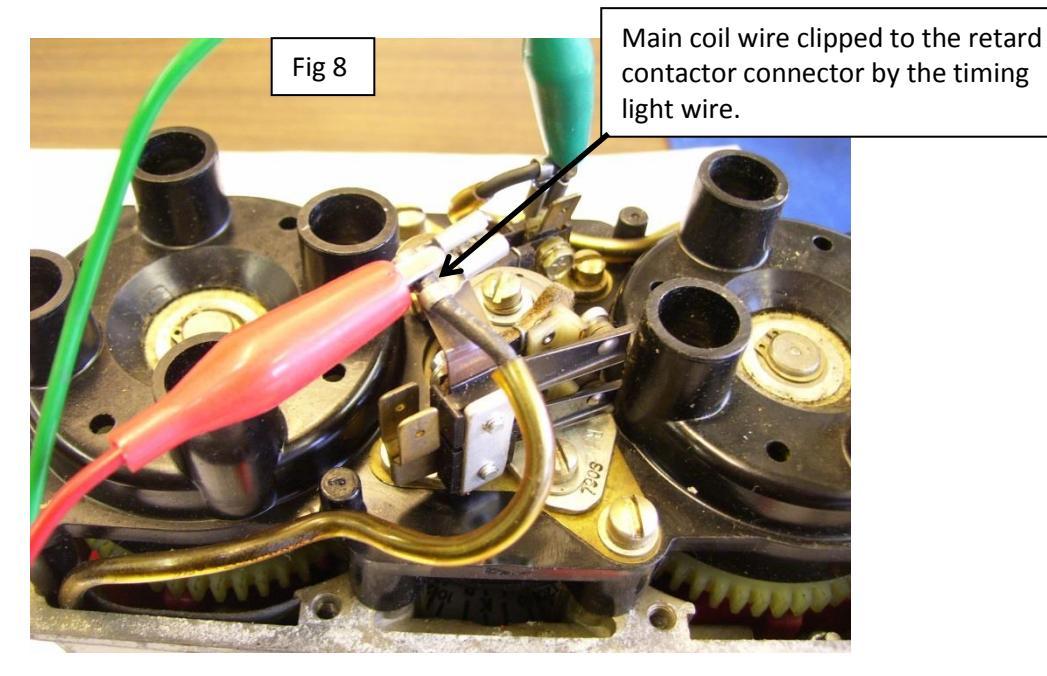
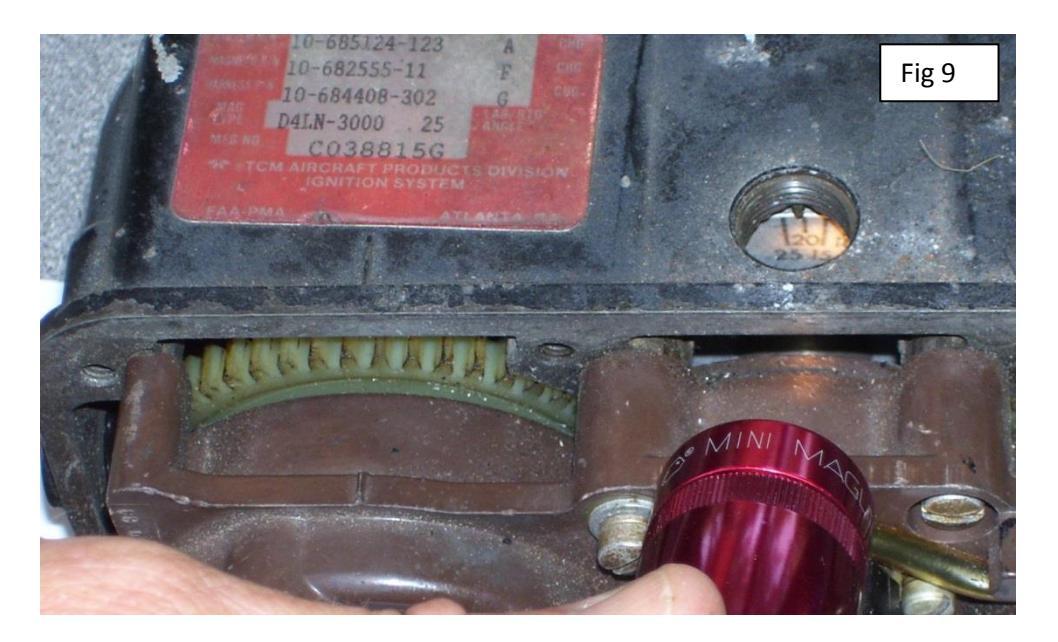
- K. Connect the timing light to the retard 'P' lead contact tang.
 - i. Install the timing light onto the retard 'P' lead connector. When using an LED style timing light, it must ground through the coil to work so it is necessary to clip the coil wire to the contactor 'P' lead contact with the timing light wire. (Fig 8)

- Loosen the cam securing screw and rotate the cam so that the retard points open when the 20° mark on the rotating magnet is exactly adjacent to the mark cast into the magneto housing. (Fig 9) The main cam will maintain its positon on the shaft because of the taper.

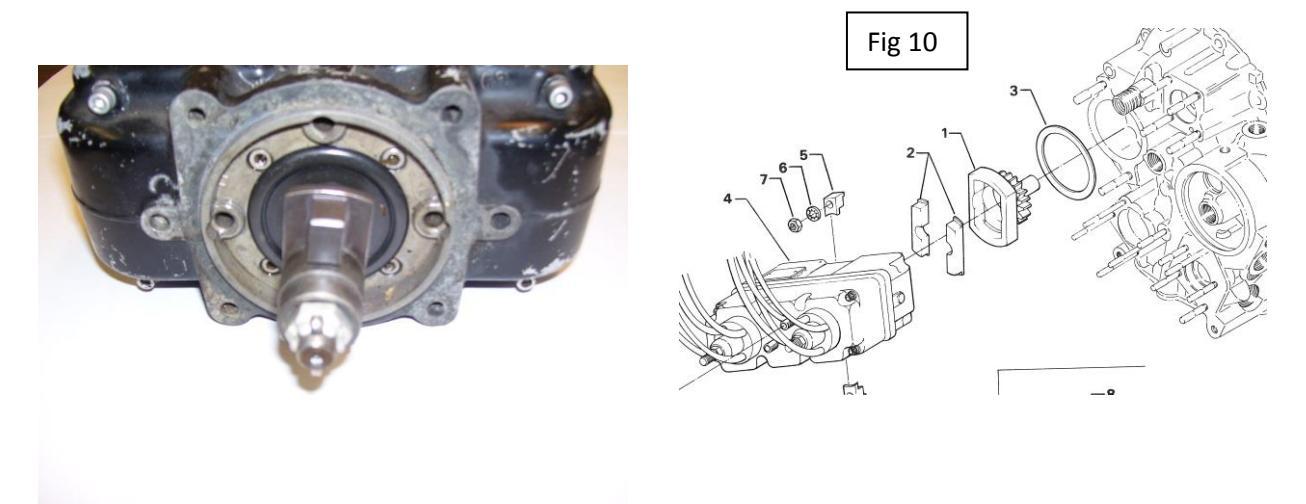
i. Occasionally, the adapter will come out of the engine with the magneto or need to be repositioned due to the magneto having the adapter in a different position.

- ii. Install the adapter into the engine in a positon that will allow the magneto to be installed and rotated a few degrees in both directions so the magneto to engine timing may be adjusted. The adapter has an odd number of gear teeth and if the angle is a little off, the adapter can be rotated 180° and reinstalled with the palls in a slightly different positon.

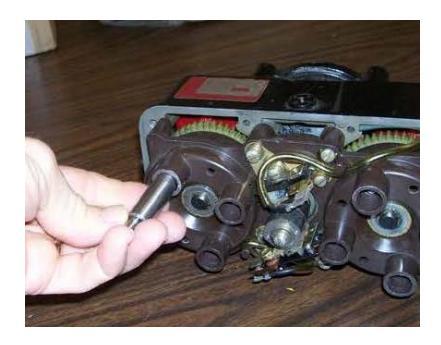
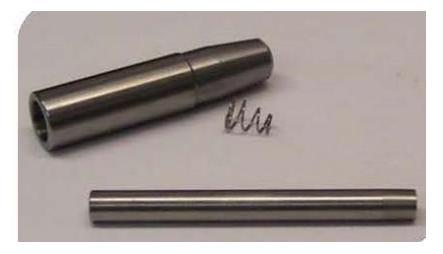
T-0179 Magneto block spring installation tool

- iv. Spring missing from the distributor block.
 - 1. Bendix and Enstrom both have tools to insert the spring into the magneto block.
