# Enstrom Maintenance Alert

**28-16186-1 Pilot Collective Socket**

**Enstrom: F-28C; S/N 429, Time in Service Unknown**

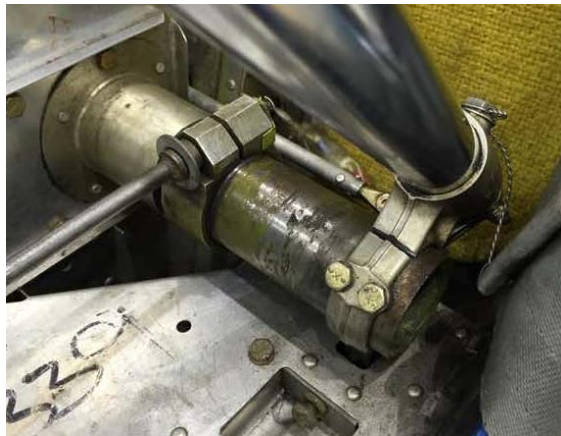
It was reported that a technician found a cracked pilot's collective socket (P/N 28-16186-1) on a F28-C helicopter. The time and history of the helicopter is not known. Enstrom recommends inspecting the collective mounts carefully during scheduled inspections or any time the collective cover is removed.

SDB's 0050, & 105 also apply to issues that have occurred with the collective system.
