ENSTROM
HELICOPTER CORPORATION

Stinger Tube Bracket/Rivet Repair

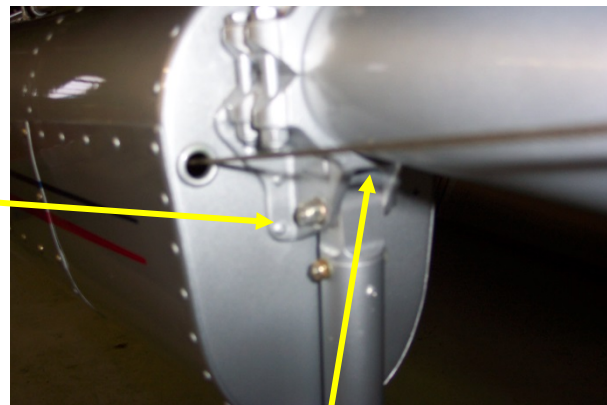
Smoking around the rivets through the stinger tube attach bracket usually indicate looseness of the bracket. If they are found loose, it's much easier to replace the rivets with structural screws than over size rivets. The screws that hold gas tanks into a Piper Cherokee wing are the proper size to use in the tailcone brackets.

MS27039-0809 or AN525-832R8

Push up and down on the stinger tube with your finger across the casting to determine whether the stinger tube and bracket are loose on the bulkhead.
