# SERVICE DIRECTIVE BULLETIN

SERVICE DIRECTIVE BULLETIN NO. 0116  
Revision 3

1. SUBJECT: Cyclic and Collective Control Tube Assembly Inspections
2. MODEL: F-28F, F-28F-R, 280FX and any additional models that have been modified by adding rubber boots
3. EFFECTIVITY: F-28F Series: Serial Numbers 747 through 832\*  
280FX Series: Serial Numbers 2013 through 2147\*  
\*All Models: Any earlier Serial Number modified with the Control Tube Cover Installation
4. REFERENCE: Enstrom F-28A/F-28C Series Maintenance Manual, Latest Revision  
Enstrom 280/280C Series Maintenance Manual, Latest Revision  
Enstrom F-28F/280FX Series Maintenance Manual, Latest Revision

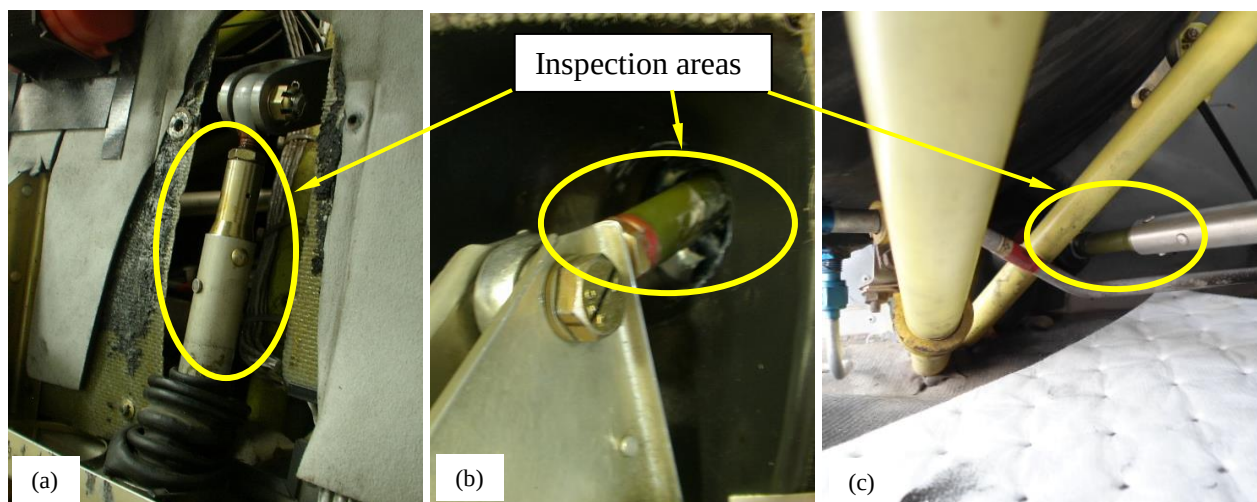
7.7. Locate the cyclic (lateral and longitudinal) and collective control tube assemblies (Figure 1). Remove the tie wrap and inspect the surface near and under the boot for corrosion (Figure 2). Use a flashlight or bright light source as necessary for the inspection.

Figure 1. Inspection areas; (a) collective control tube assembly and cyclic control tube assembly ((b) as viewed from the cabin through the backwall and (c) as viewed through the upper left side engine cowling).

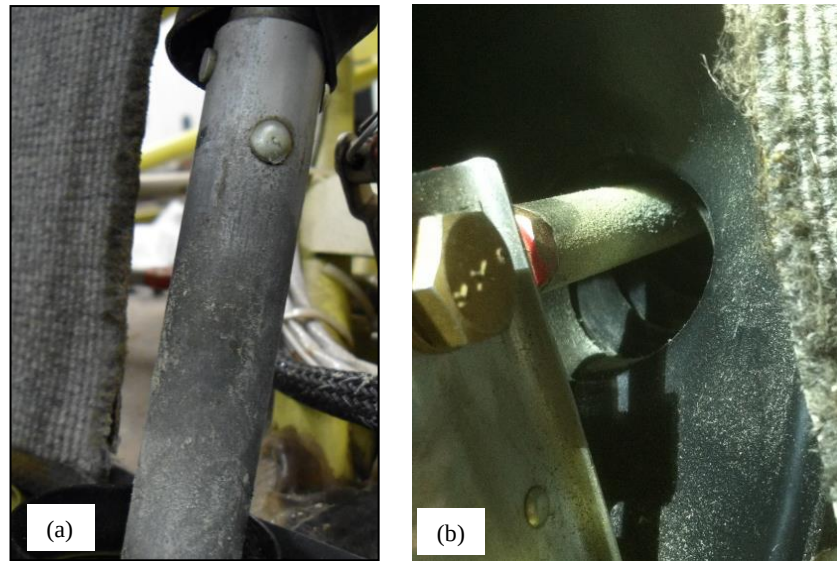
Enstrom has received reports of corrosion on the surface of cyclic and collective control tube (push-pull rods) assemblies. The corrosion is limited to the area of the tube in contact with the rubber boot. During the investigation, it was determined that a residue on the interior surface of the boot (a result of the manufacturing process) and a reaction with ambient moisture caused the corrosion on the aluminum surface of the tube. Enstrom has incorporated a cleaning process to ensure the boots are free of residue on assembly.

Figure 2. Examples of corrosion; (a) collective control tube assembly, and (b) cyclic control tube assembly.

7.9. If corrosion is detected and damage is less than 0.010" (0.25 mm deep), perform the following:

7.9.3. Blend out damage less than 0.010" (0.25 mm deep). Clean and apply corrosion protection to the control tube surface (i.e. Alodine or epoxy primer).

7.10. If corrosion is detected and damage exceeds 0.010" (0.25 mm deep), perform the following:

7.10.3. Install a new control tube assembly as follows:

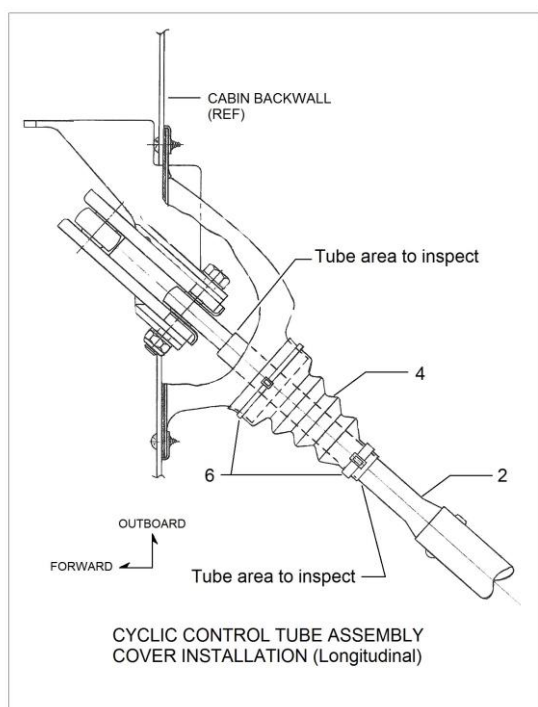
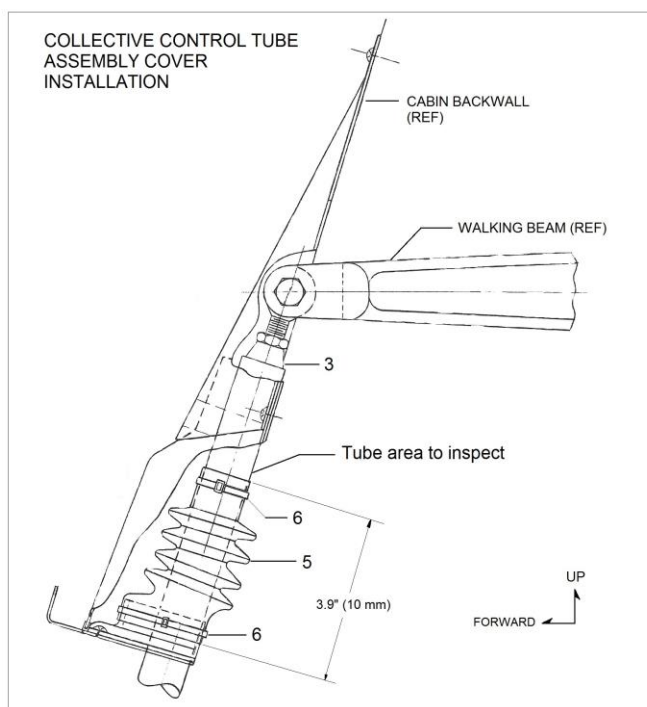
Figure 3: Cyclic and Collective Control Tube Cover Installation

7.10.5. Install boot to indicated length in Figure 3.

7.10.5.1. Position collective in full up position when cable tie is added at this dimension.

9.1. Replacement parts: see Figure 3 below.
